**MSAD No. 75 Envelope Analysis  
Report  
May 31, 2021  
*Updated July 2021*  
Prepared by: CHA Architecture**

The MSAD No. 75 School District contracted with CHA Architecture, P.C. to conduct an analysis of the existing cladding at the Mt. Ararat Middle School and make recommendations for recladding the existing building.

### HEAD DETAIL - FIBER CEMENT SIDING CONDITION

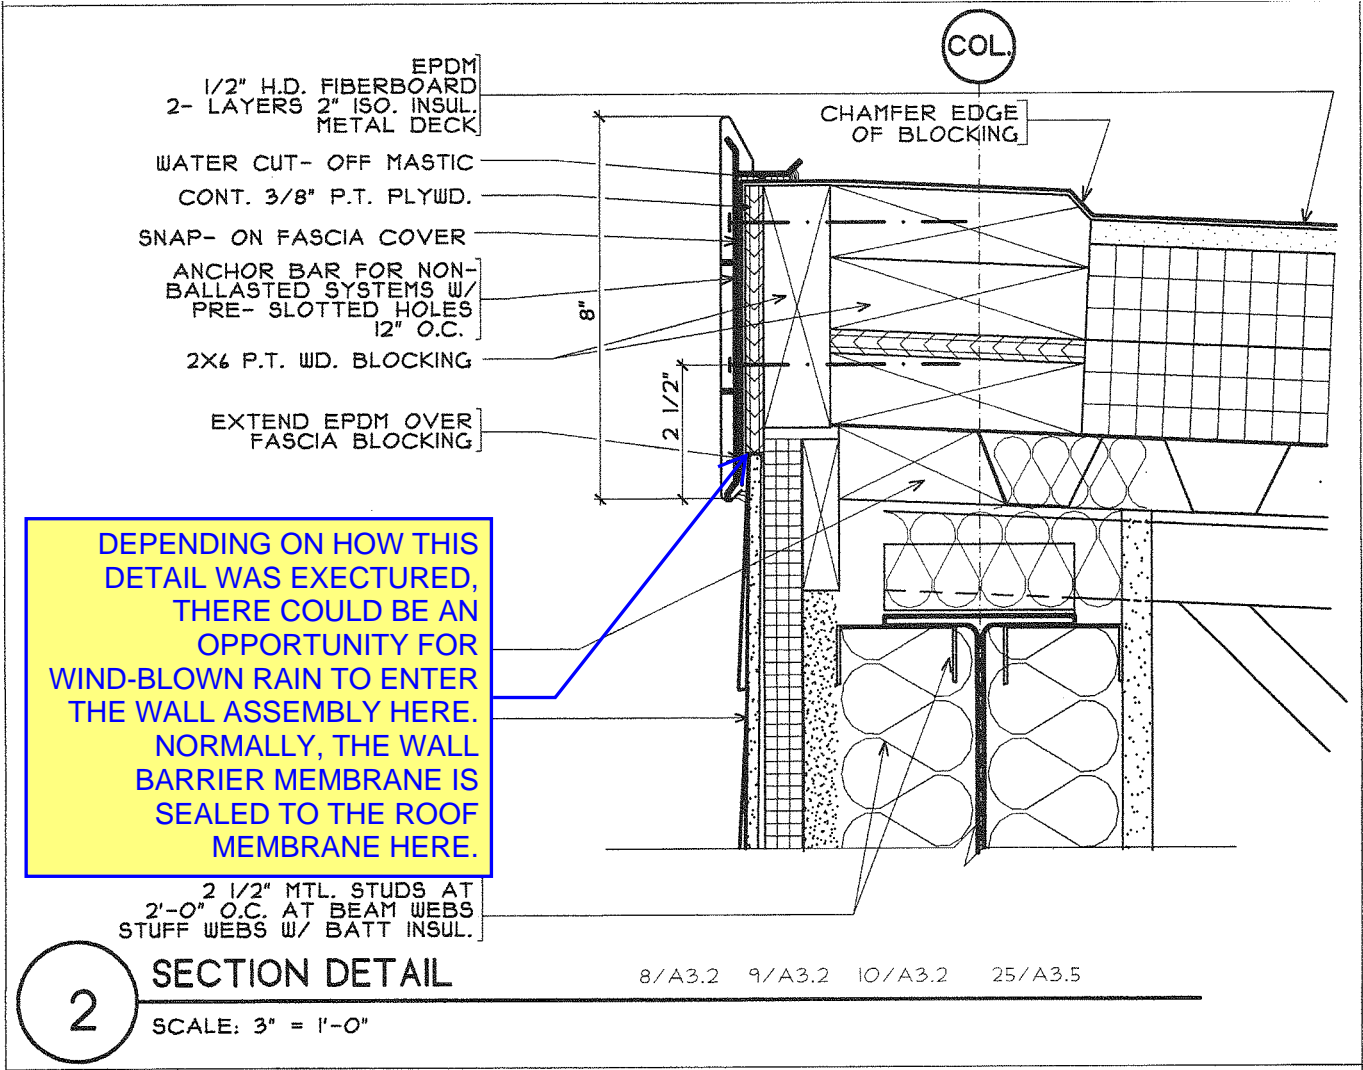
DEPENDING ON HOW THIS  
DETAIL WAS EXECTURED,  
THERE COULD BE AN  
OPPORTUNITY FOR  
WIND-BLOWN RAIN TO ENTER  
THE WALL ASSEMBLY HERE.  
NORMALLY, THE WALL  
BARRIER MEMBRANE IS  
SEALED TO THE ROOF  
MEMBRANE HERE.

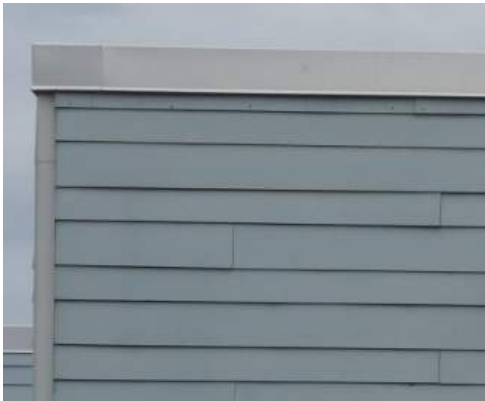
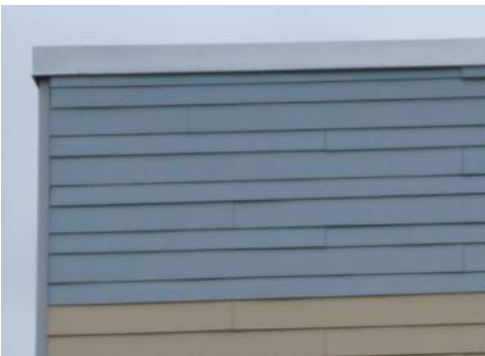
Roof fascia observed at the building (formed and nailed brake metal) does not appear to be the same heavy-duty type of fascia drawn and noted in the detail above (two-piece with extruded aluminum anchor bar with snap on painted metal finish fascia).

The product shown in the detail has a continuous, rigid anchor bar that hold the roof membrane tightly to the roof edge blocking. This would have provided greater resistance to wind uplift and provide a generally more uniform joint than a shop-bent metal fascia held down with metal clips.

Sealing this joint against water infiltration is critical, particularly at windward facades of tall buildings that are exposed to higher wind pressures. Water that enters a wall assembly at the top of the can travel a long distance before its effects are recognized. This can make pinpointing the source of water infiltration difficult.

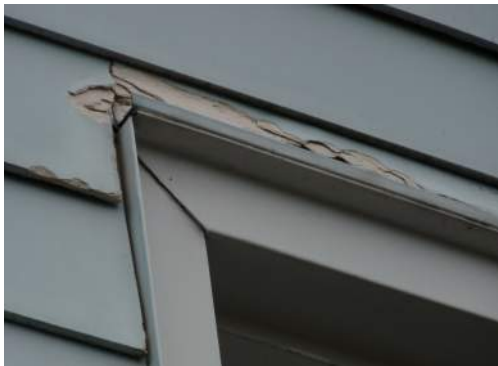
Installed condition does not match detail in some locations. U-shaped metal trim at window heads creates a trough that holds water against the FCS, leading to delamination and dissolution.

U-shaped trim also concentrates water flow to the jambs, instead of allowing it to drip along the length of the window head. This concentrated flow is likely to cause delamination and dissolution of FCS at cut edges of clapboards, particularly since sealant is present between clap board edges and jamb trim.

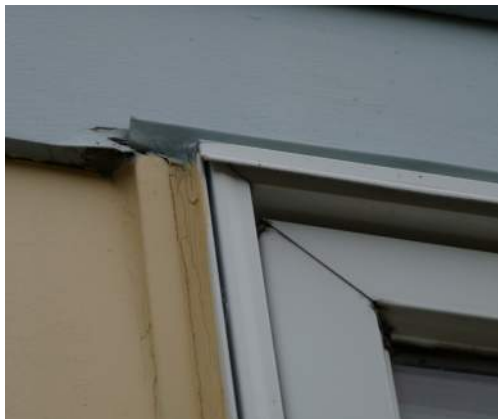
Another variation includes what appears to be head drip flashing, bent upwards to form a trough. Metal jamb trim is provided here to receive the clapboard ends, and substantial amount of sealant has been provided between clapboard ends and metal trim and between the metal trim and a separate piece of vertical window trim.

Sealant is a double-edged sword. When properly applied, sealant is part of a system that keeps water out of a wall assembly. Where water has already infiltrated the wall assembly, sealant can have a detrimental affect of trapping water with the wall assembly.

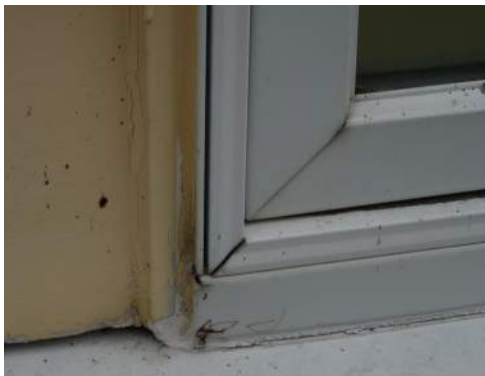
This variation of the window jamb condition resembles the drawn detail, with the addition of sealant between the FCS clapboards and metal J-trim.

The use of flanged windows is assumed based on the construction details. It's possible that if windows without flanges were installed, creating a different and possibly more complicated condition at window perimeters.

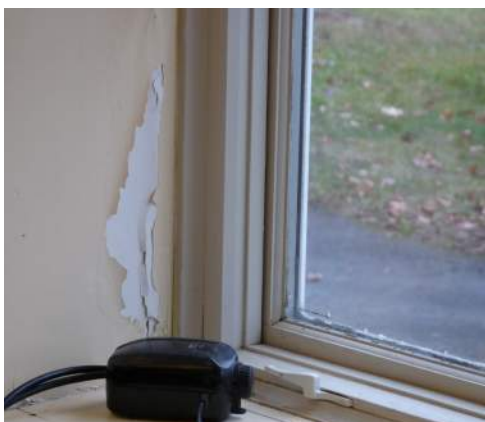
Damage to interior gypsum wall board caused by water moving through wall assembly layers dropping at window jambs. This raises concern about additional water damage to fiberglass batt insulation installed between cold-formed metal studs.

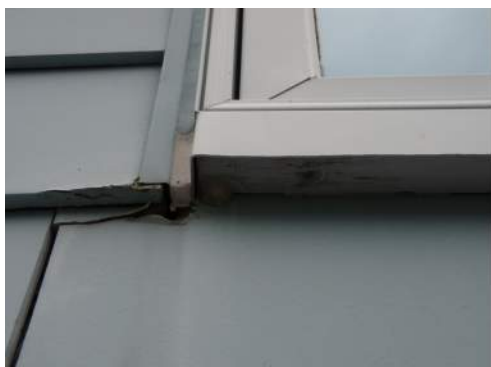
Details call for an extruded aluminum frame extender below the window units sill. These typically lock into a slot in the window unit, providing a tight that's resistant to water infiltration.

The existing sill appears to have been shop-fabricated from pre-finishes brake metal; it's not an extruded peice that would have come from the window manufacturere's standard kit of parts.

While the installed condition is probably not as weather-resistant as the detailed condition, it's unlikely that the sill constitutes is a major water infiltration route, because the window head has already interrupted the vertical flow of water within the wall assembly. However, water damage may be evident below the corners of the sill because of water traveling withing the wall along window jambs.

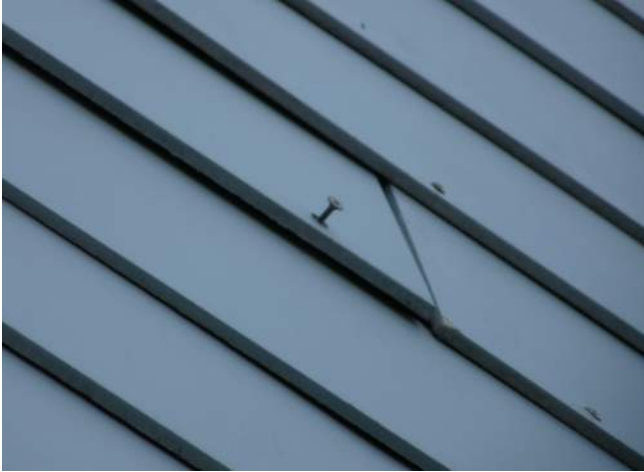
Many fasteners have pulled away from the clapboards, suggesting that not all fasteners are attached to steel studs. Gypsum sheathing has very little fastener-holding capacity and fasteners driven into gypsum sheathing will work themselves out over time as the clapboards are subjected to wind and weather.

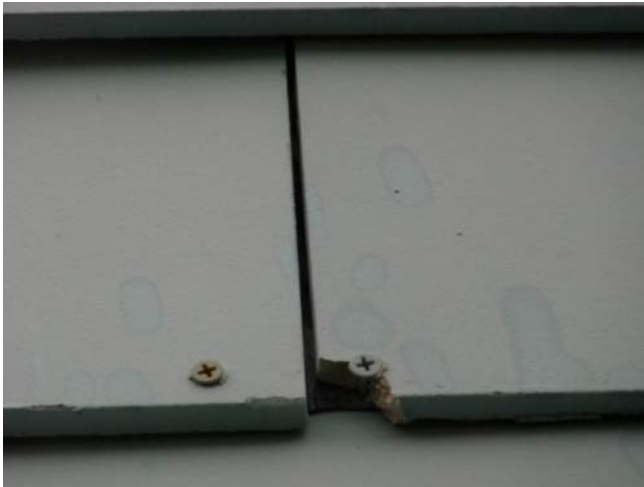
Some fasteners are not concealed behind clapboards. These may have been installed originally or installed later as attempts to force rippling clapboards to lie flat. This is problematic because clapboards of this type are known to expand and contract with variation in temperature and humidity. Bituthane strips placed behind vertical butt joints may have been the installer's way of trying to assure weather tightness at these dynamic joints.

Fixing lower corner of the clapboards works against these expansion and contraction forces. Boards that are not free to move will be prone to crack or ripple.

Under the best of circumstances, fiber cement boards of this type will not last indefinitely, and the ones at the middle school are clearly at the end of their service life and should be replaced.

Given their poor condition, and the lack of a conventional weather resistive membrane in the wall assembly, it's fortunate that more water infiltration through walls has not occurred.

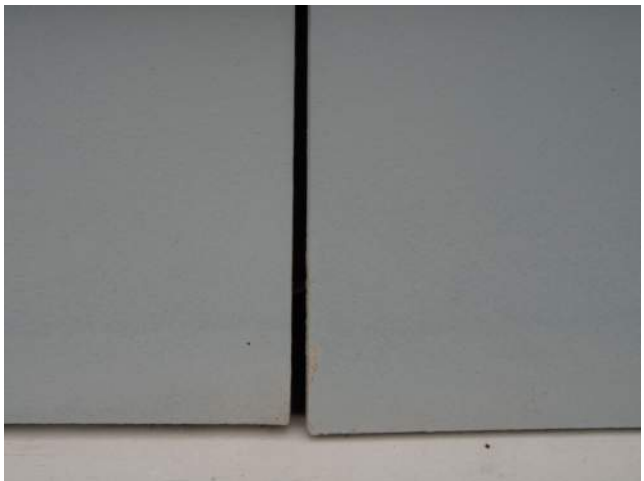
A multitude of different fasteners were used, some of which were interior grade and have rotted and failed.

Replacing the clapboards with formed metal wall panels, similar to those installed at the Orion Center and adding a continuous weather-resistive barrier to the face of the existing sheathing can be expected to solve these problems. No cladding system can be expected to be completely water tight, so adding a weather resistive membrane layer behind the cladding that's properly flashed to expel infiltrating water, is critical to the integrity and longevity of the wall assembly.

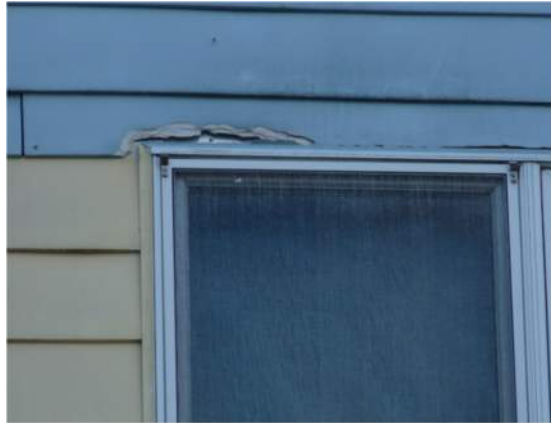
It is apparent that the j-channel at the window head is holding water and seeping into the cementitious siding above the head.

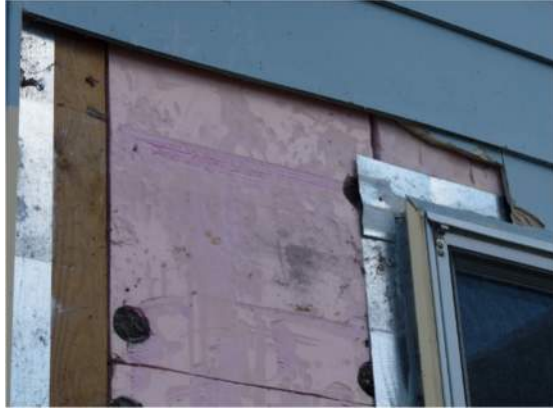
Poly-iso insulation is attached with button fasteners; fasteners have been covered with sealant. Seams of poly-iso insulation have not been sealed, and as suspected are a potential path for water getting to the sheathing.

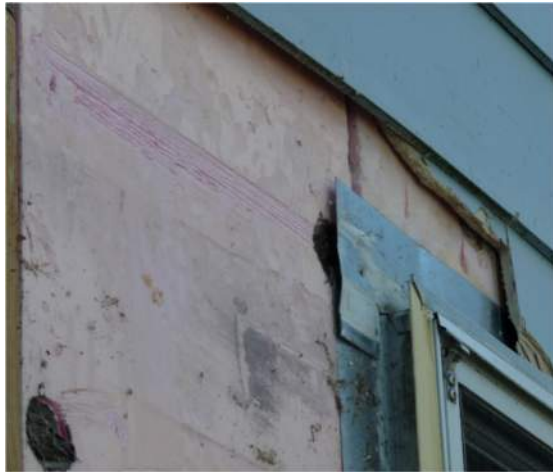
Location of window head flashing confirmed that the assumed plane of water is the face of the poly-iso insulation.

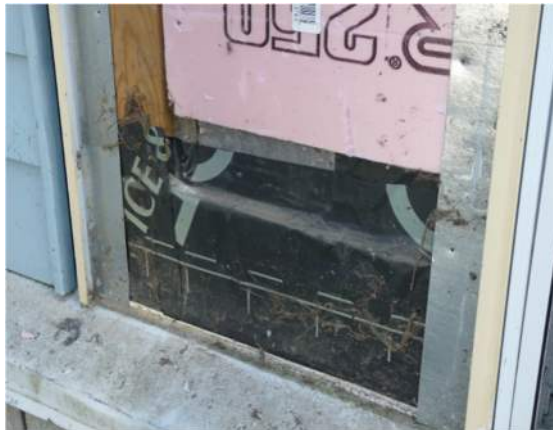
Ice and Water Shield has been turned up at the sill transition below the siding. However, there is evidence of a gap between the Ice and Water Shield and the poly-iso insulation, exposing the paper-faced sheathing.

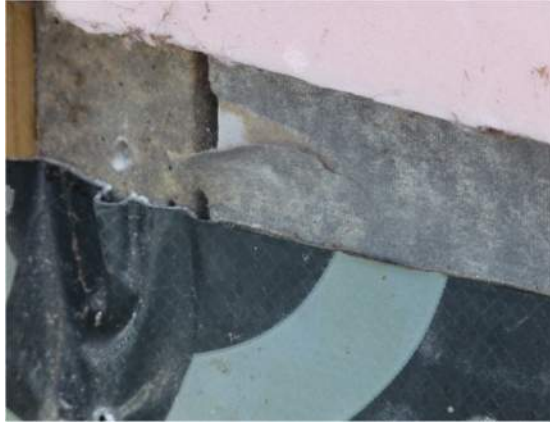
Paper-faced sheathing is showing some signs of damage where exposed to the water plane.

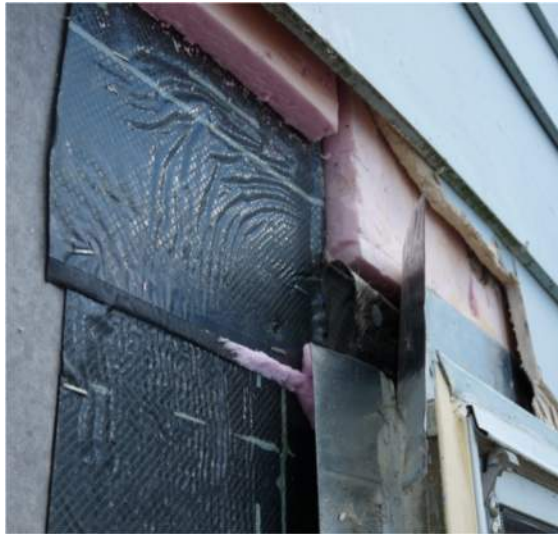
Window blocking has been wrapped with a vapor barrier product, mechanically fastened to the sheathing behind the insulation.

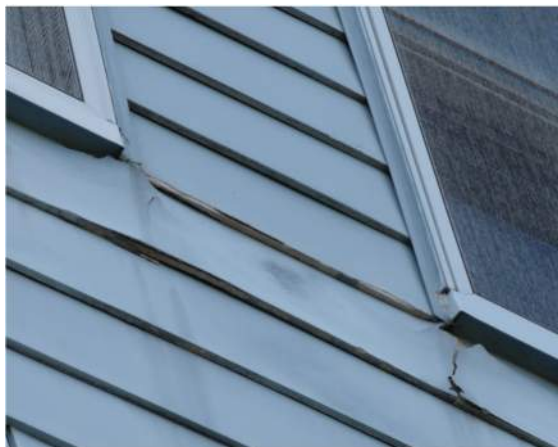
Damage to the siding at the outside sill corners of the windows indicated that water trapped in the j-channel at the head of the window eventually travels down the jambs, seeping into the siding.

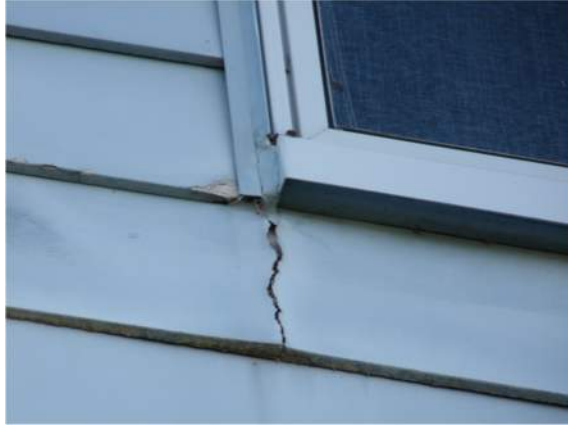
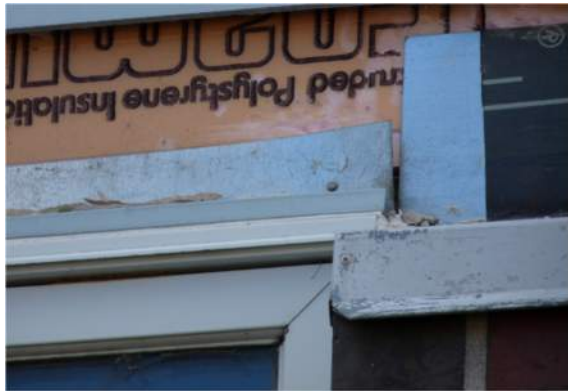
Flashing joints at the window head and the top of masonry transition do not overlap and are not sealed.

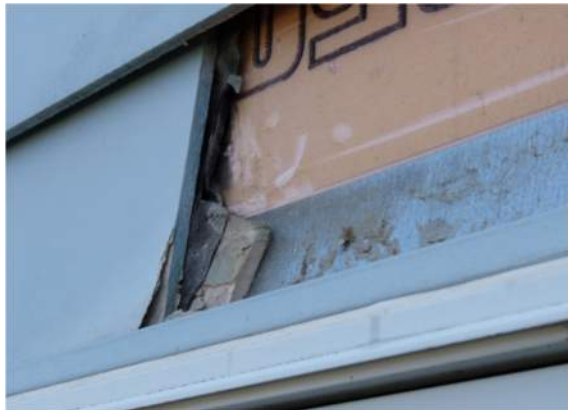
Gypsum board used as a spacer at the window head to hold siding off head flashing.

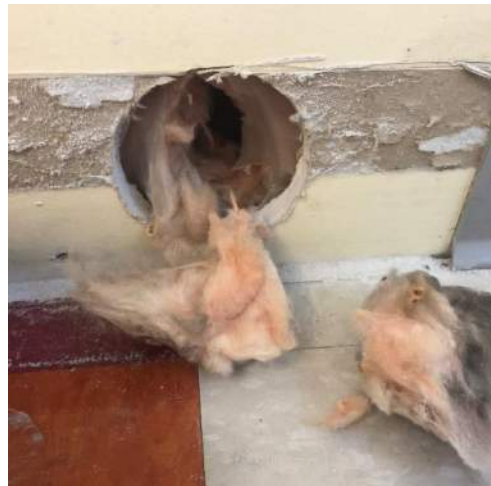
Typical condition of wall cavity batt insulation.

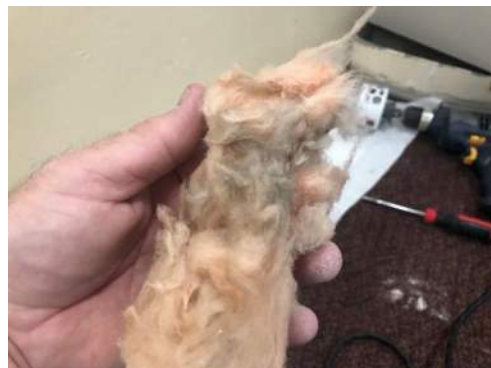
Batt shows no indication of water infiltration into wall cavity.
