Maine School Administrative District 75
Asphalt Assessment Study Report

Prepared for
Maine School Administrative District 75
50 Republic Avenue
Topsham, ME 04086

RFS 20-9466.001

June 09, 2021

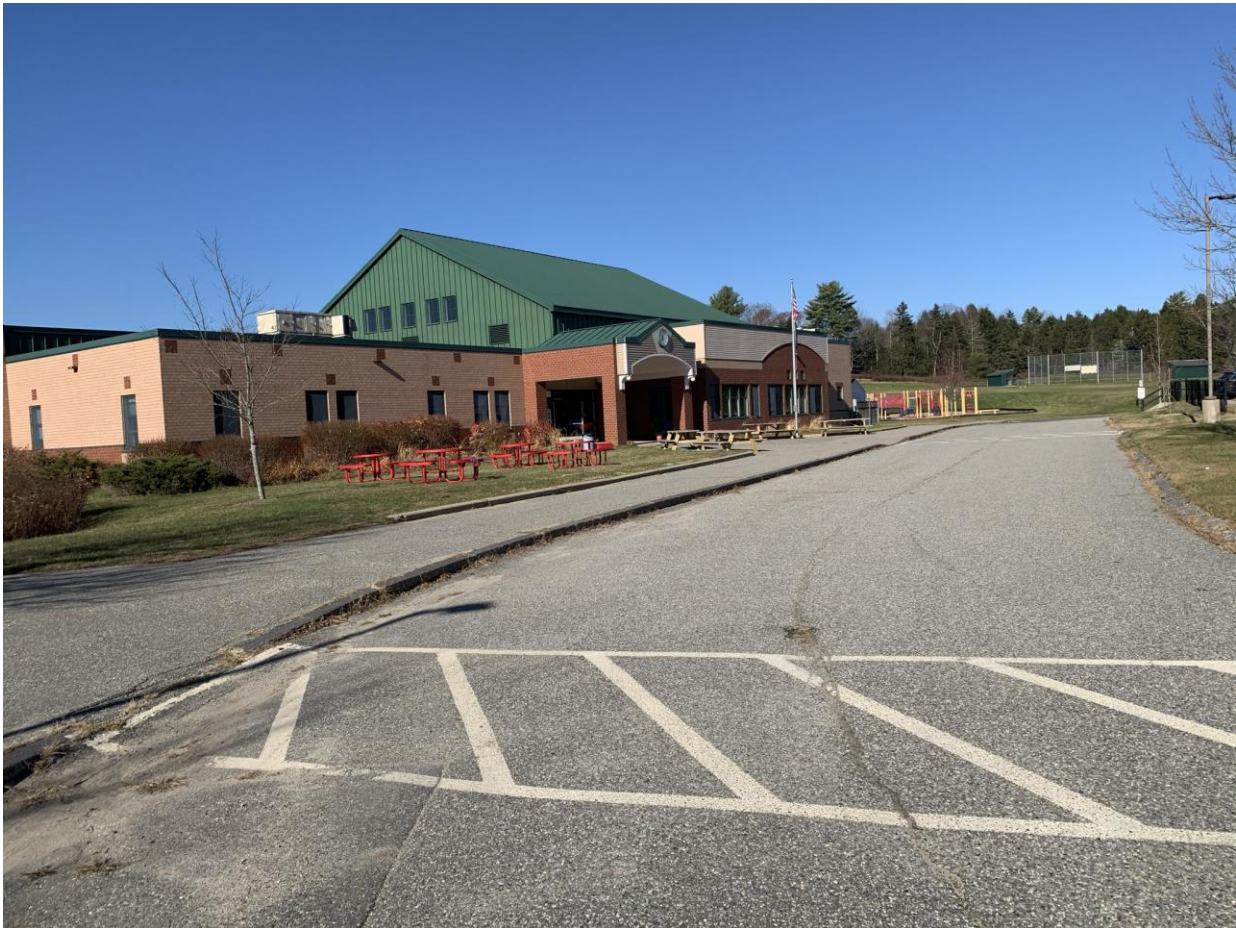
Access drive/ bus lane: The bus route goes through the parking area and loops around one-way in front of the school and back out. The access drive/ bus loop pavement is in fair to good condition.

The bus lane at the front of the school

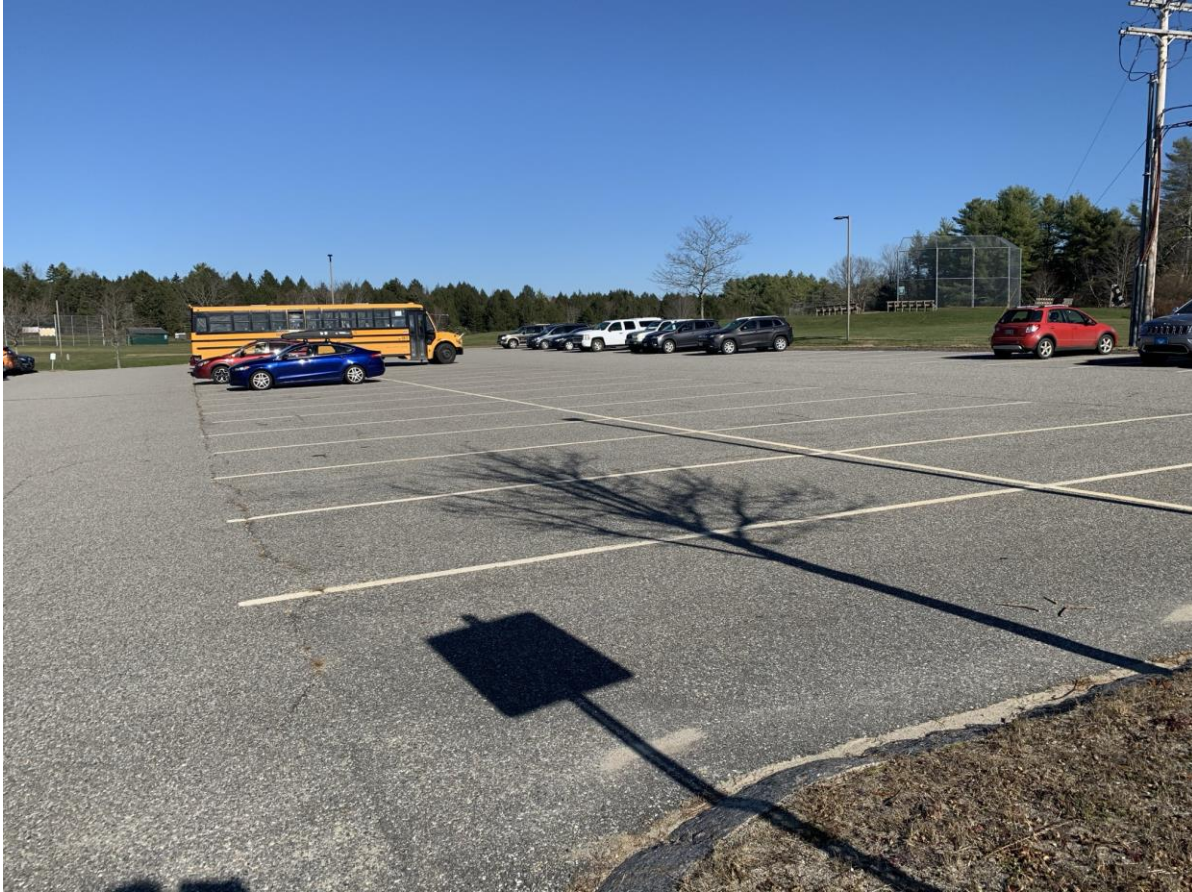
Parking area: The only parking area for the school is approximately 31,000 SF in size and accommodates 95 vehicles. The pavement is in fair to good condition with some visible cracks but is in fair condition overall. In fact, all of the pavement on the site appears to be of similar vintage and in similar condition, except for the service drive behind the school.

Bowdoin Central School Parking Area

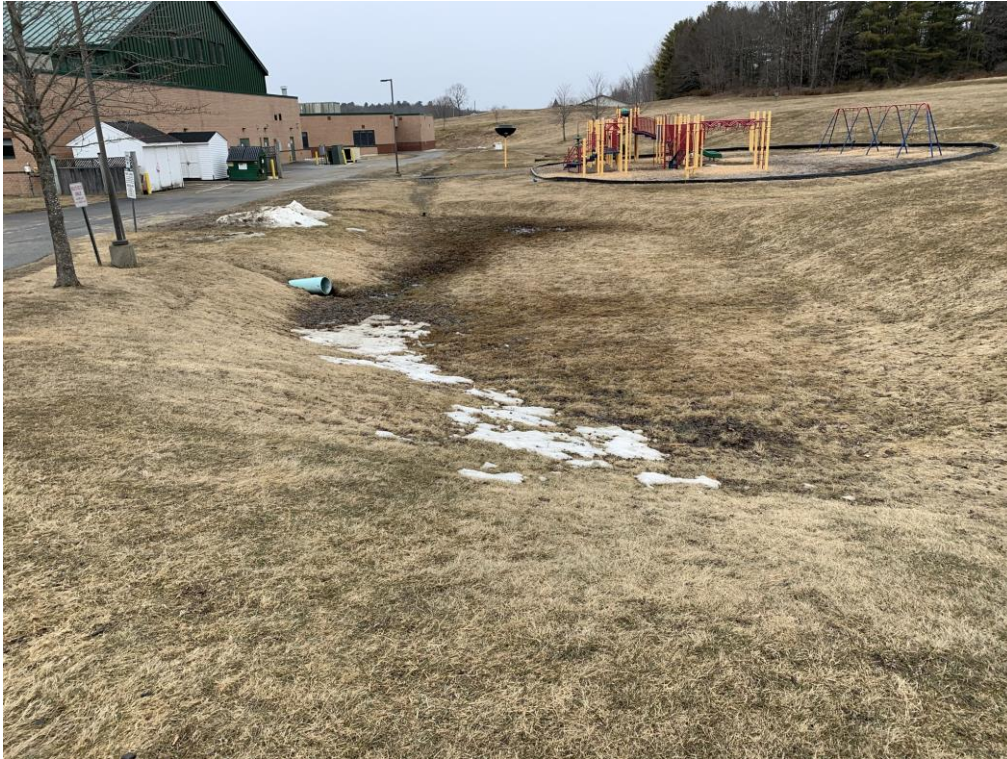
Rear service drive/ playground: There is an 8,000± SF paved area to the rear of the school which provides access for maintenance and delivery vehicles. This area also serves as a playground. The pavement in this area is in fair to poor condition, with cracks, patches, and frost heaves observed. A large patch was recently placed at the east end of this area, abutting the bus loop. The topography rises from the rear of the school to the north, resulting in a lot of runoff flowing toward the school and creating wet areas at the rear of the school, between the service drive and playground. This drainage issue has to do with the surrounding topography, and although not ideal, is outside of the scope of this report. However, there were frost heaves and undulating pavement observed in the service drive abutting this area, which is likely due to poor base materials, improper compaction, poor drainage beneath the pavement, or a combination thereof. Therefore, when this pavement is replaced, a base of free-draining material (clean stone), sloped to drain away from the school, is recommended.

Bowdoin Central School: Poor drainage at rear of school

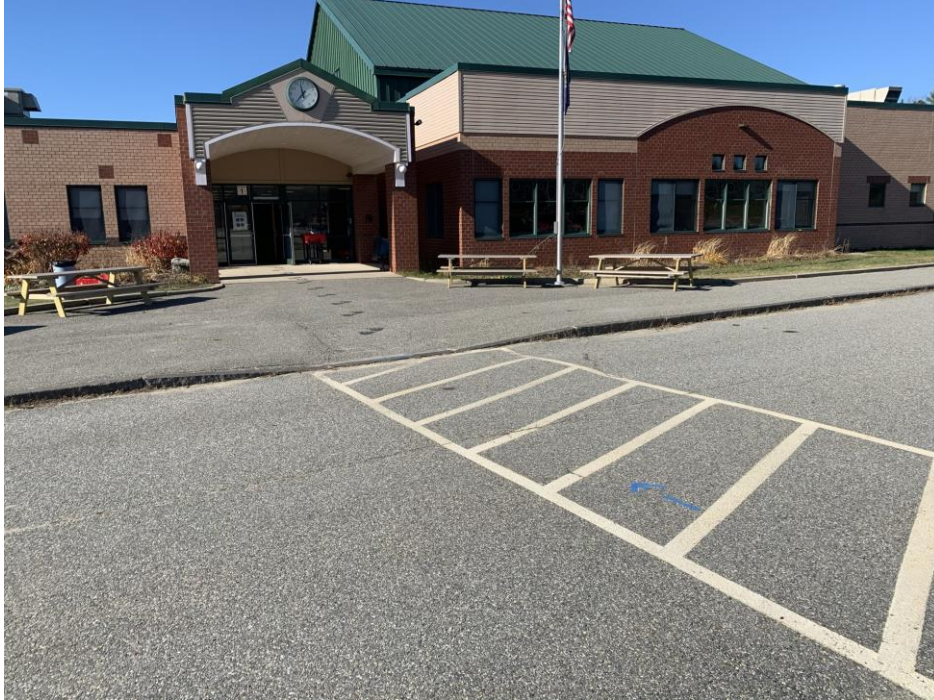
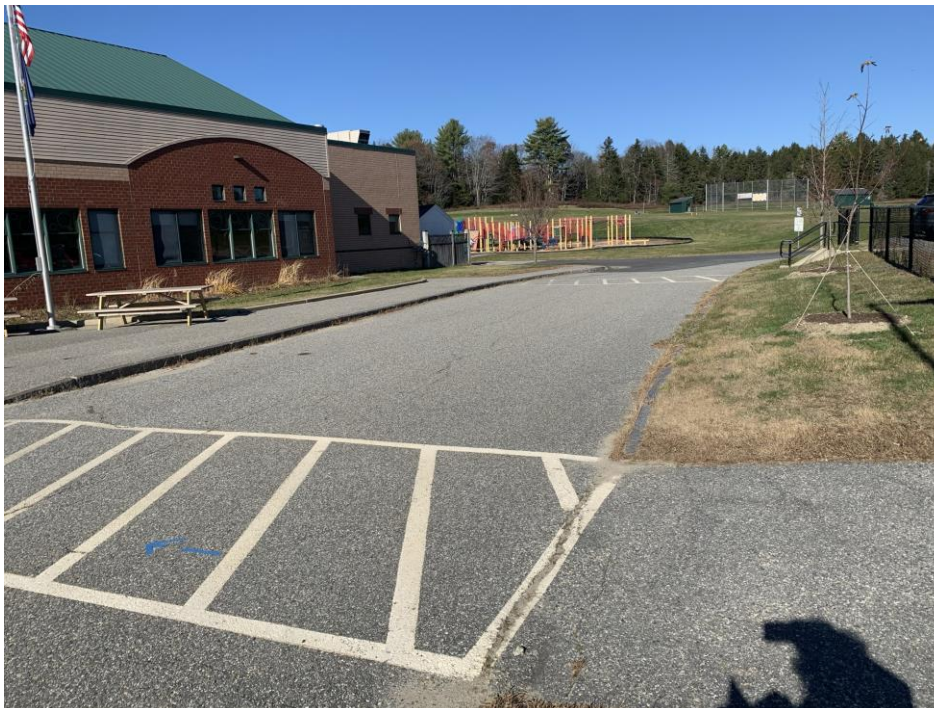
Front walkway/ entry plaza: There is a 5000± SF asphalt walkway at the front entrance to the school that extends the length of the front of the school, encompasses the main entrance plaza area, and extends out to the entrance drive. This walkway is bordered by vertical granite curbing along its length and abuts the bus lane. This pavement is in fairly good condition.

Bowdoin Central School front entry plaza/ walkway and bus lane

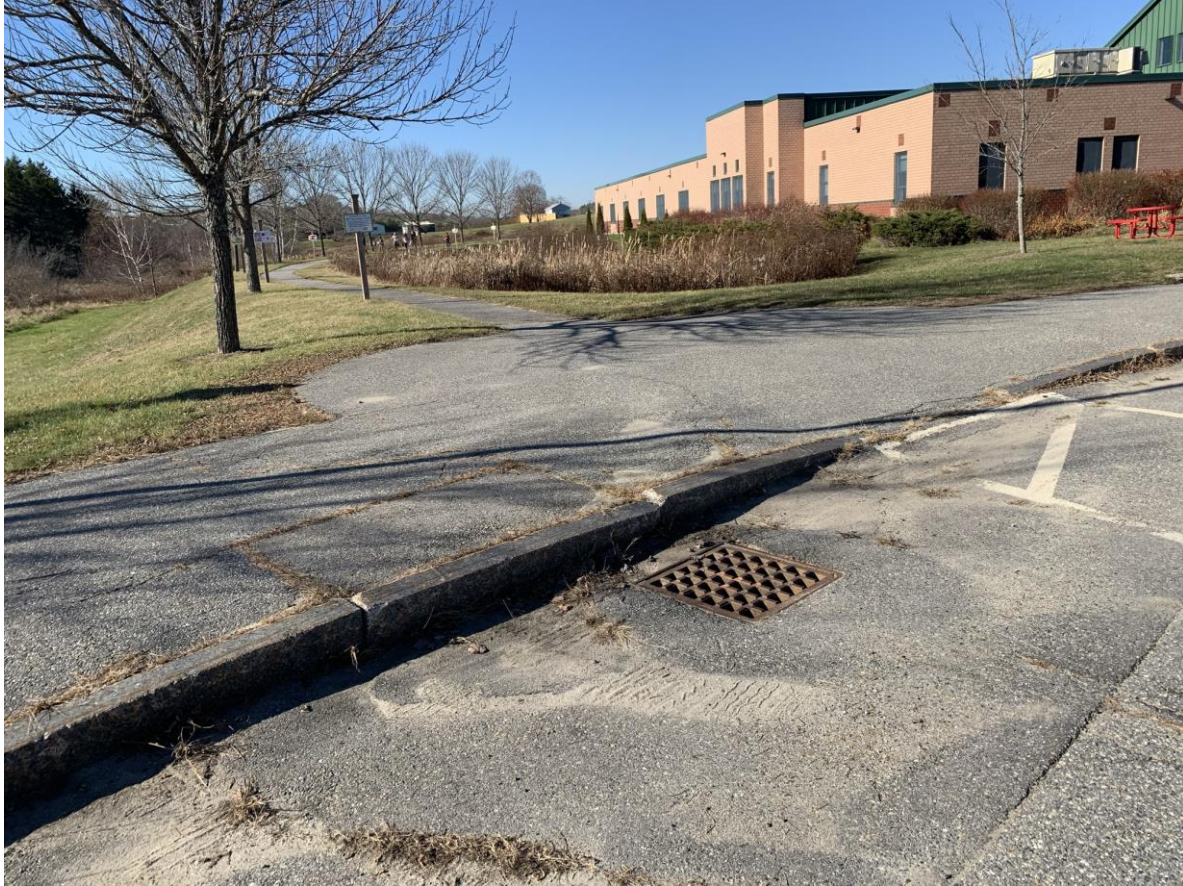
Interpretive trail walkway: A 750-foot long paved walkway connects the front parking area to the rear of the school. The walkway pavement is in good condition and also serves as an interpretive trail.

Bowdoin Central School Interpretive trail walkway

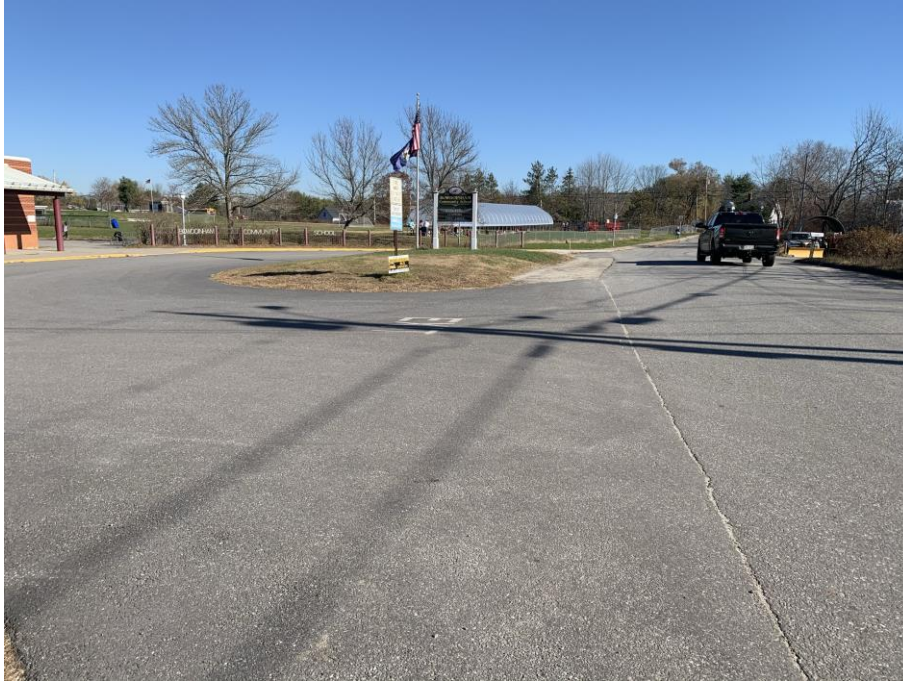
Access drive: The Bowdoinham Community School has a total of approximately 28,000 SF of asphalt surfaces, with access off of Cemetary Road. Two of these access points provide a U-shaped bus lane that loops in front of the school. This bus loop drive consists of newer pavement in good condition.

Bowdoinham Community School U-Shaped Bus loop

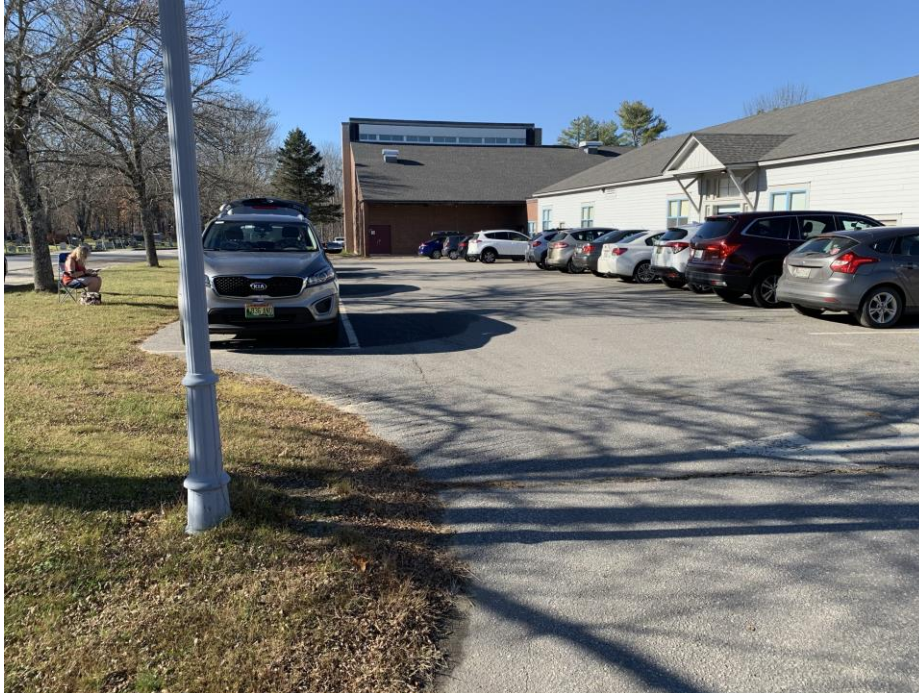
Main parking area: There is a parking area in front of the school parallel with Cemetary Road which has capacity for 19 vehicles. This parking area has direct access onto Cemetary Road and is also connected to the bus lane. The pavement in this parking area is in fair to poor condition with cracks and potholes observed. There is a drainage issue at the west end of this parking area, where obvious ponding occurs around a catch basin, which has caused significant pavement deterioration.

Bowdoinham Community School main parking area parallel to Cemetary Road

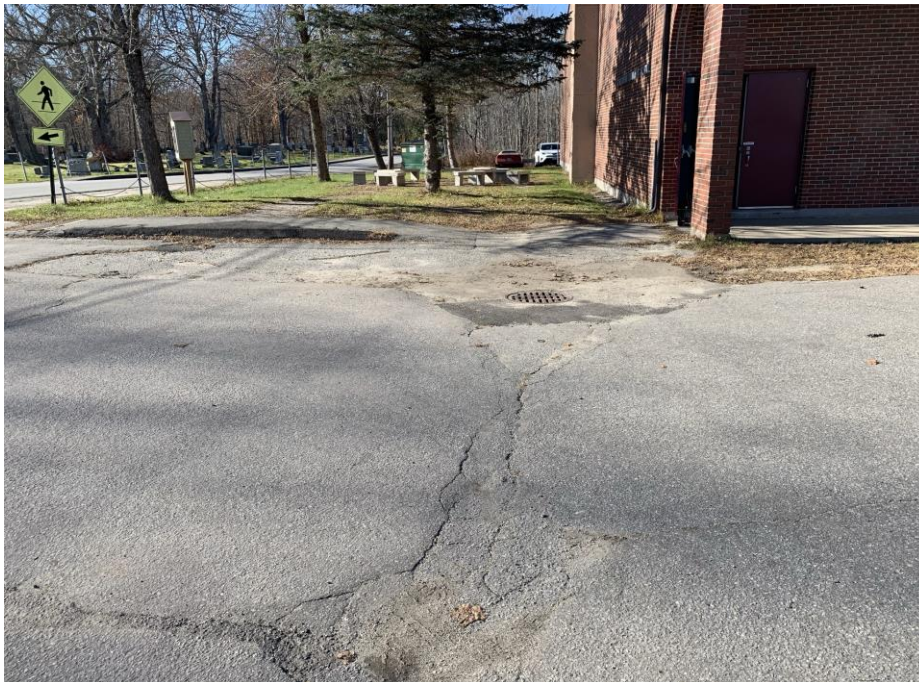
West end of main parking area- note significant pavement deterioration due to ponding at catch basin

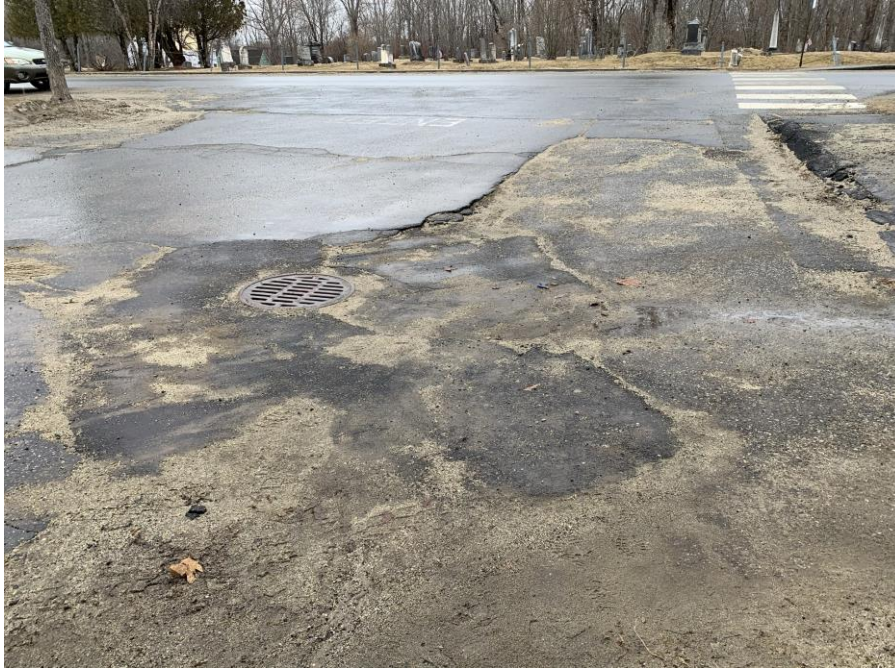
West end of main parking area where there is significant pavement deterioration due to ponding at catch basin

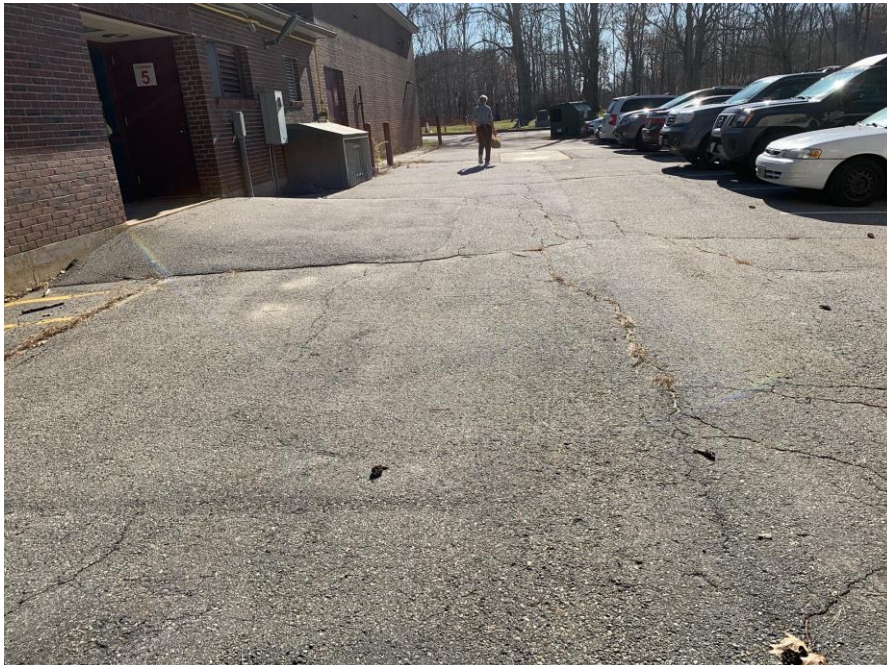
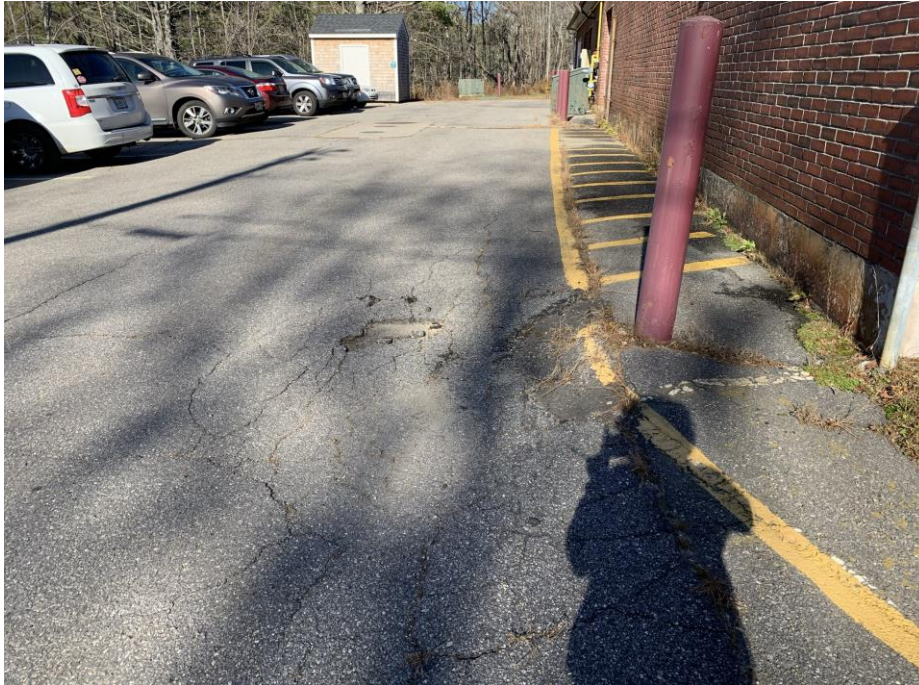
West side parking area: There is a 5600± SF paved area on the west side of the school with separate access of Cemetary Road. This area is for maintenance and delivery access and has parking for 14 vehicles. The pavement in this area is in poor shape, with cracks, patches, and frost heaves observed. District personnel report that there is a buried underground fuel oil tank beneath this parking area that should be removed when this pavement is replaced.

Bowdoinham Community School west side parking area

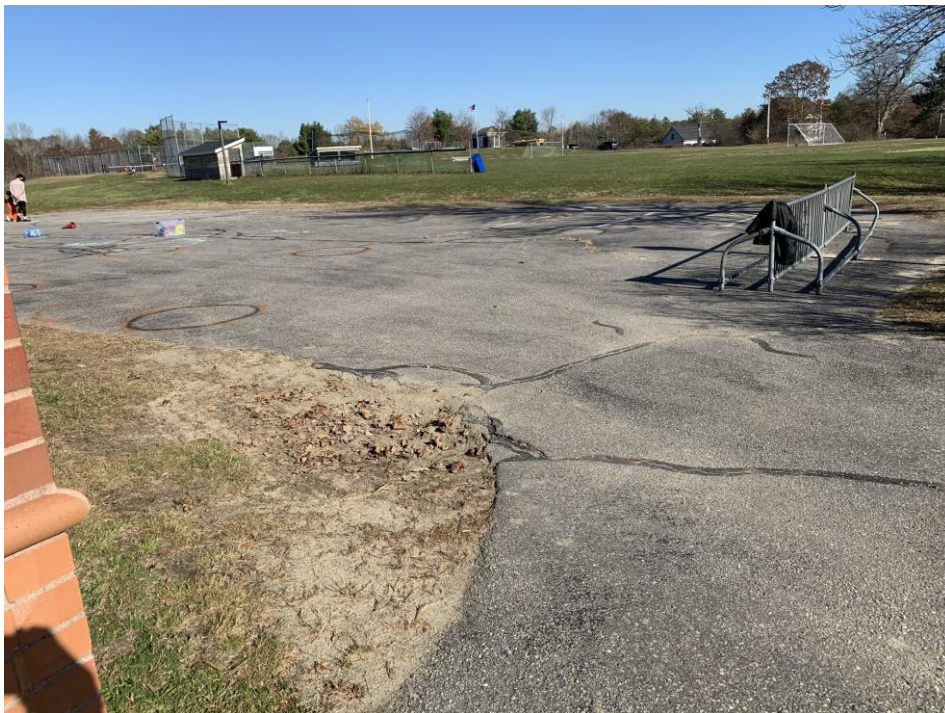
Paved playground: There is a 6000± SF paved playground area on the east side of the school that is used only as a play area. The pavement in this area is in poor condition, with cracks supporting grass growth, areas of differential settling, and deteriorated pavement observed.

Bowdoinham Community School paved playground

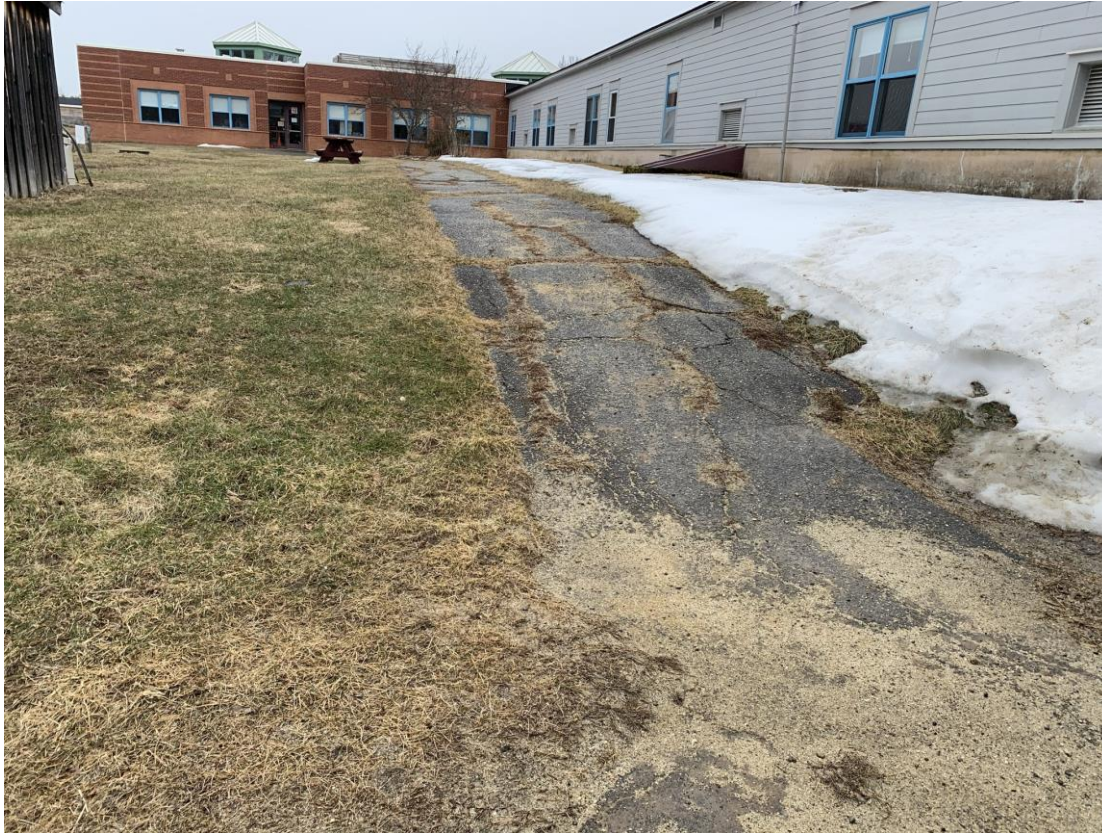
Rear walkway: There is a $300\pm$ foot long paved walkway (estimated $1200\pm$ SF), on the north side of the school that connects the playground to the rear of the school. This walkway is in poor condition, with cracks supporting grass growth and deteriorated pavement. The western end of this walkway is too steep and should be replaced with a set of steps and/or a ramp.

Bowdoinham Community School rear walkway where stairs are needed

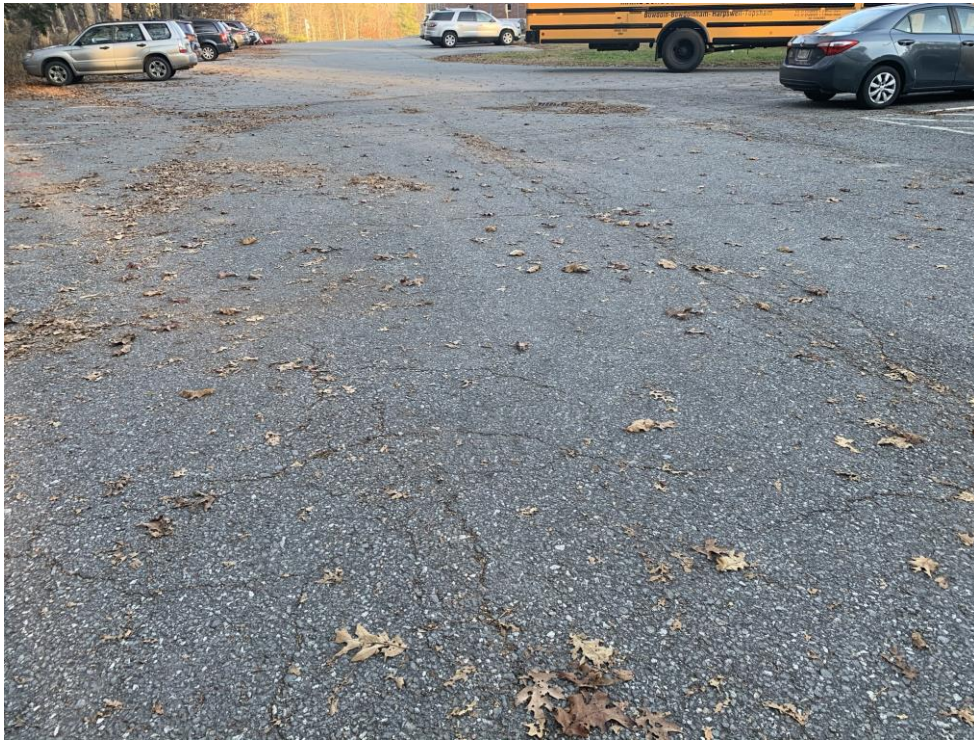
Parking area: There is a 21,000-SF parking area next to the bus drop-off loop at the top of the hill which has capacity for approximately 50 vehicles. The pavement in this parking area is in fair to poor condition with significant cracks and areas of differential settlement observed.

Harpswell Community School Parking area

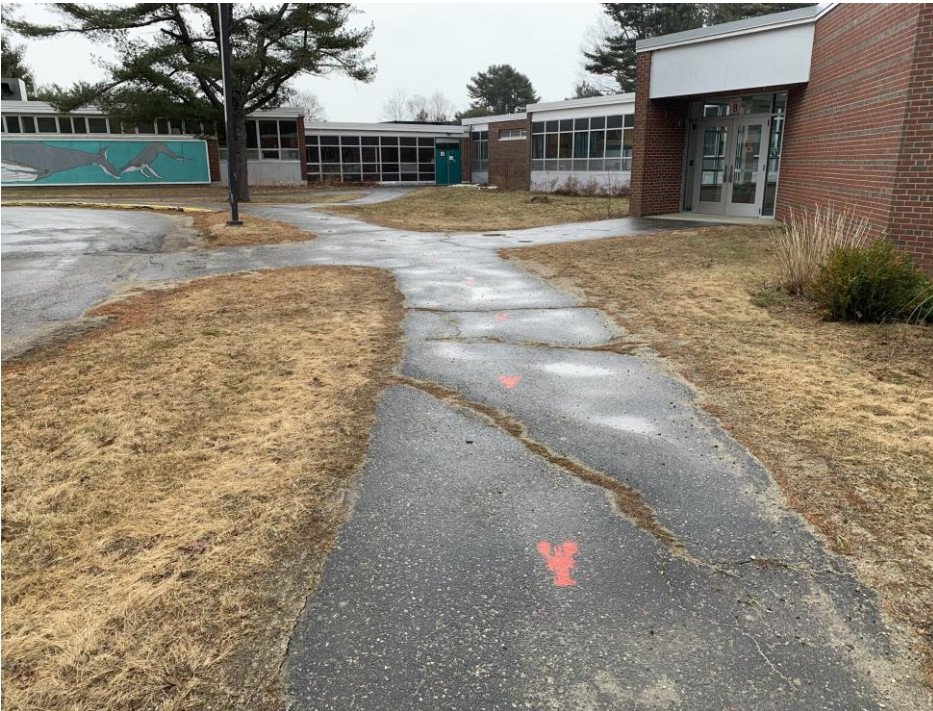
Front walk & entry plaza: There is an 8000-SF asphalt walkway at the front entrance to the school that extends the length of the front of the school, abuts the bus drop-off lane, encompasses the main entrance plaza area, and connects the parking area to the school. This pavement is in fair to poor condition.

Harpswell Community School front walk coming from parking area

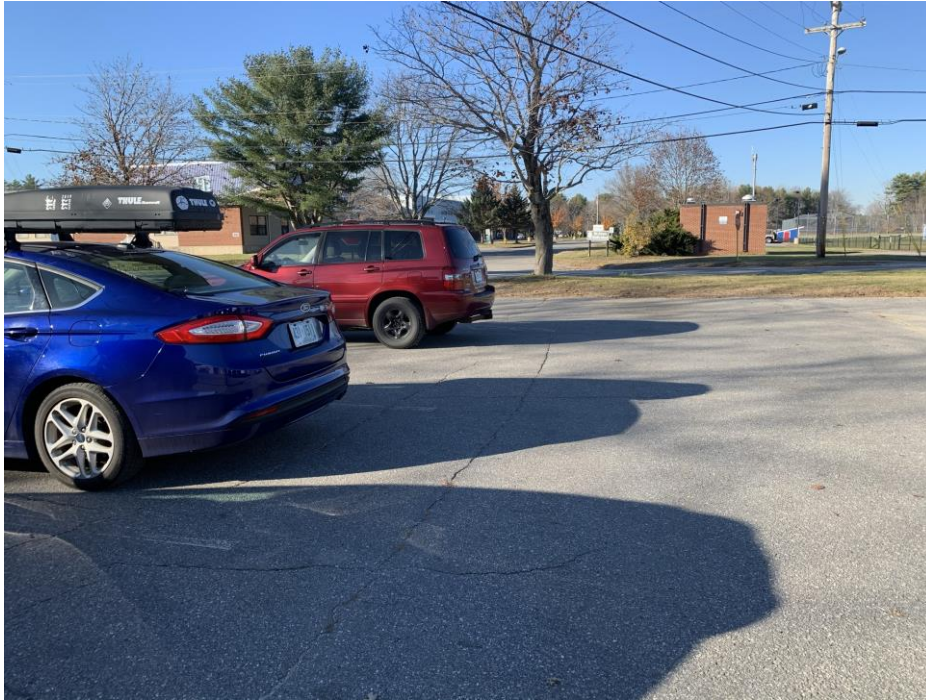
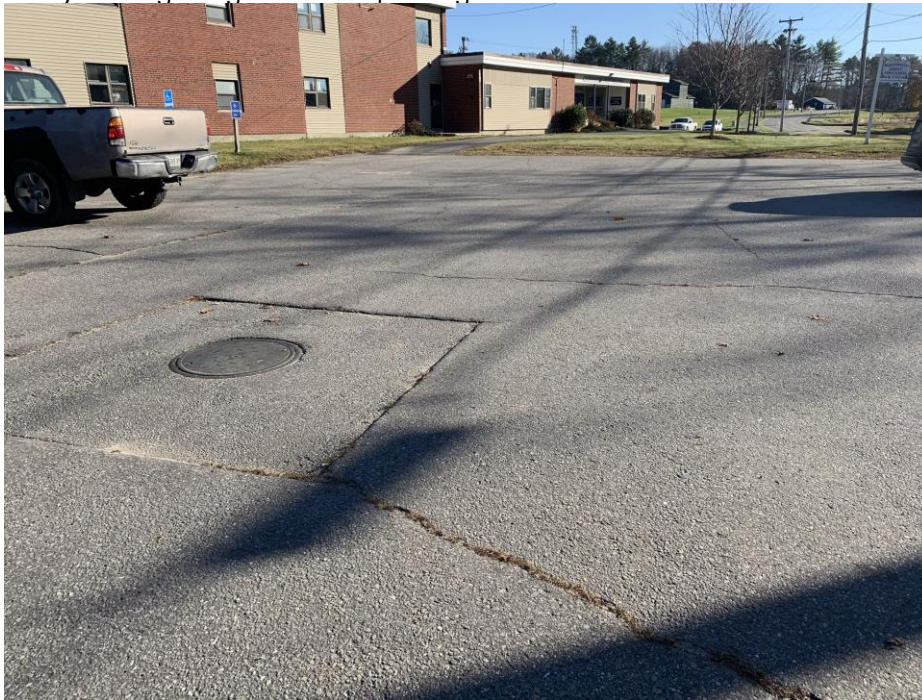
Northern parking area: The northernmost parking area for the Merrymeeting building is 9000± SF and has capacity for approximately 22 vehicles. The pavement in this parking area is showing signs of age; it has patches and cracks and is in fair condition.

Merrymeeting Lodge northern parking area

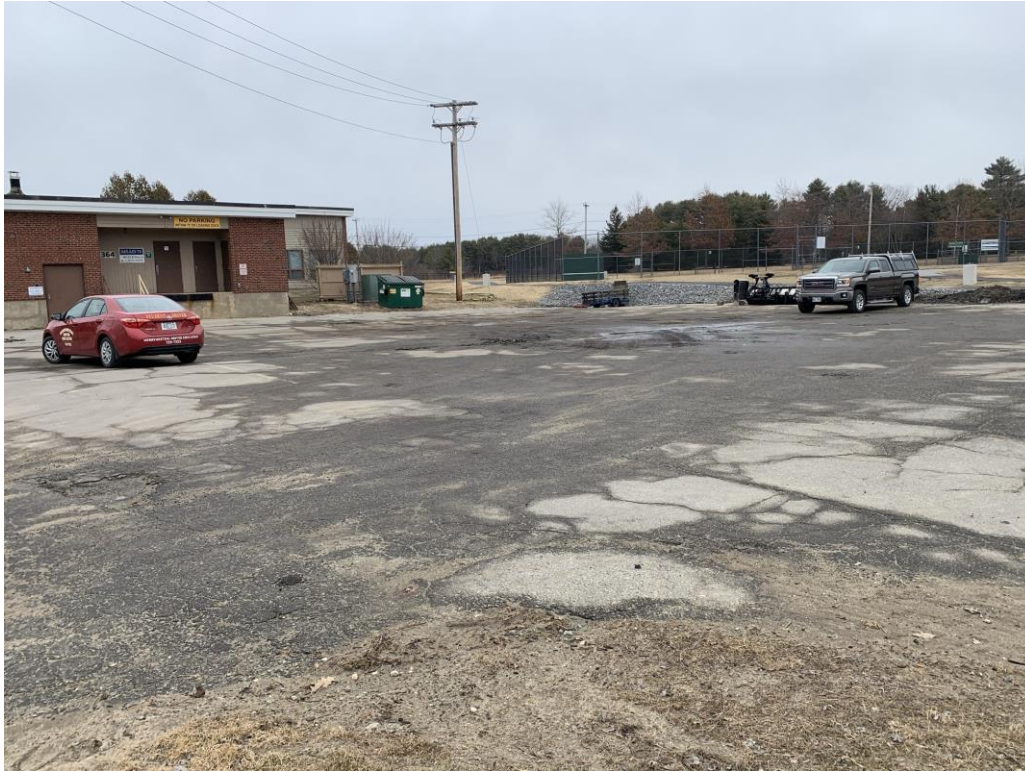
Southern parking area: The southernmost parking area for the Merrymeeting building is 14,000± SF and has capacity for approximately 20 to 25 vehicles. The pavement in this parking area is in very poor condition with significant rutting, cracks, patches, and potholes. The sidewalk bordering the southern edge of the lot which leads to the tennis courts has recently been replaced.

Merrymeeting Lodge southern parking area

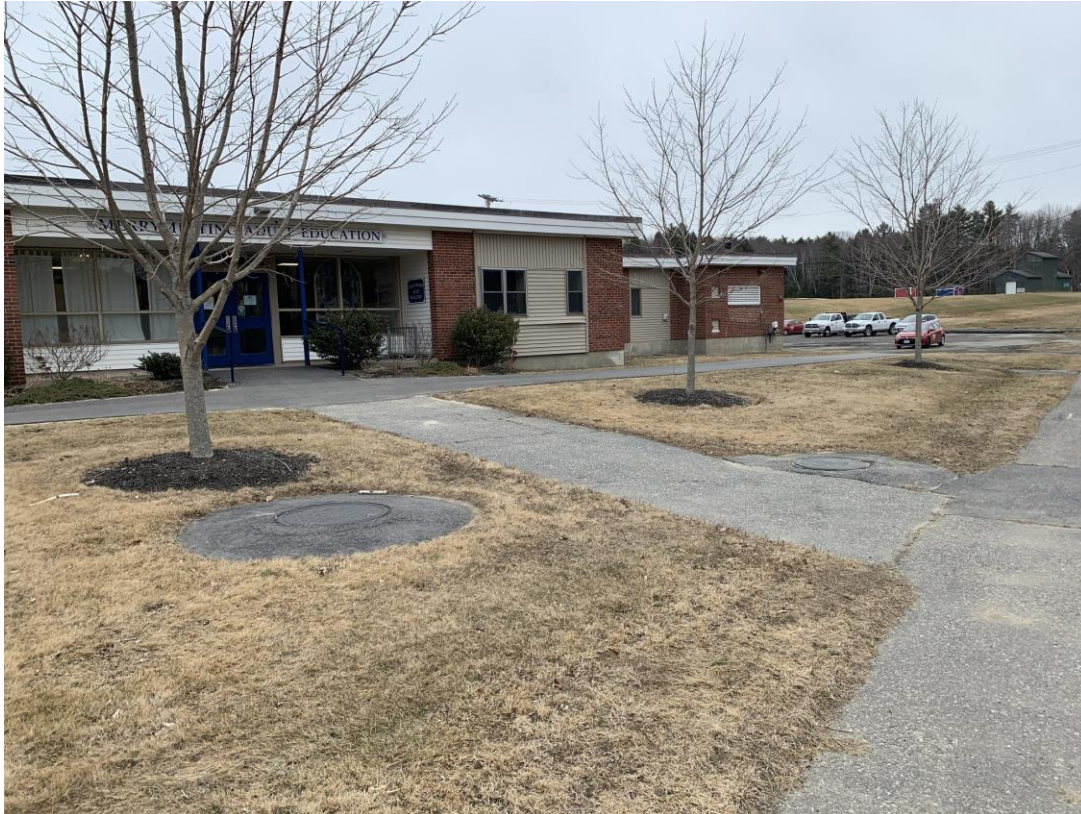
Walkways: The walkway directly in front of the Merrymeeting building which connects to both parking areas is in new condition, as is the walkway behind the building that connects to the tennis courts. The walkway along Republic Ave in front of the Merrymeeting building is covered in the Republic Avenue section of this report. The walkway connecting the Merrymeeting building to the sidewalk on Republic Ave is in fair condition as shown below.

Merrymeeting Lodge connecting sidewalk between the new sidewalk and Republic Ave.

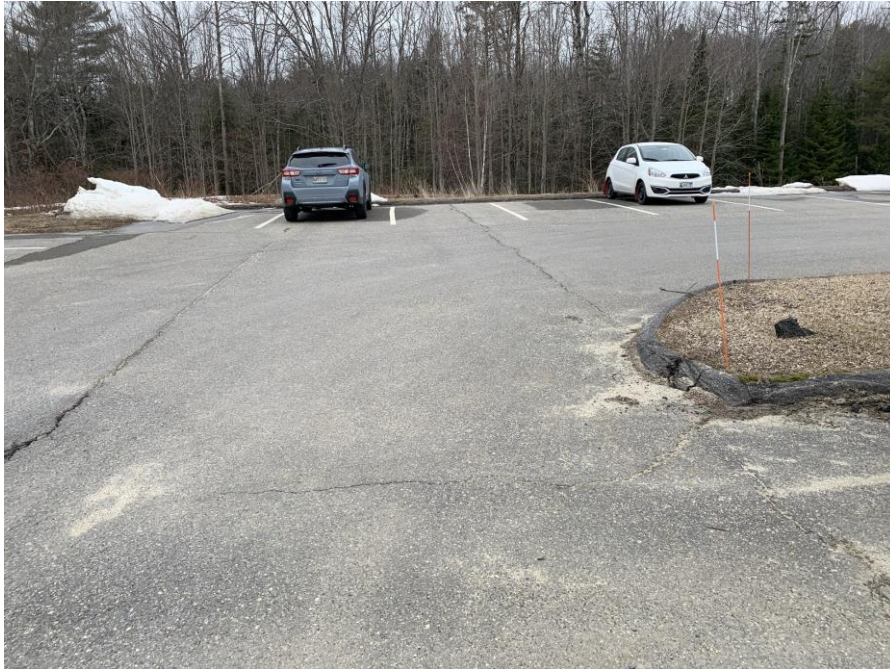
Parking: Parking area #1 is a 21,000-SF, 52-space lot on the west side of the building in fair condition. There is another drive from parking area #1 that wraps around the north side of the building and connects to Republic Ave with parking for another 7 vehicles (parking area #2; 4600 SF). Parking area #2 and the connecting drive and are in fair condition.

MSAD Office parking area #1

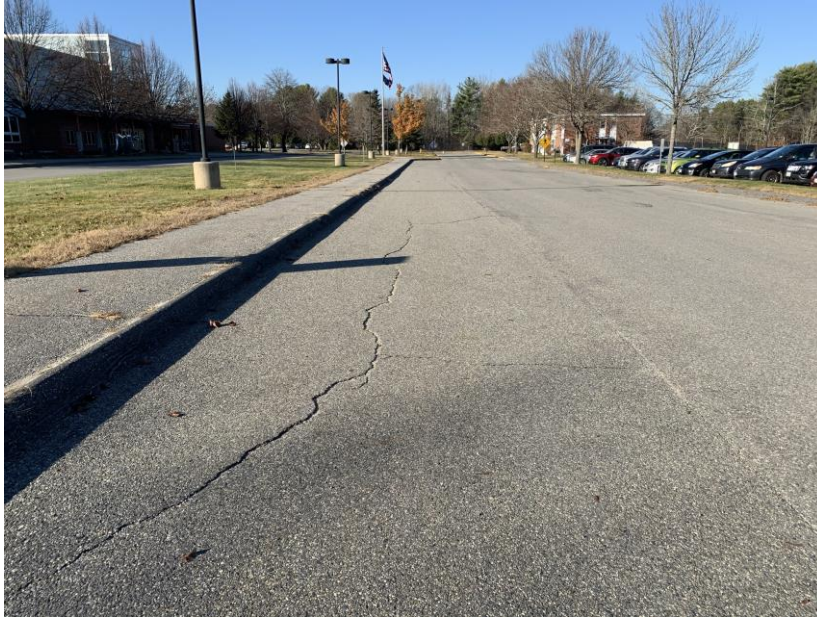
Access Drive: The Ararat Middle School driveway is technically a continuation of Republic Avenue although it is not a through-way. The Republic Ave driveway extends from Canam Drive for a straight distance of $800 \pm$ feet parallel to the front of the school. The road then makes a U-turn and runs directly in front of the school for the bus drop-off. The bus drop-off lane and Republic Ave run parallel to each other and are separated by grassed islands. The drive is in mostly fair condition, with a few areas of potholes and cracking. The bus lane is in fair to good condition.

Mt. Ararat Middle School Republic Ave access drive facing north with east parking area on right

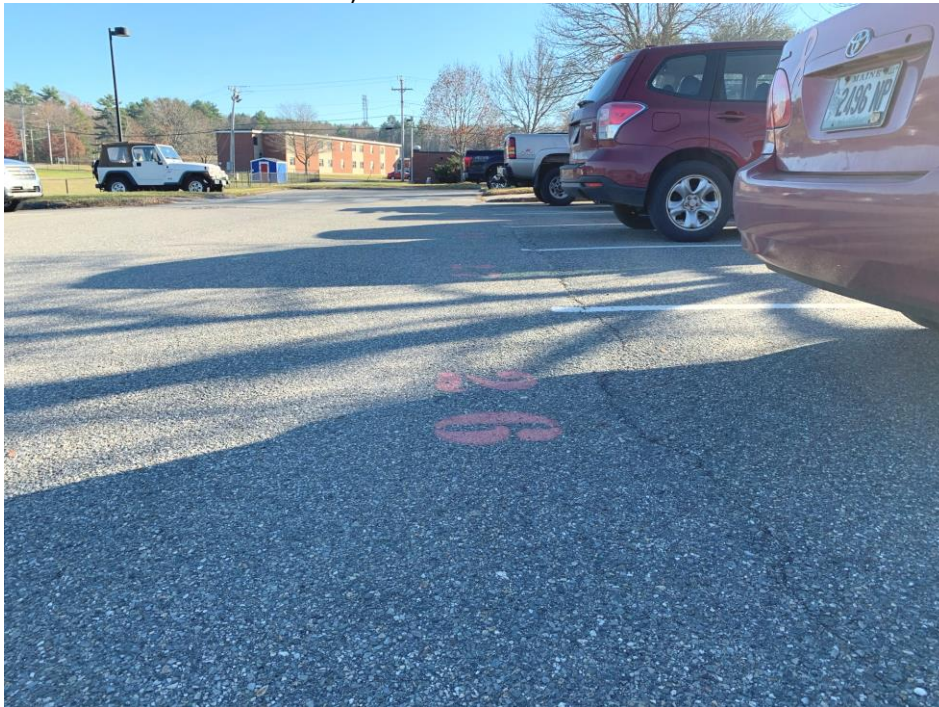
East Parking Area: The east parking area located parallel to Republic Ave is 26,000± SF, accommodates 75 vehicles, and is in fair condition.

Mt. Ararat Middle School East Parking Area is in fair condition

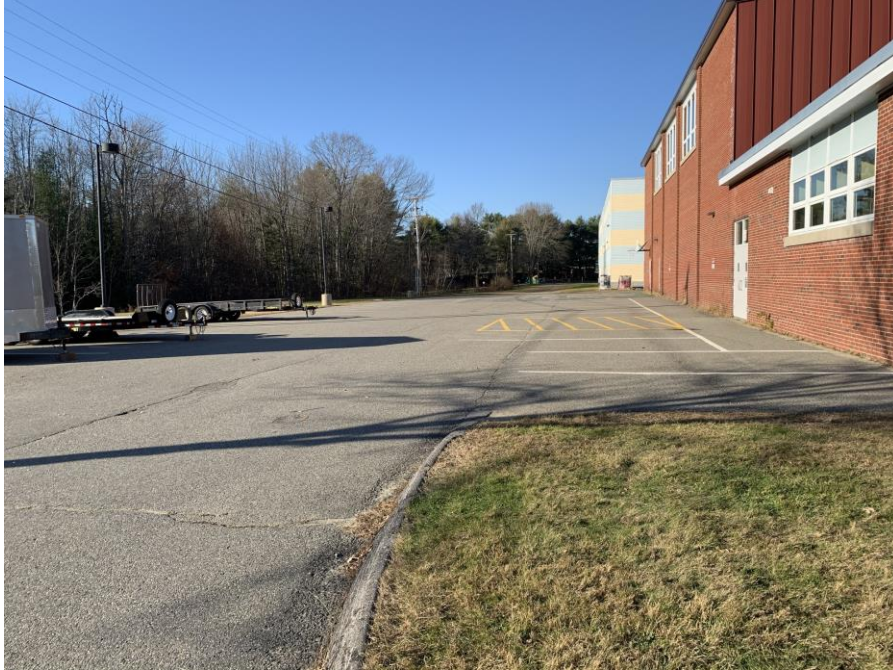
West Parking Area: There is a 12,000± SF west parking area that can accommodate 32 vehicles located behind the Orion Theater and is accessed through the District Office Building parking lot.

The west parking area is in fair condition.

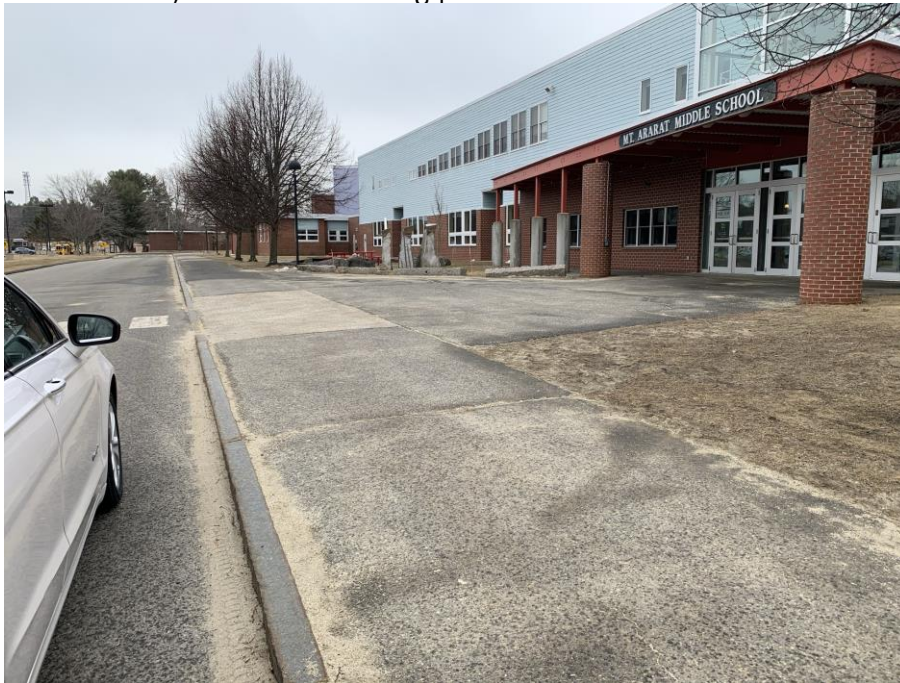
Main Entrance Plaza & Sidewalks: The asphalt entrance plaza at the main entrance to the school is in fair condition, with more cracking present than the rest of the main walkway parallel to the bus lane.

Mt. Ararat Middle School sidewalk at main entrance

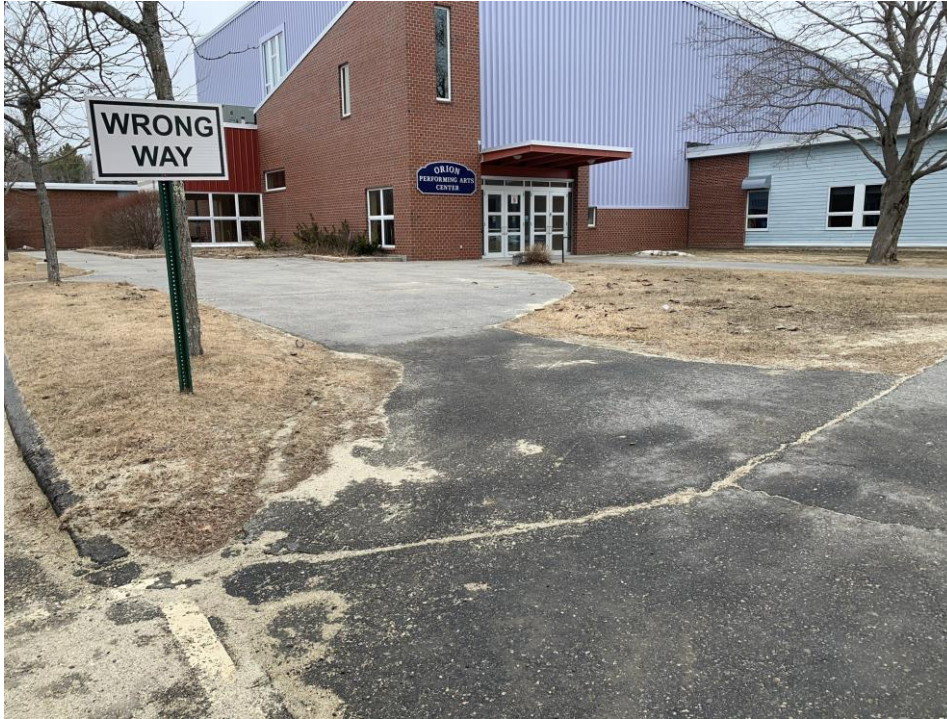
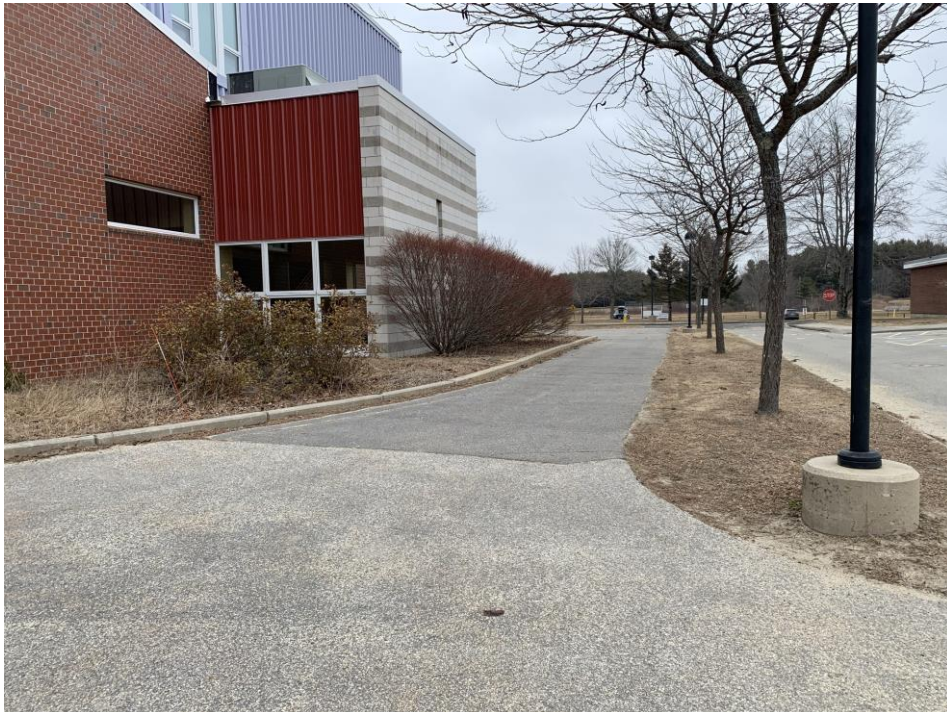
Orion Theater Walkways: The walks surrounding the Orion Theater are in fair condition, and appear to have been partially replaced over the years.

Orion Theater Walkways

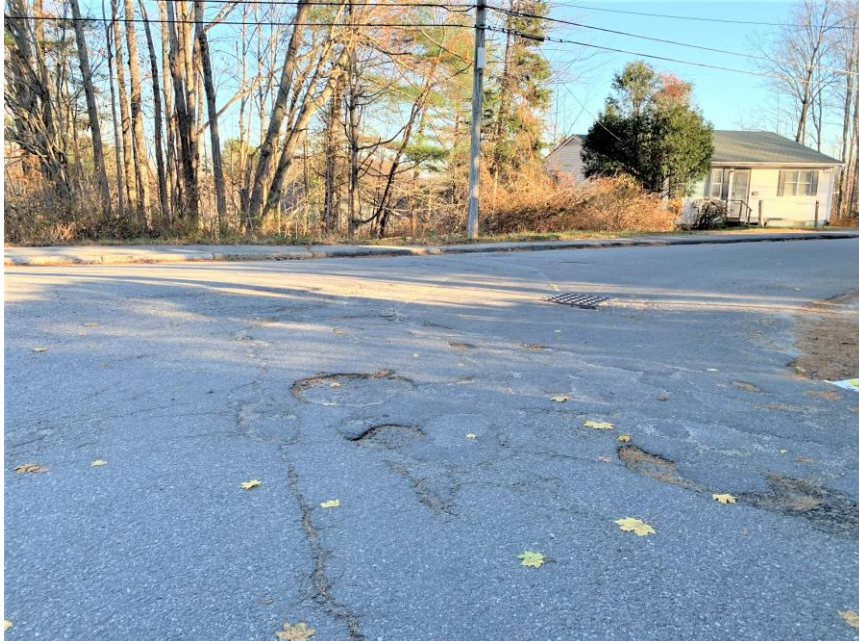
Williams-Cone School main entrance drive at junction with Perkins Street is in poor condition

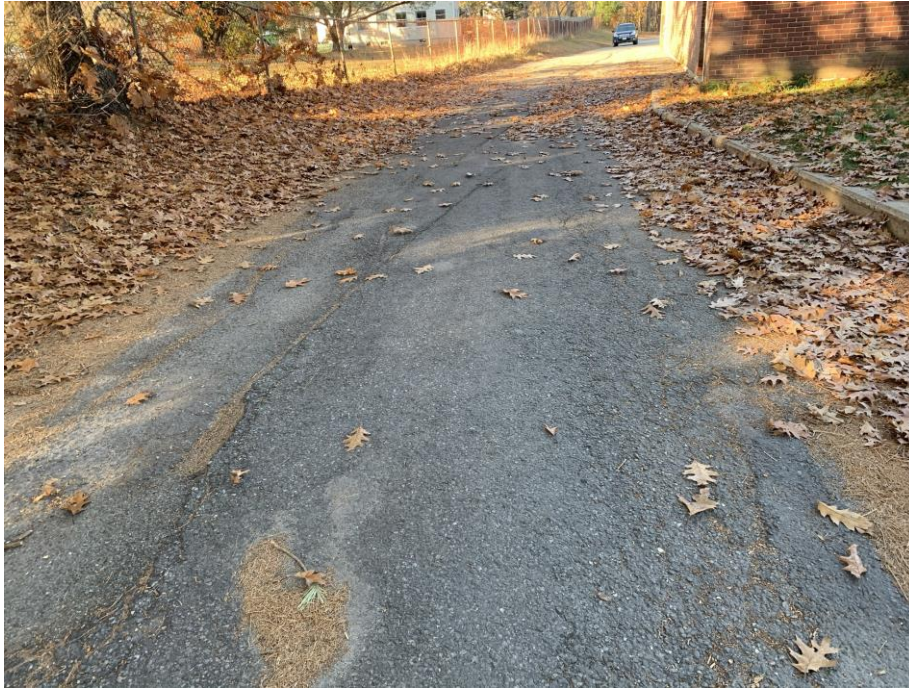
Northwest Parking Area: Another driveway branches off the main access drive that leads to the rear of the school (northwest side.) The drive and parking area are in very poor condition, with large potholes and significant amounts of spalling and cracked pavement observed. The parking area accommodates approximately 21 vehicles. The drive wraps around the north side of the school and connects to a large paved playground on the northeast side of the school.

Williams-Cone School driveway to northwest parking area
