Maine School Administrative District 75
Asphalt Assessment Study Report

Prepared for
Maine School Administrative District 75
50 Republic Avenue
Topsham, ME 04086

RFS 20-9466.001

June 09, 2021

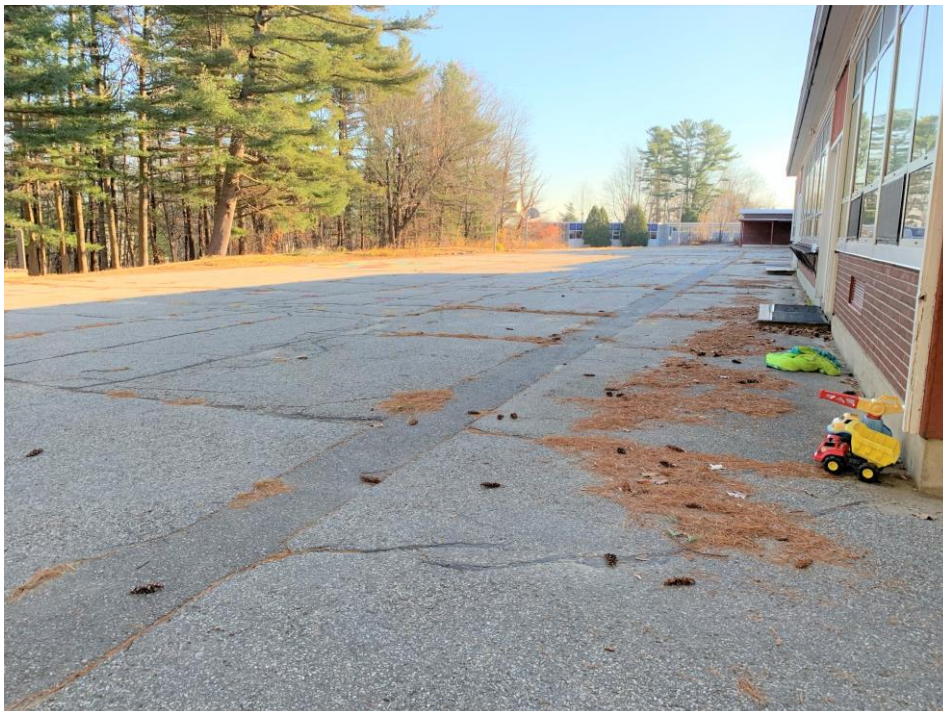
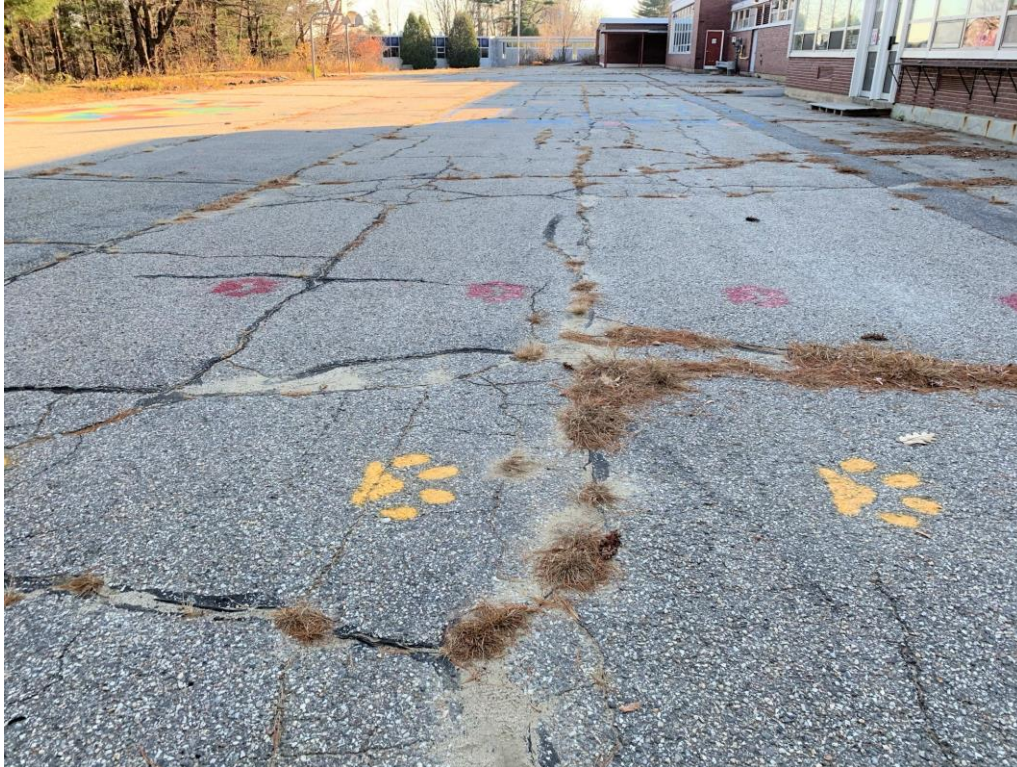
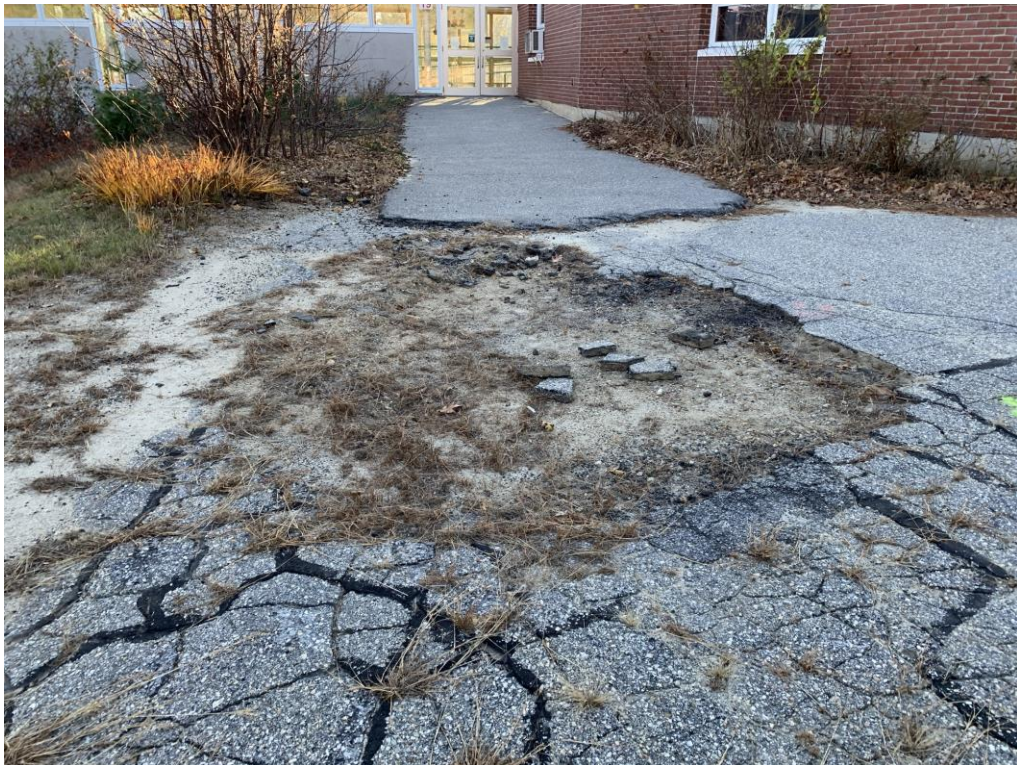
Playground: The paved playground on the northeast side of the school is 22,000 SF in area and in poor condition. This area is crisscrossed with cracks and grass growing up through the pavement.

Williams-Cone School paved playground in very poor condition

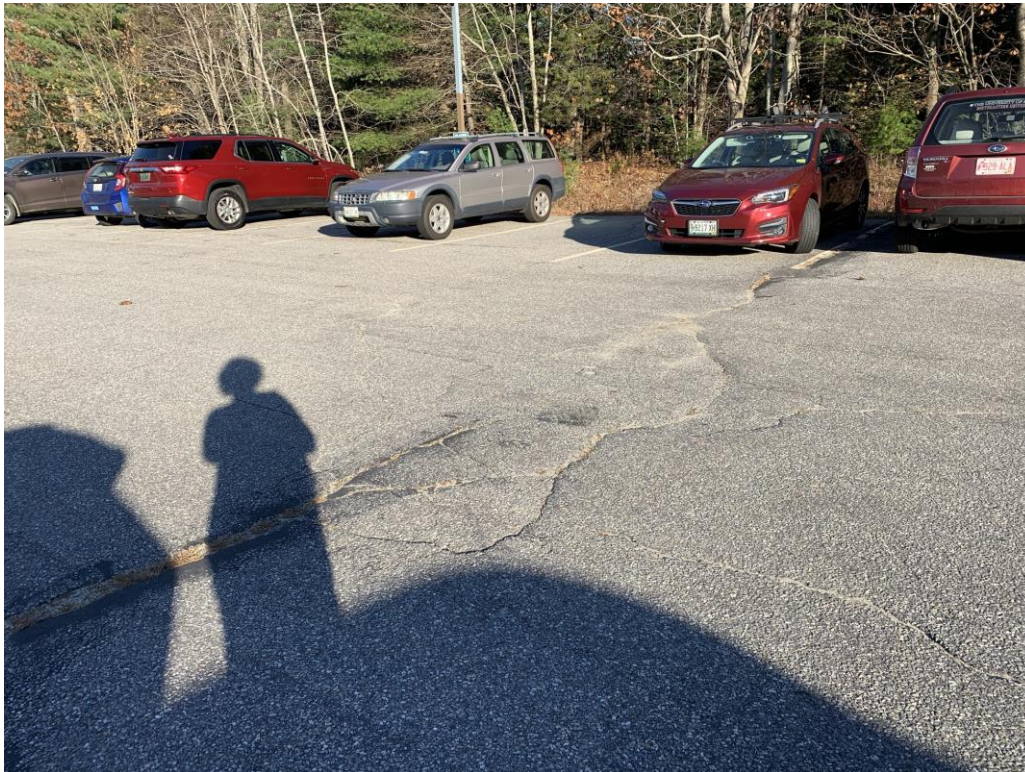
Parking: There are three large parking areas serving the school. The northern parking areas are in fair to good condition. The northeast parking area contains $12,000 \pm$ SF of pavement and about 40 spaces. The northwest parking area contains $11,000 \pm$ SF of pavement and $28 \pm$ spaces. The southern parking area contains $10,000 \pm$ SF of pavement and $41 \pm$ spaces. The southern parking area is in fair to poor condition.

Woodside Elementary School southeast parking area

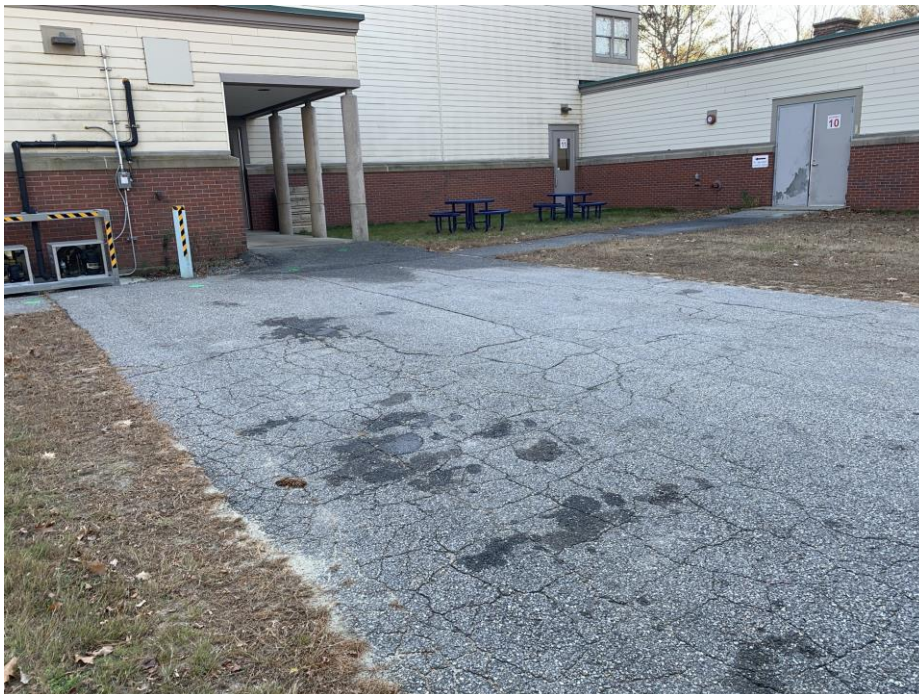
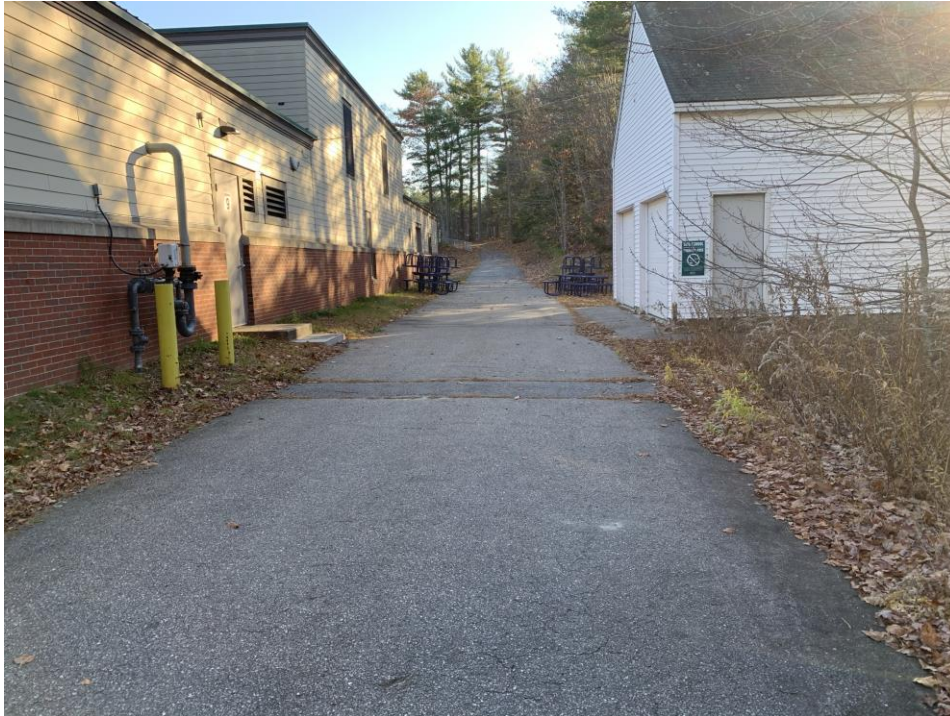
Service Road & Loading Area: A service drive approximately 570 feet long branches off the top of the “U” of the entrance drive and wraps around the rear of the school. This drive contains 8,500± of pavement and is in fair condition. The 2500± SF loading area is in fair to poor condition.

Woodside Elementary School service drive at loading area

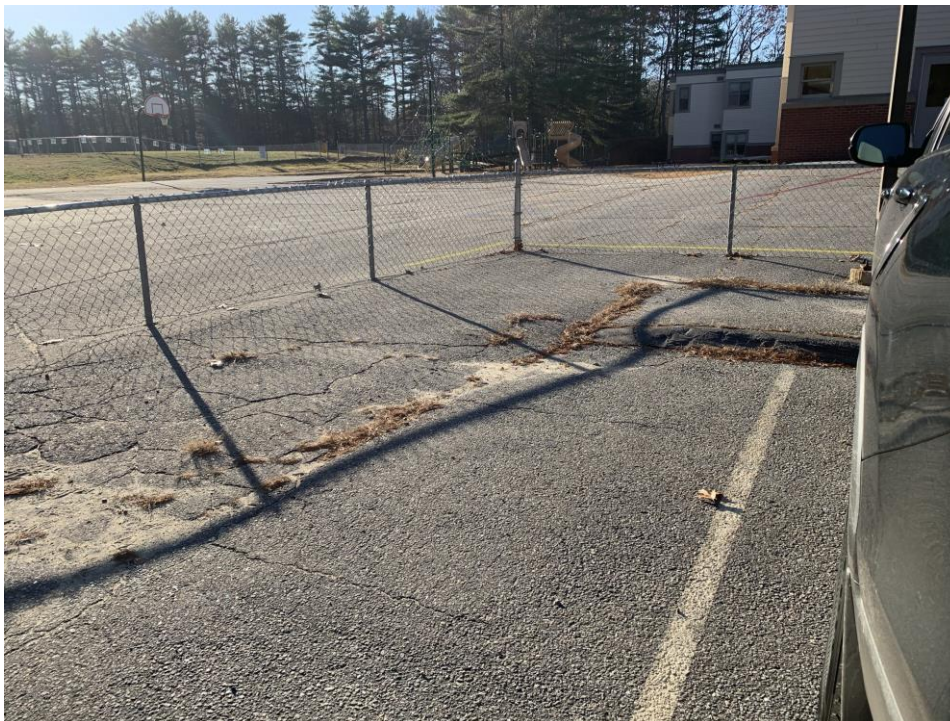
Playground: There is a paved playground area off the southeast corner of the building. This playground contains 9,000± of pavement and is in fair to poor condition with many cracks.

Woodside Elementary School looking at paved playground from end of southern parking area

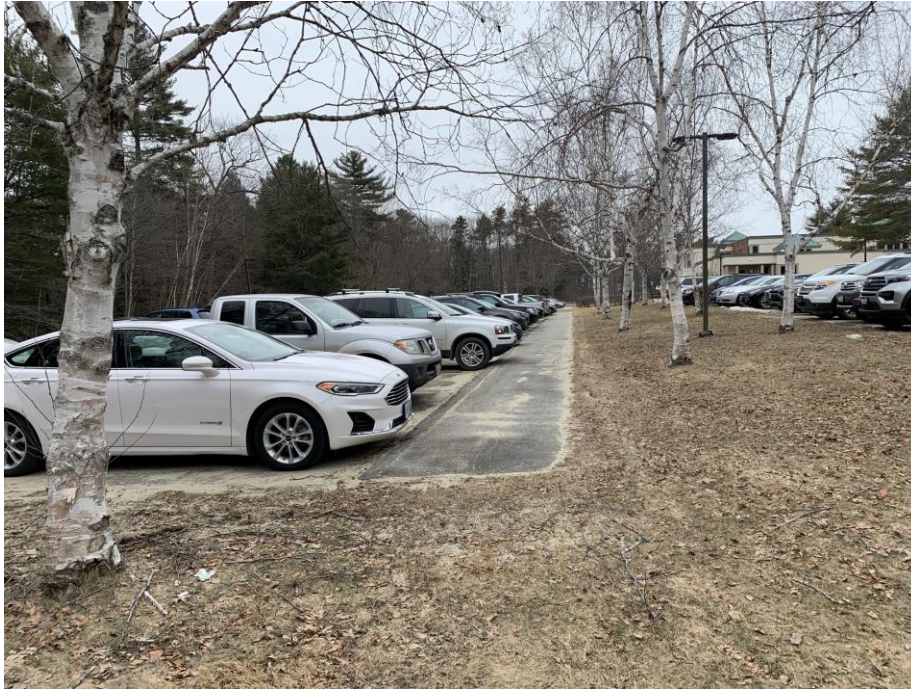
Sidewalks: The main entrance plaza and walkway in front of the school is concrete in good condition and not a part of this study. There are sidewalks bordering the northeast and northwest parking areas that are in fair to good condition. There is a sidewalk bordering the southern parking area and another extending from the southern parking area out to the Barrows Street that are in fair to somewhat poor condition.

Sidewalk bordering the northeast parking area
