**MSAD No. 75 Envelope Analysis  
Report  
May 31, 2021  
*Updated July 2021*  
Prepared by: CHA Architecture**

The MSAD No. 75 School District contracted with CHA Architecture, P.C. to conduct an analysis of the existing cladding at the Mt. Ararat Middle School and make recommendations for recladding the existing building.

### HEAD DETAIL - FIBER CEMENT SIDING CONDITION

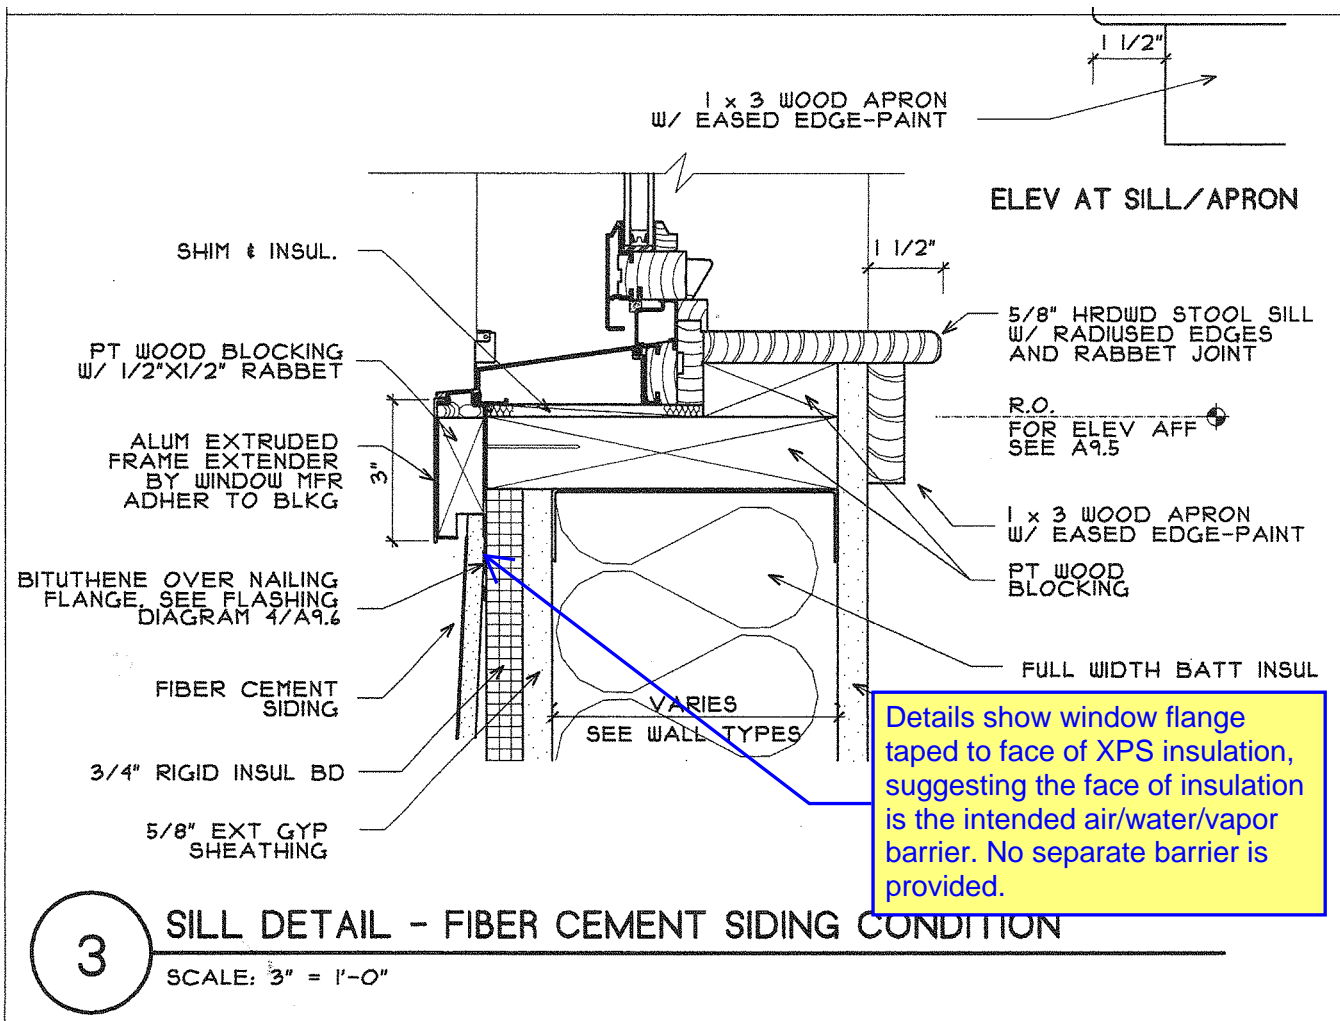
Damage to interior gypsum wall board caused by water moving through wall assembly layers dropping at window jambs. This raises concern about additional water damage to fiberglass batt insulation installed between cold-formed metal studs.

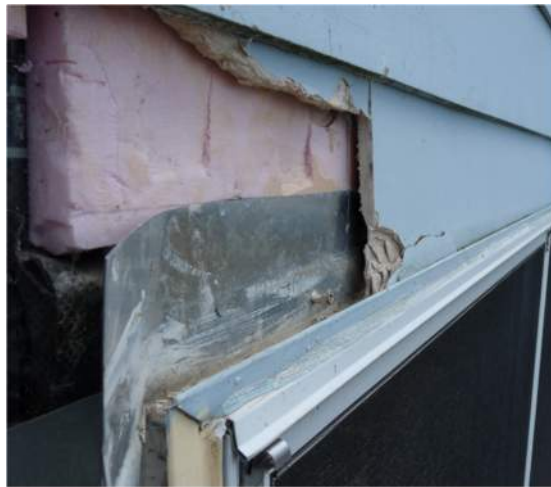
It is apparent that the j-channel at the window head is holding water and seeping into the cementitious siding above the head.
