Maine School Administrative District 75
Asphalt Assessment Study Report

Prepared for
Maine School Administrative District 75
50 Republic Avenue
Topsham, ME 04086

RFS 20-9466.001

June 09, 2021

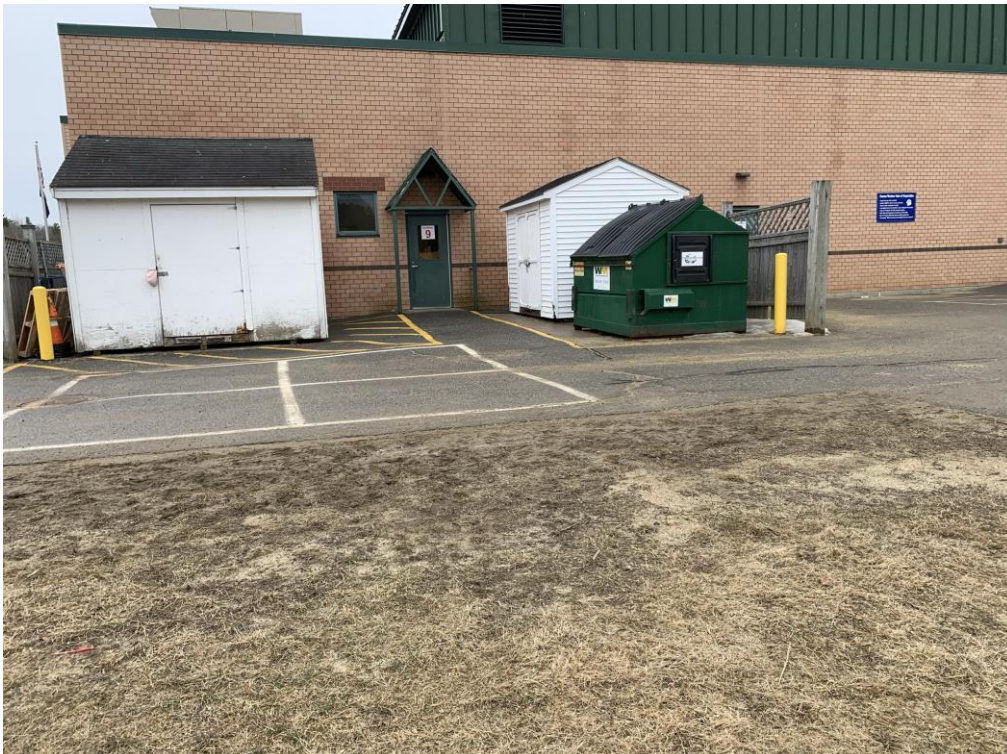
Rear service drive/ playground: There is an 8,000± SF paved area to the rear of the school which provides access for maintenance and delivery vehicles. This area also serves as a playground. The pavement in this area is in fair to poor condition, with cracks, patches, and frost heaves observed. A large patch was recently placed at the east end of this area, abutting the bus loop. The topography rises from the rear of the school to the north, resulting in a lot of runoff flowing toward the school and creating wet areas at the rear of the school, between the service drive and playground. This drainage issue has to do with the surrounding topography, and although not ideal, is outside of the scope of this report. However, there were frost heaves and undulating pavement observed in the service drive abutting this area, which is likely due to poor base materials, improper compaction, poor drainage beneath the pavement, or a combination thereof. Therefore, when this pavement is replaced, a base of free-draining material (clean stone), sloped to drain away from the school, is recommended.

Bowdoin Central School: Deformed pavement/ heaving can be seen near the shed on the left.

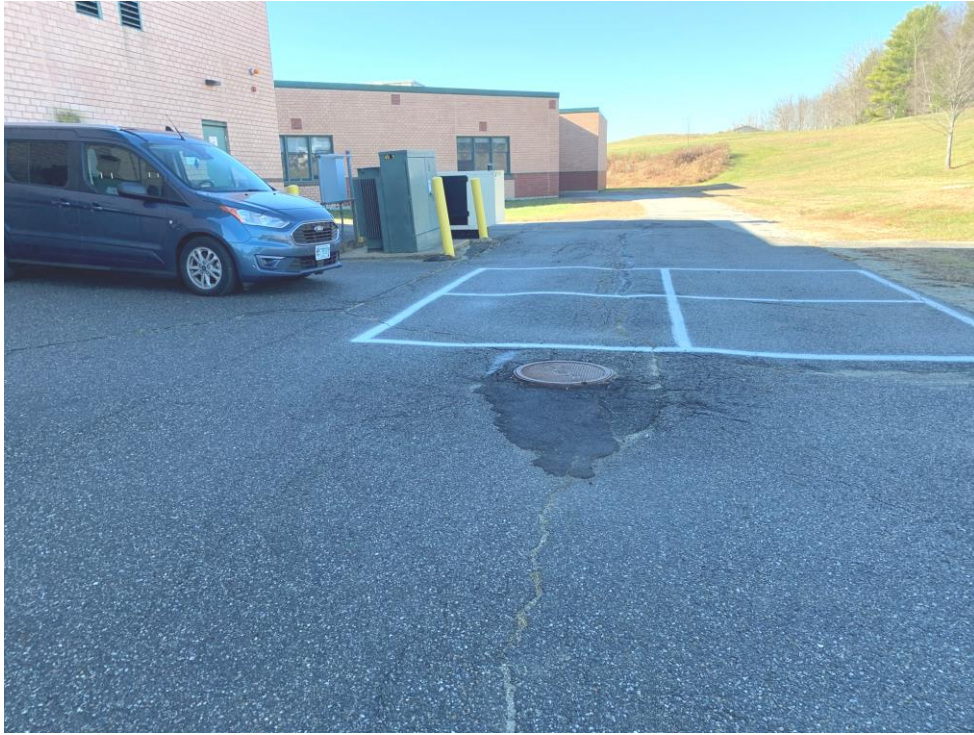
Bowdoin Central School rear service drive/ playground - note heaves

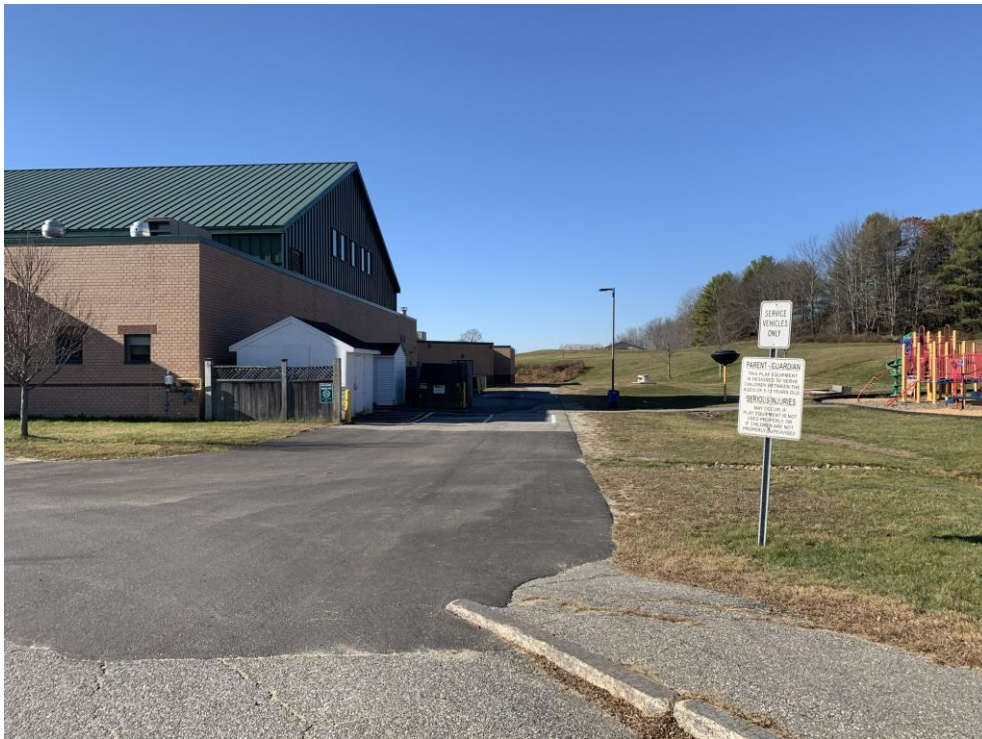
Bowdoin Central School rear service drive/ playground – note large patch of new pavement

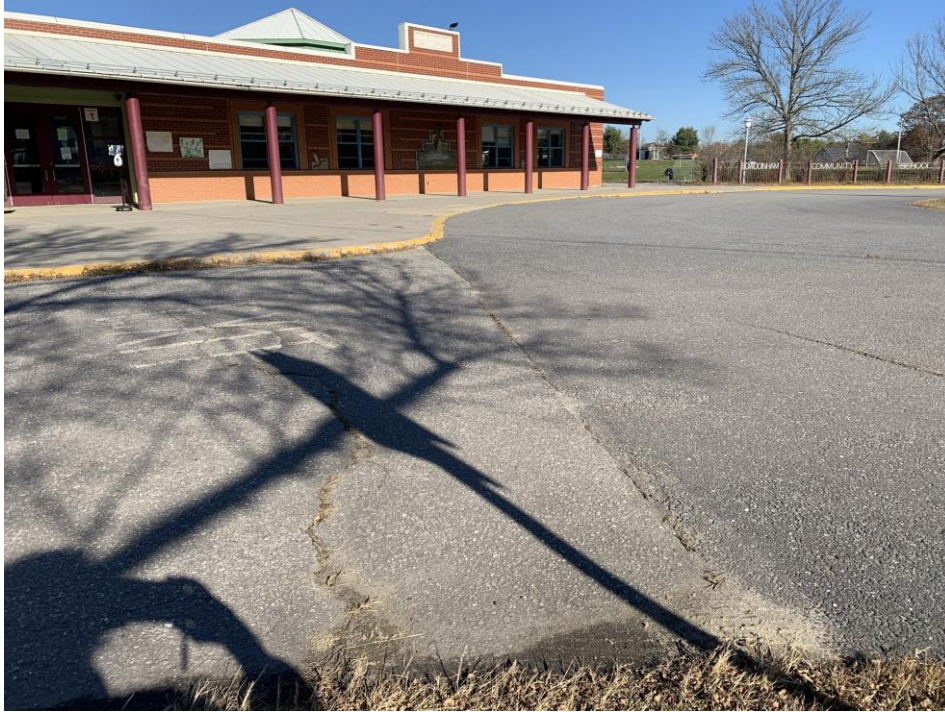
Bowdoinham Community School junction of front walk, bus loop, and main parking area

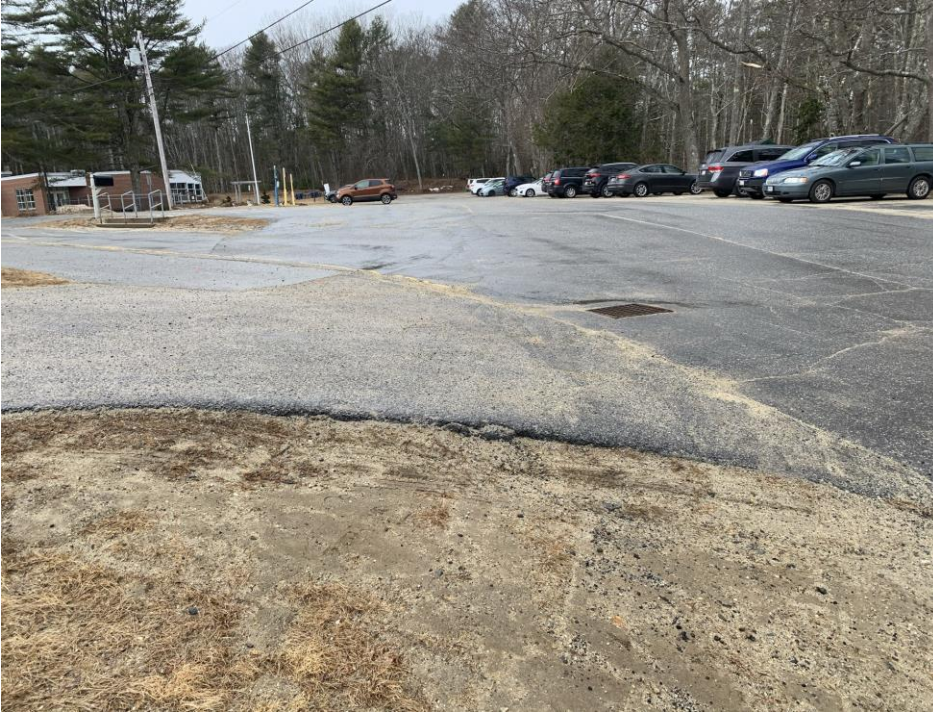
Harpswell Community School facing parking area from top of driveway with bus loop at left

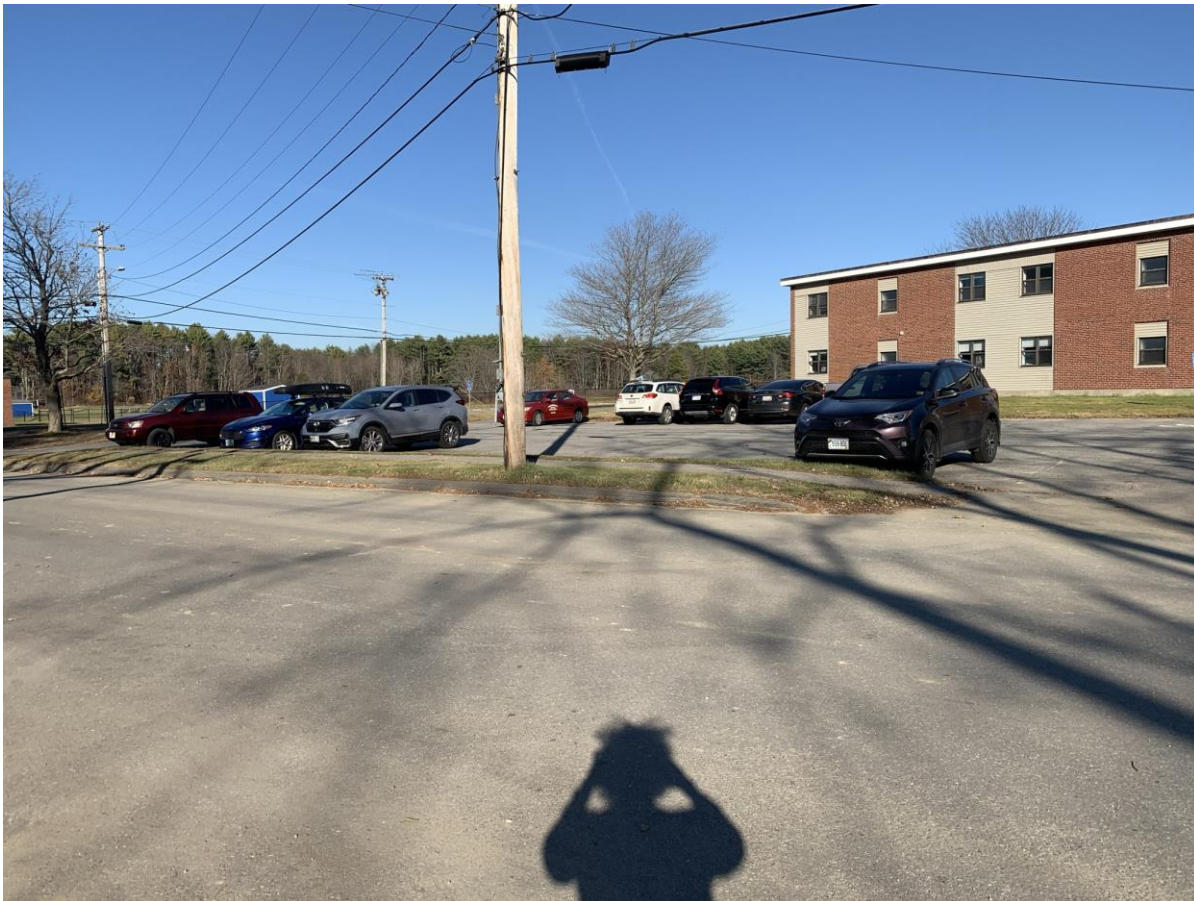
Merrymeeting Adult Education Lodge entrance to northern parking area off Republic Ave

Northern parking area: The northernmost parking area for the Merrymeeting building is 9000± SF and has capacity for approximately 22 vehicles. The pavement in this parking area is showing signs of age; it has patches and cracks and is in fair condition.

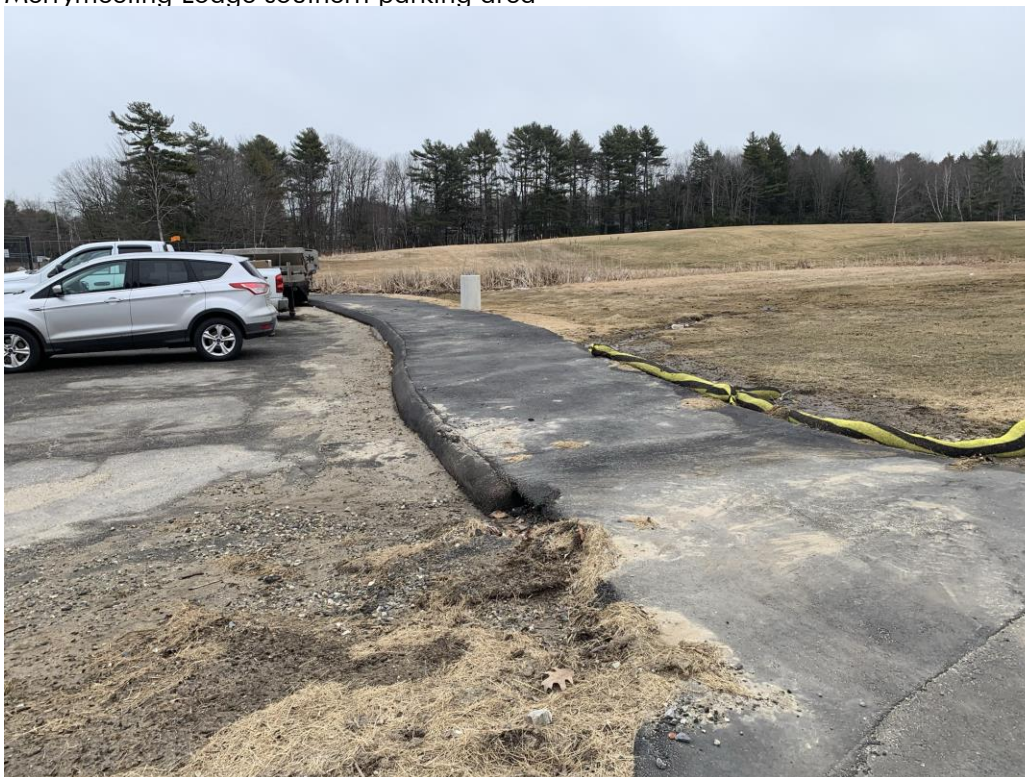
Southern parking area: The southernmost parking area for the Merrymeeting building is 14,000± SF and has capacity for approximately 20 to 25 vehicles. The pavement in this parking area is in very poor condition with significant rutting, cracks, patches, and potholes. The sidewalk bordering the southern edge of the lot which leads to the tennis courts has recently been replaced.

Merrymeeting Lodge southern parking area showing new sidewalk

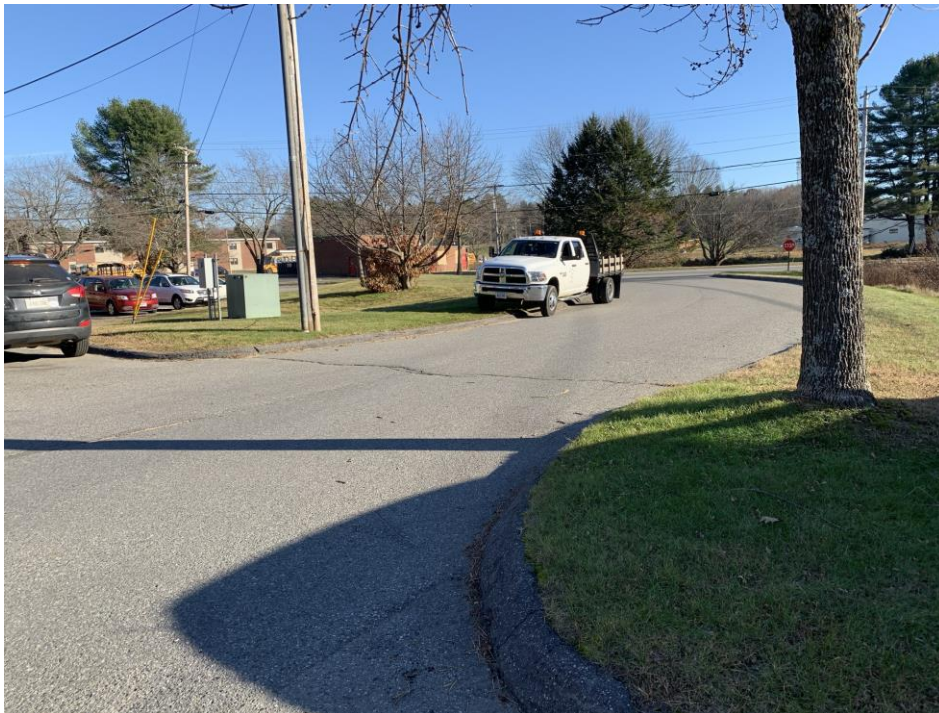
Access: The MSAD 75 Administrative Office is located at 50 Republic Avenue, and is part of the Mt. Ararat Middle School campus. The MSAD District Office is in a separate building adjacent to the middle school. The office grounds have a total of approximately 35,000 SF of asphalt surfaces. There is a separate 150± foot long driveway off Canam Drive for the District Office building located on the west side of the building which is in fairly good condition (shown below.) There is a service drive off Canam Drive that provides access to a loading dock and dumpster that is also in fair to good condition.

The MSAD office main drive looking back out to Canam Drive

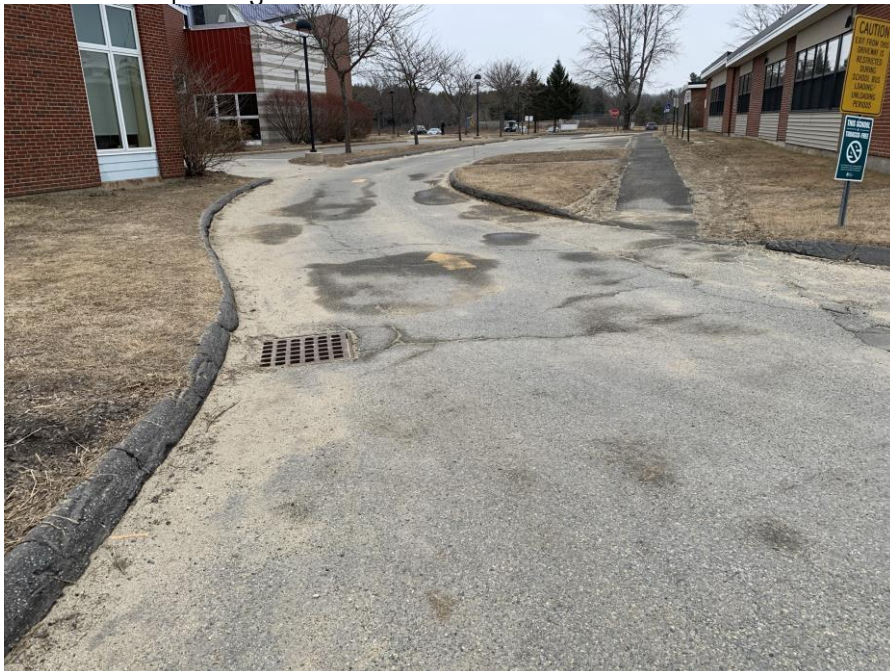
Parking: Parking area #1 is a 21,000-SF, 52-space lot on the west side of the building in fair condition. There is another drive from parking area #1 that wraps around the north side of the building and connects to Republic Ave with parking for another 7 vehicles (parking area #2; 4600 SF). Parking area #2 and the connecting drive and are in fair condition.

MSAD Office drive connecting parking area #2 to Republic Ave and parking area #2

Priorities for MSAD Office Building: The pavement at this facility varies in condition in different areas. The driveway from Canam Drive and the service area drive are in fairly good condition. The driveway connecting parking area #2 and Republic Ave and parking area #2 itself is in fair to poor condition. Stormwater runoff reportedly pools at parking area #2 along the curbing, so this area should be graded to drain when the work is done.

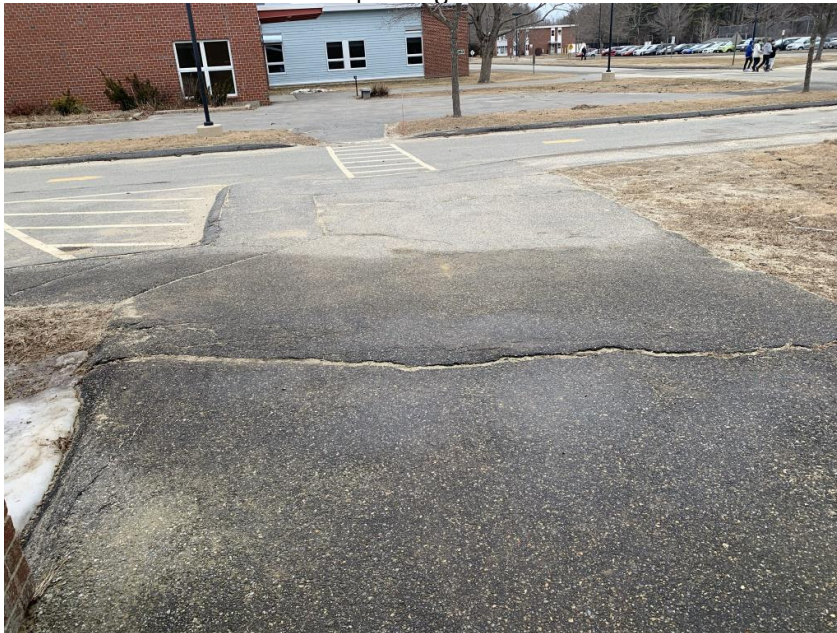
Sidewalk: The walkway connecting the two parking areas to the front of the school and Republic Ave is in fair condition, as shown below.

MSAD Office walkway at main entrance

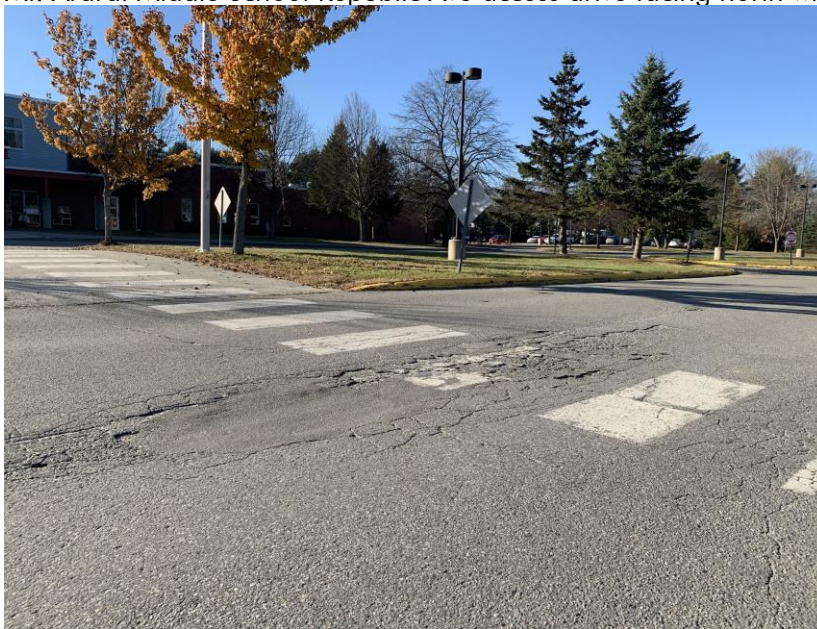
Access Drive: The Ararat Middle School driveway is technically a continuation of Republic Avenue although it is not a through-way. The Republic Ave driveway extends from Canam Drive for a straight distance of $800 \pm$ feet parallel to the front of the school. The road then makes a U-turn and runs directly in front of the school for the bus drop-off. The bus drop-off lane and Republic Ave run parallel to each other and are separated by grassed islands. The drive is in mostly fair condition, with a few areas of potholes and cracking. The bus lane is in fair to good condition.

Mt. Ararat Middle School Republic Ave access drive facing main entrance to school

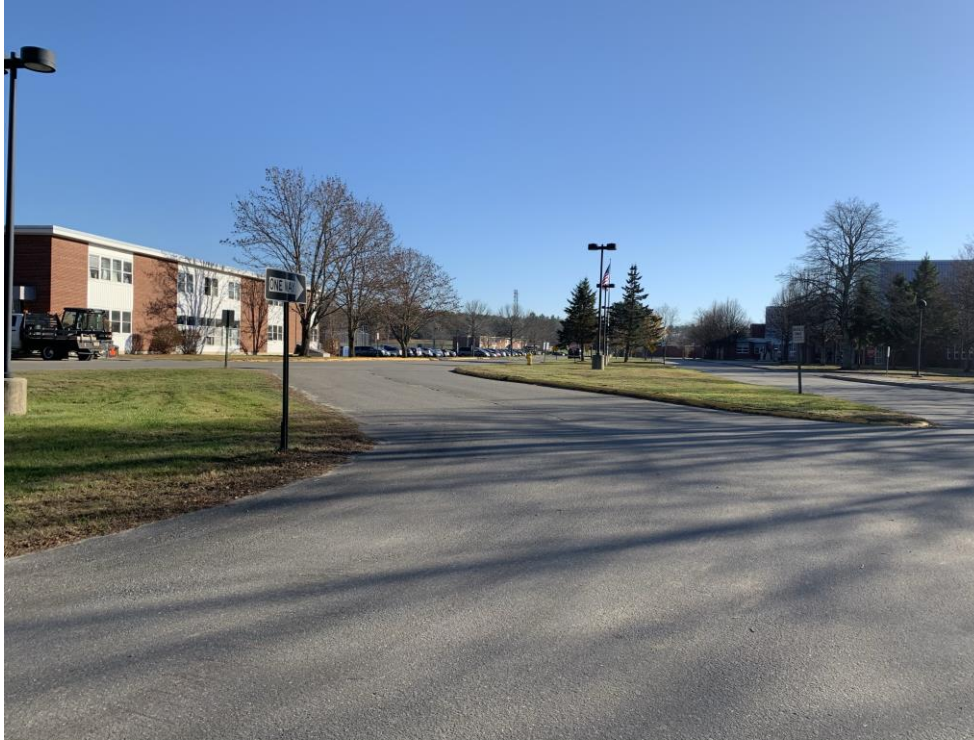
Mt. Ararat Middle School Republic Ave facing south from cul-de-sac with bus lane on right

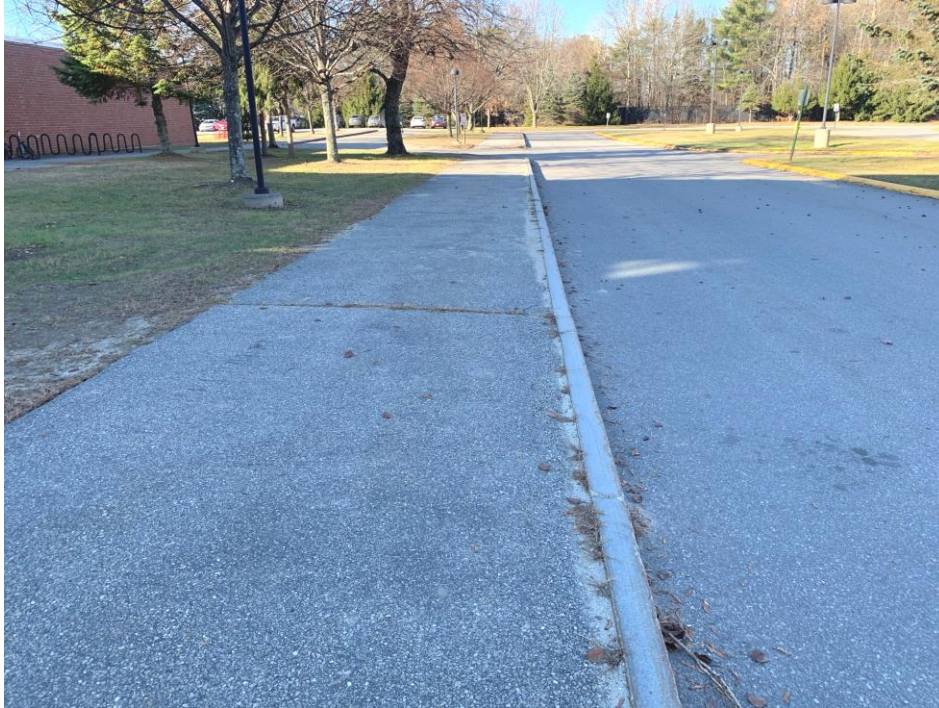
Mt. Ararat Middle School Sidewalk along bus lane looking north toward U-turn

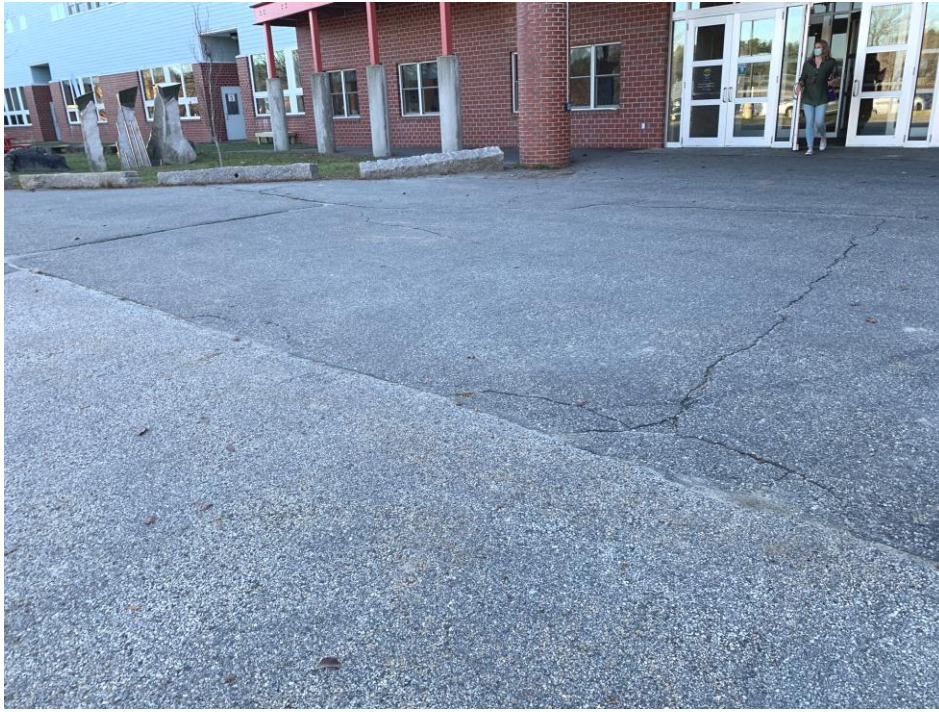
Main Entrance Plaza & Sidewalks: The asphalt entrance plaza at the main entrance to the school is in fair condition, with more cracking present than the rest of the main walkway parallel to the bus lane.

Mt. Ararat Middle School main entrance plaza

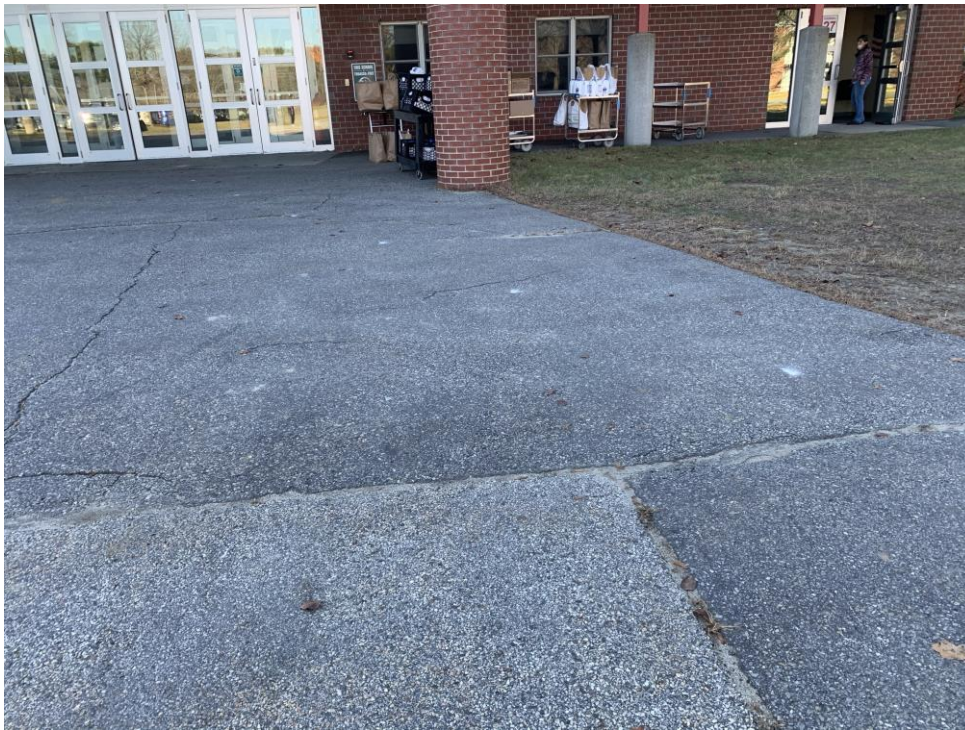
Mt. Ararat Middle School main entrance plaza

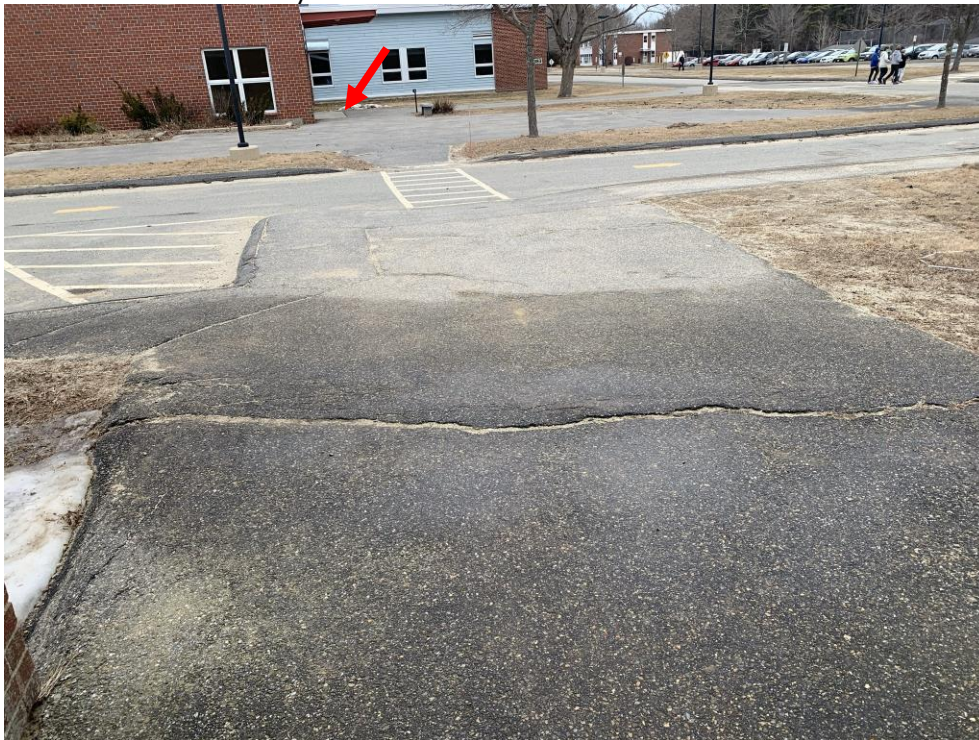
Orion Theater walks as viewed from main entrance to MSAD office. Arrow points to main theater entrance.

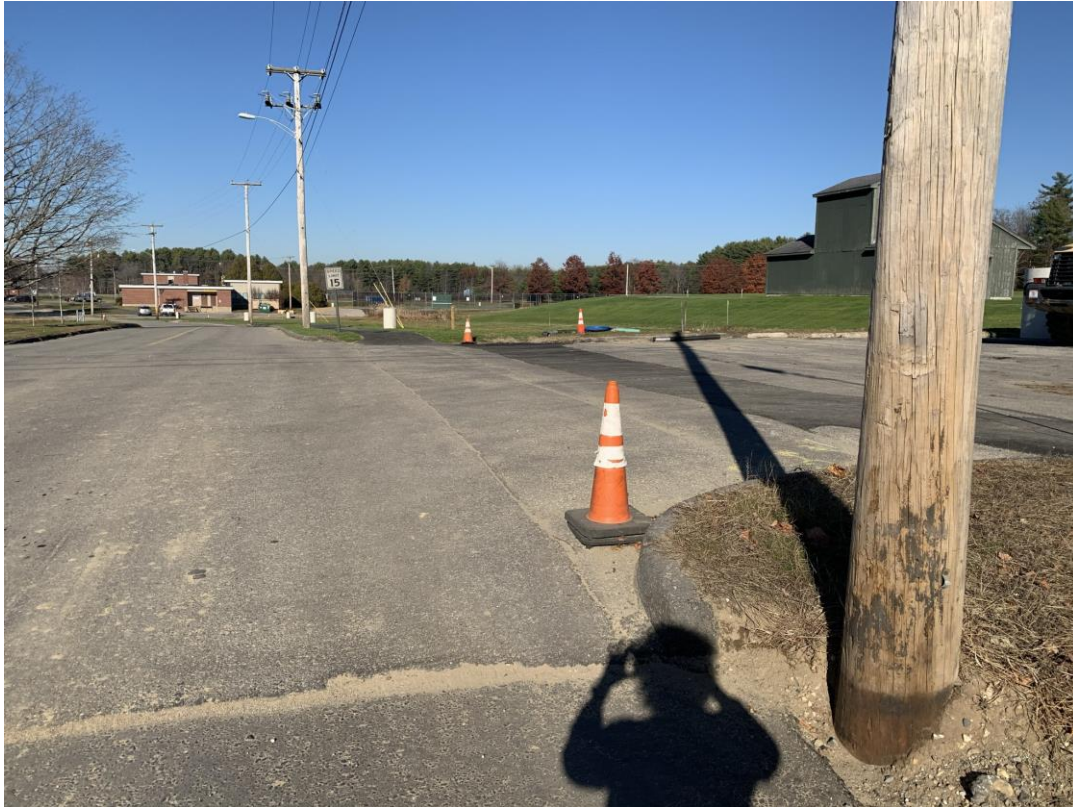
General: Republic Avenue connects the middle school to the high school. The area of this road being evaluated is the first 860±feet from Canam Drive heading toward the high school, terminating at the small practice field auxiliary parking area opposite the Wicked Joe Coffee Roasters building, but not including the aux parking area. This section of the road contains approximately 24,000± SF of pavement in fairly good condition with minor cracks and one utility patch observed. There is an asphalt berm curb on both sides of the road which is also in fairly good condition.

Republic Ave, facing north from the beginning of the study area with the entrance to the Aux Parking lot on right

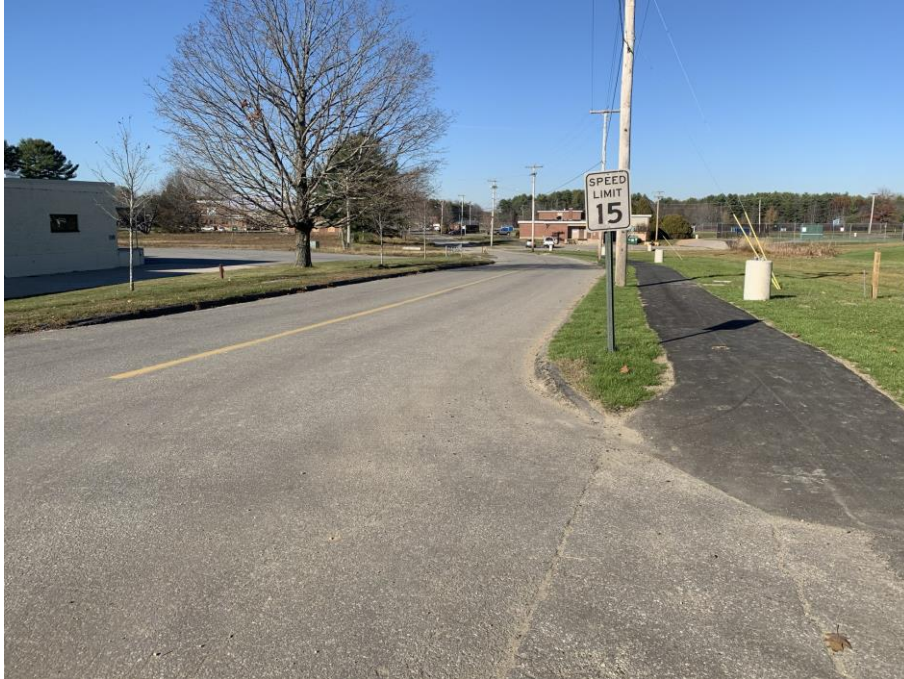
Republic Ave, facing north from the entrance to the Aux Parking lot on right. Note new sidewalk.

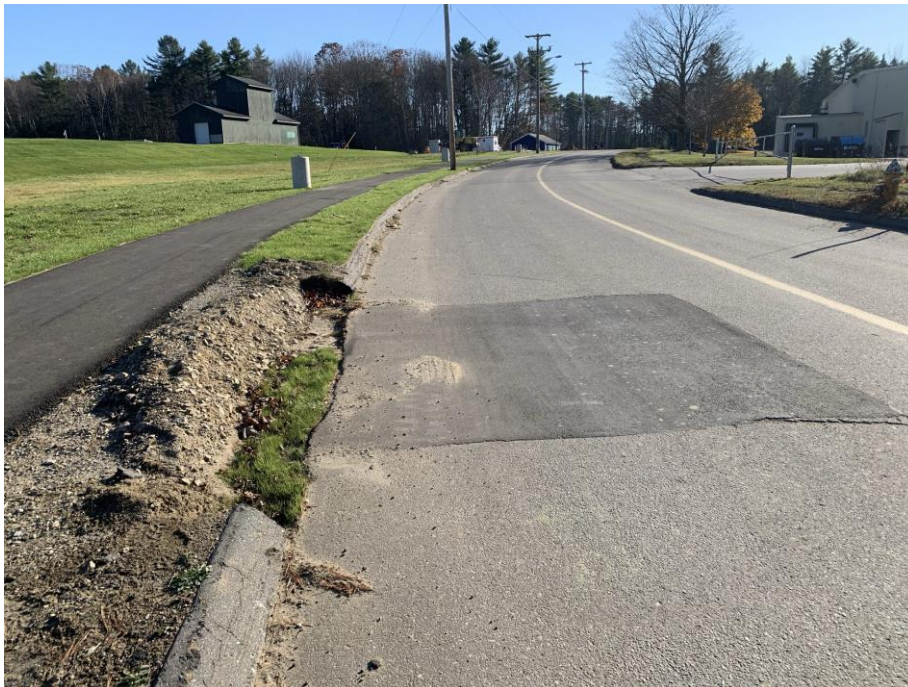
Republic Ave, facing south toward the Aux Parking lot, showing utility patch. Note new sidewalk.

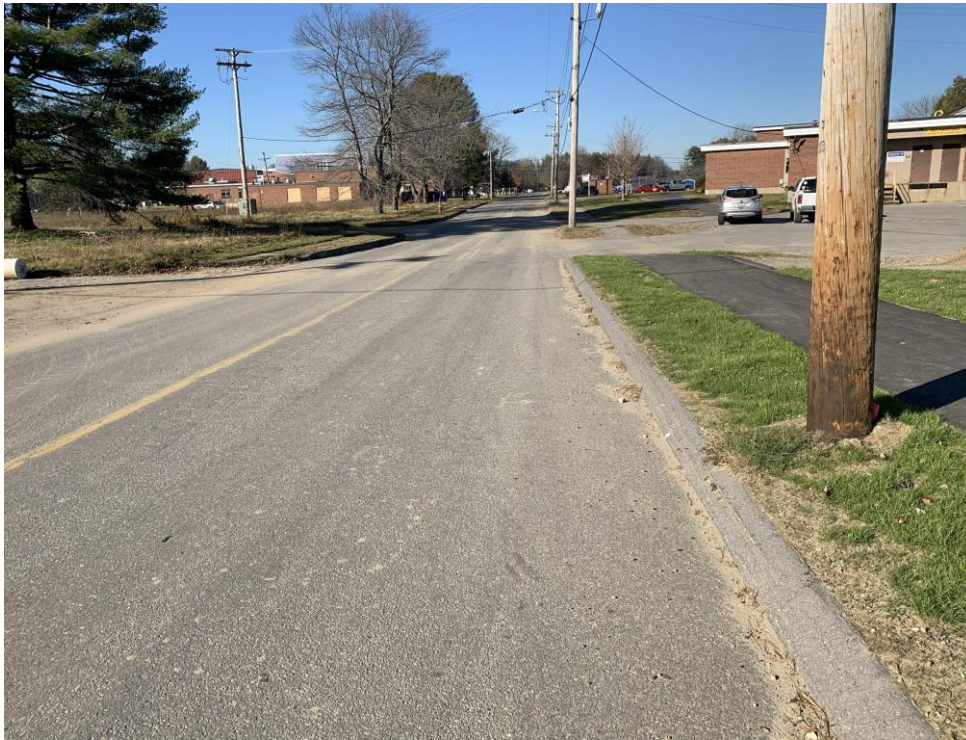
Republic Ave, facing north. Note new sidewalk & Merrymeeting building on right.

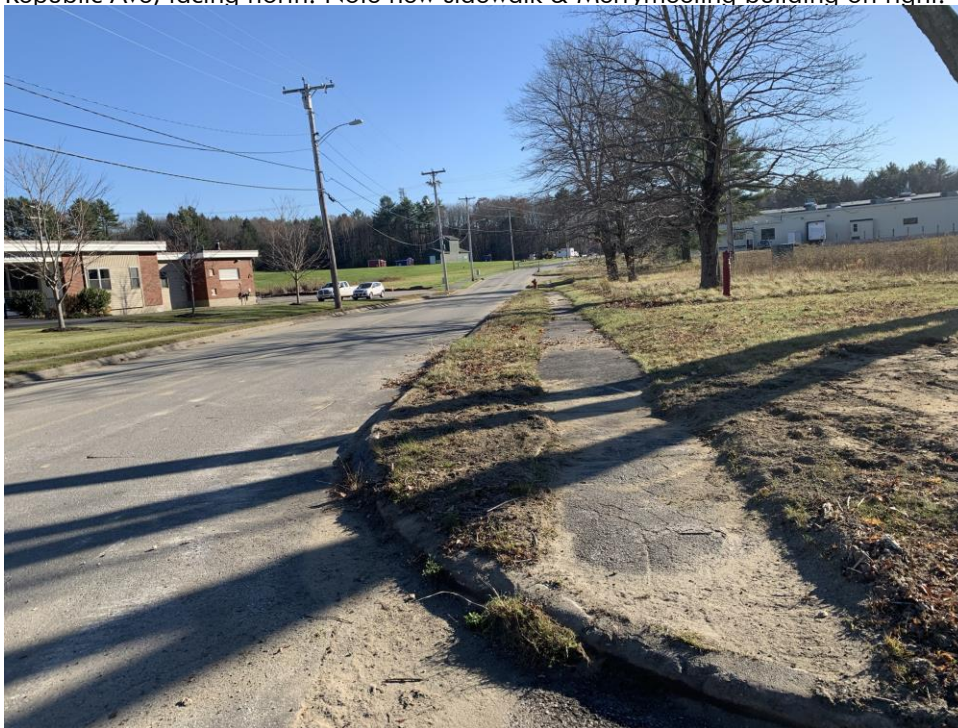
Republic Ave, facing south, showing abandoned sidewalk.

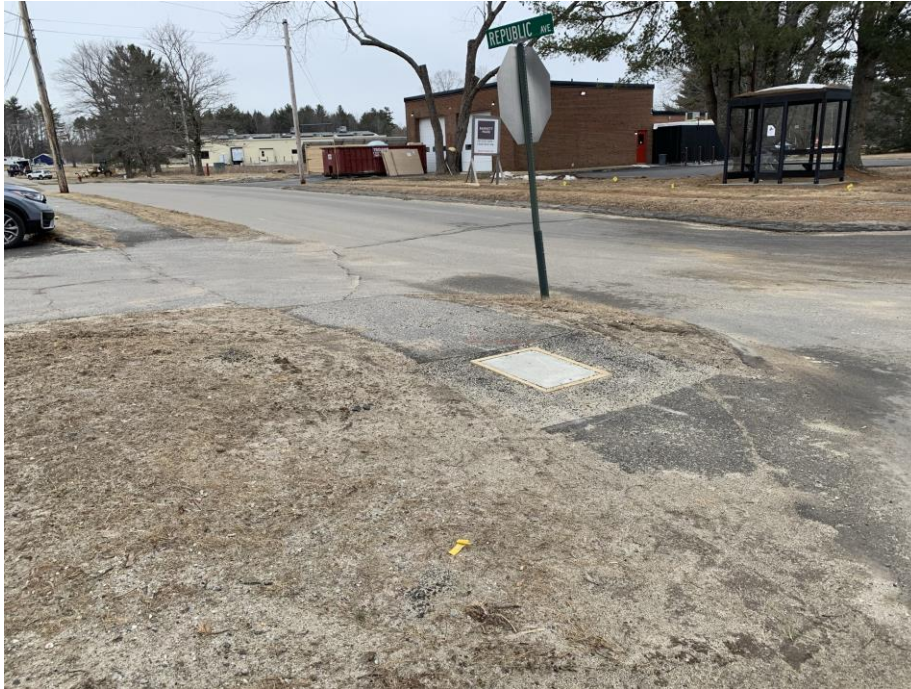
Republic Ave at intersection with Canam Drive (Merrymeeting parking at left)

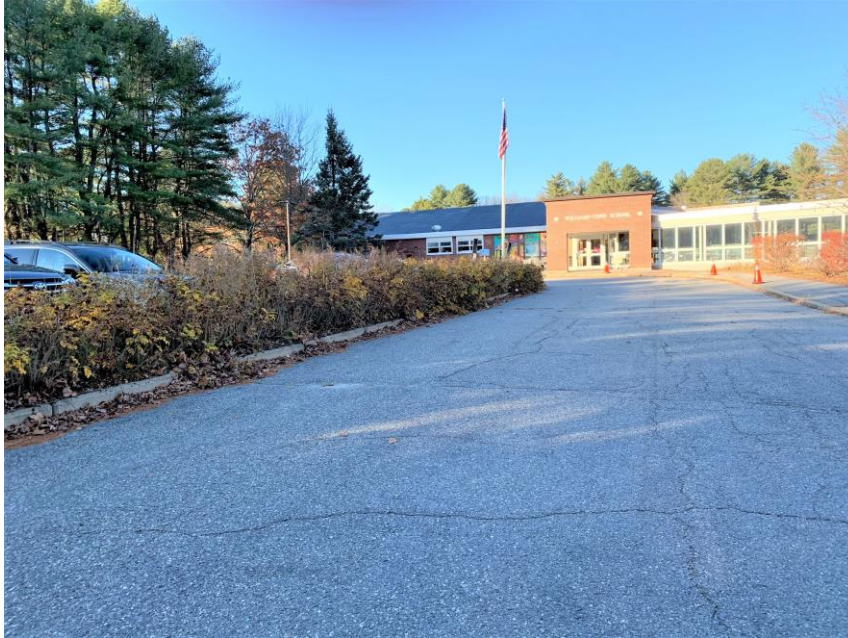
Williams-Cone School main entrance drive with central parking area visible on left

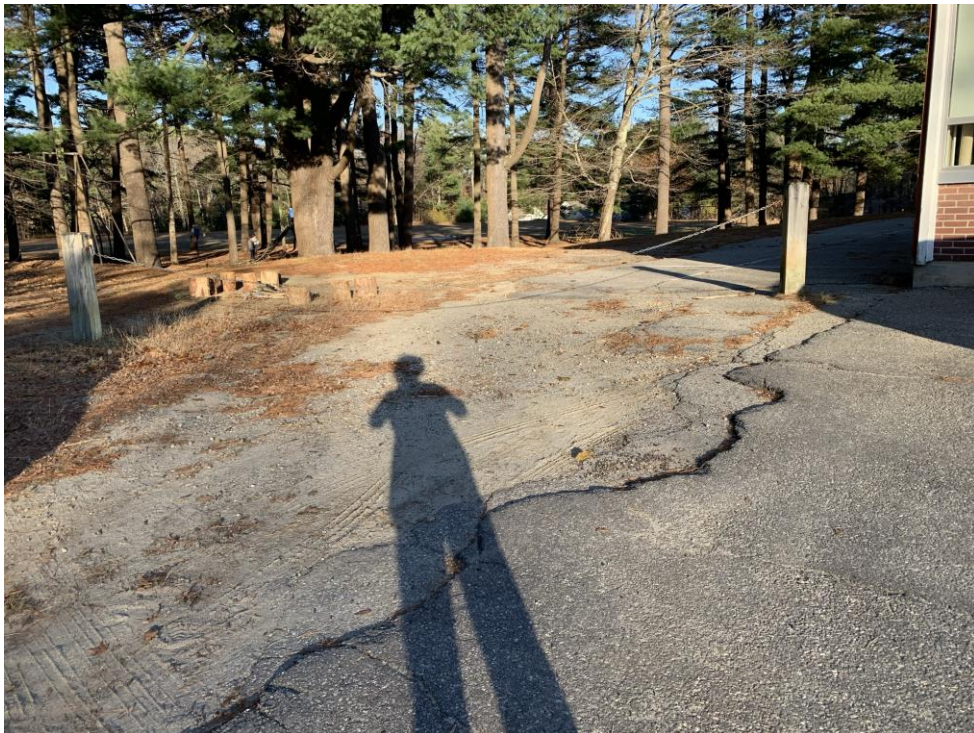
Williams-Cone School termination of NW parking area at northern end of building

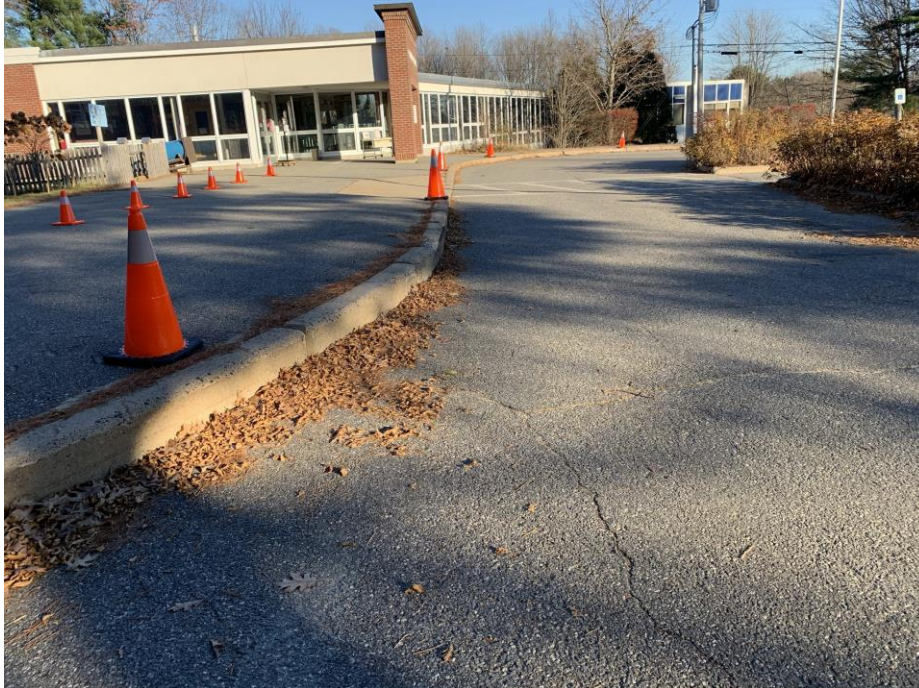
Sidewalks: The main entry plaza and connected walkways at the main entrance contain about 3300 SF of asphalt pavement in fair to good condition. This area is abutted by concrete curbing at the bus drop-off area. There is also about 95 linear feet (600± SF) of sidewalk connecting Perkins Street to the main entry plaza and walkway.

Williams-Cone School main entry plaza & bus drop-off

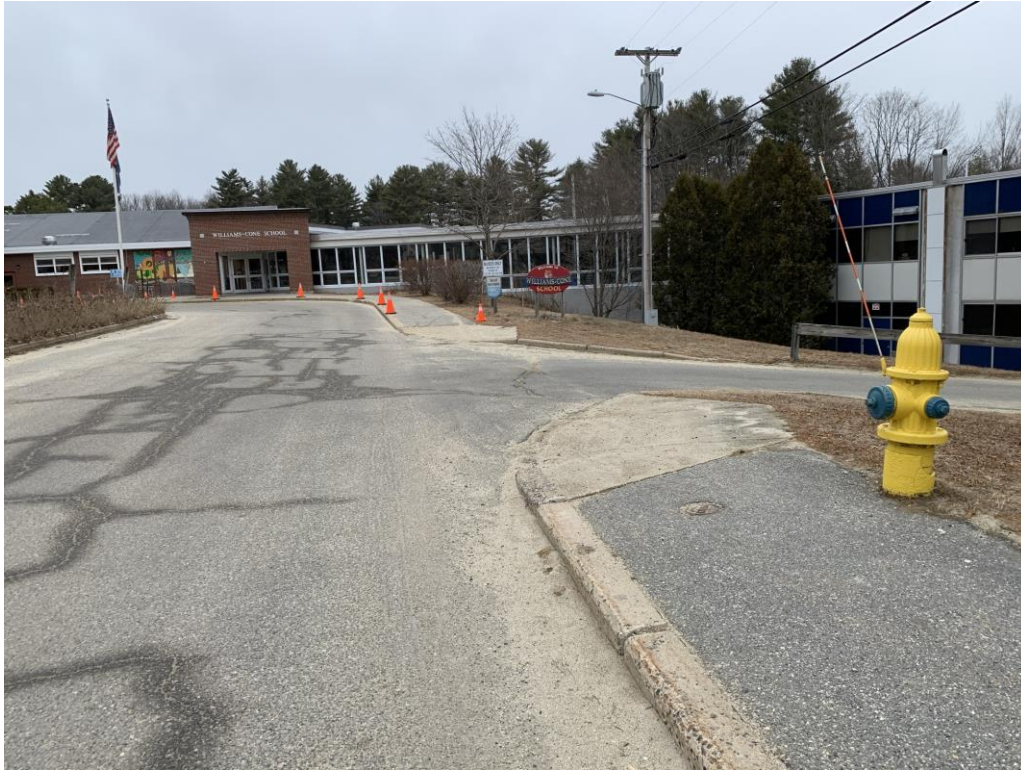
Williams-Cone School sidewalk/main entrance drive from Perkins Street. Entrance to lower parking on right.

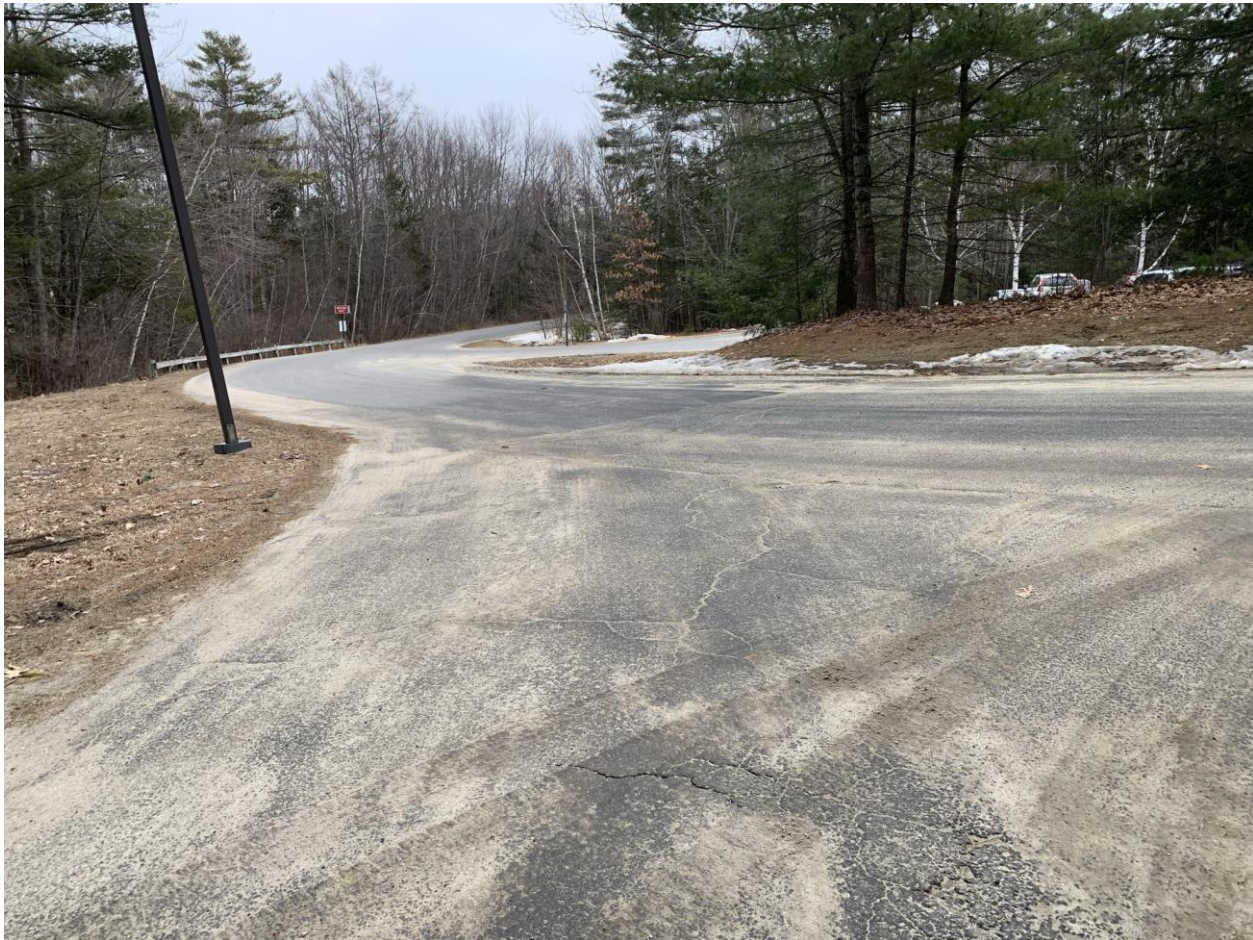
Access Drive: The Woodside Elementary School has a one-way, 1400-foot-long, U-shaped driveway that extends in a loop from Barrows Drive, passes in front of the school for bus drop-off, and returns to Barrows Drive. The entrance drive up to the top of the "U" (approximately 600 linear feet) consists of newer pavement in good condition. The top portion of the "U", the bus drop-off area, and the exit drive (totaling $800 \pm$ linear feet) consists of older pavement and shows signs of age. With the exception of the first 600 feet of entrance drive, the remaining pavement on the site appears to be about the same age, and is in fair to poor condition.

Woodside Elementary access drive at end of newer pavement taken from beginning of service road

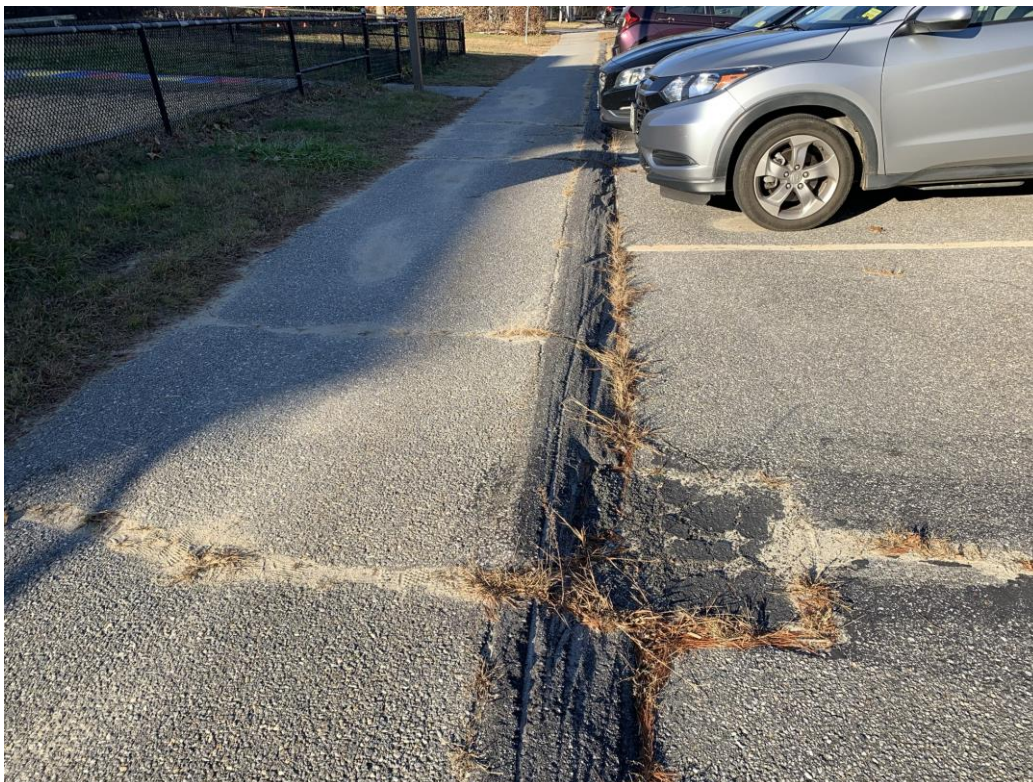
Parking: There are three large parking areas serving the school. The northern parking areas are in fair to good condition. The northeast parking area contains $12,000 \pm$ SF of pavement and about 40 spaces. The northwest parking area contains $11,000 \pm$ SF of pavement and $28 \pm$ spaces. The southern parking area contains $10,000 \pm$ SF of pavement and $41 \pm$ spaces. The southern parking area is in fair to poor condition.

Woodside Elementary School southeast parking area

Priorities for Woodside Elementary School: The southern parking area is in fair to poor condition and in the greatest need of repair, and the sidewalks bordering it should be repaired at the same time. This includes the portion of the sidewalk along the exit road closest to the southern parking area (first 100± feet.) The loading area on the north side of the school off of the service road and the paved playground are in fair to poor condition. The remainder of the pavement on the campus is in fair to good condition.
