Maine School Administrative District 75
Asphalt Assessment Study Report

Prepared for
Maine School Administrative District 75
50 Republic Avenue
Topsham, ME 04086

RFS 20-9466.001

June 09, 2021

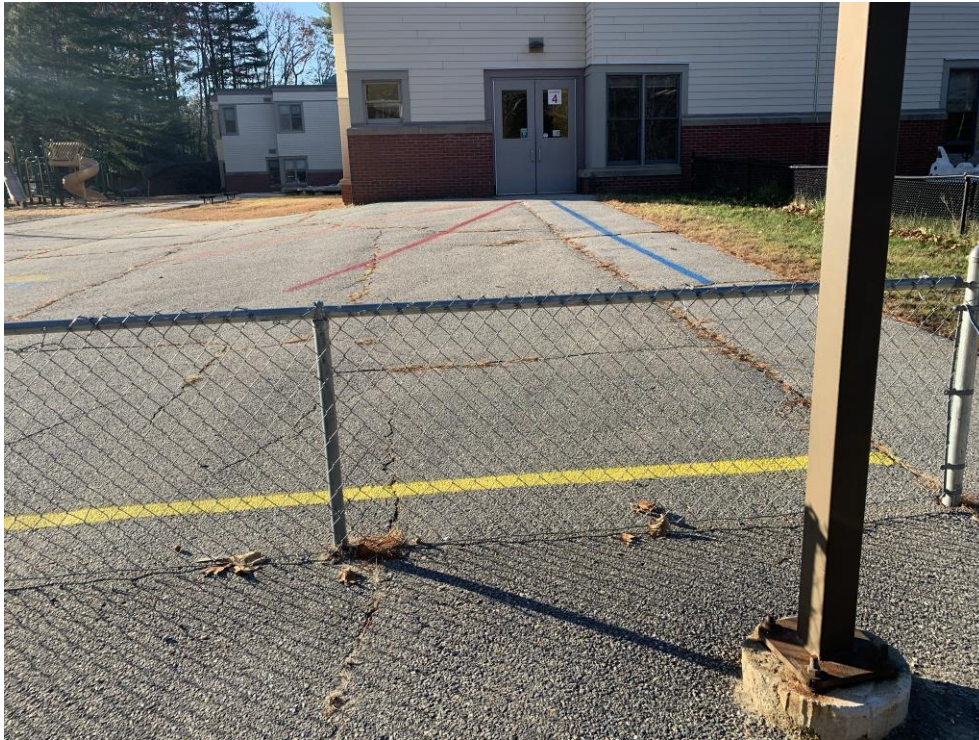
Playground: There is a paved playground area off the southeast corner of the building. This playground contains 9,000± of pavement and is in fair to poor condition with many cracks.

Woodside Elementary School looking at paved playground from end of southern parking area

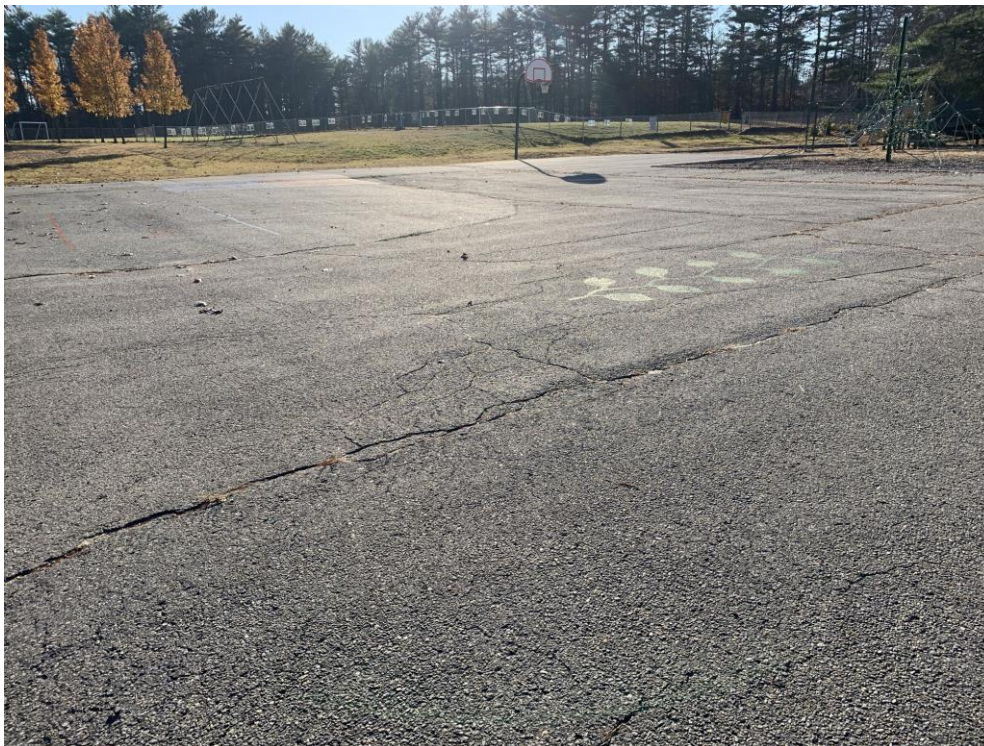
Woodside Elementary School paved playground

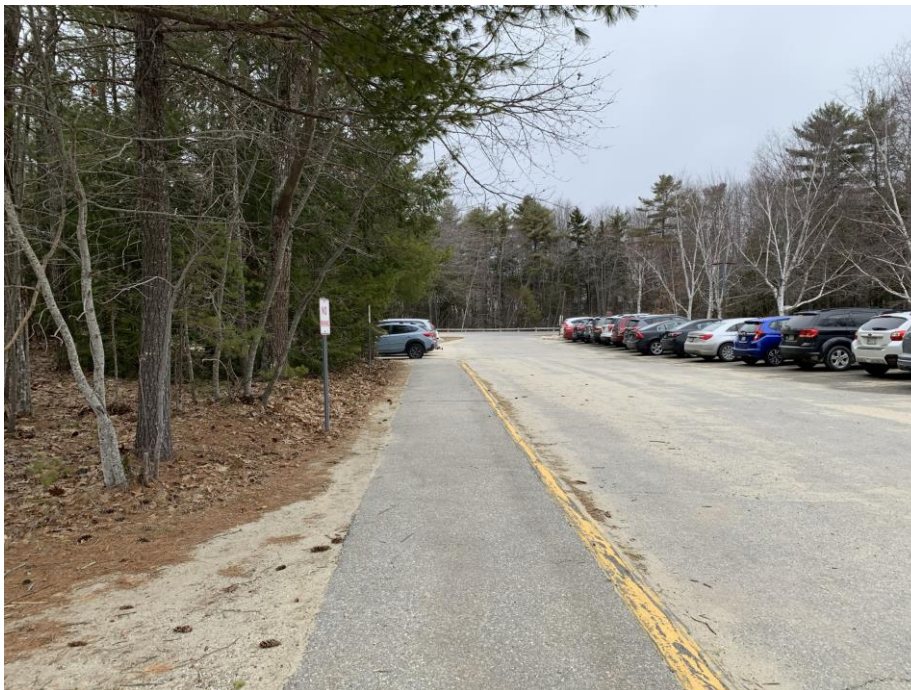
Sidewalks: The main entrance plaza and walkway in front of the school is concrete in good condition and not a part of this study. There are sidewalks bordering the northeast and northwest parking areas that are in fair to good condition. There is a sidewalk bordering the southern parking area and another extending from the southern parking area out to the Barrows Street that are in fair to somewhat poor condition.

Sidewalk bordering the northwest parking area

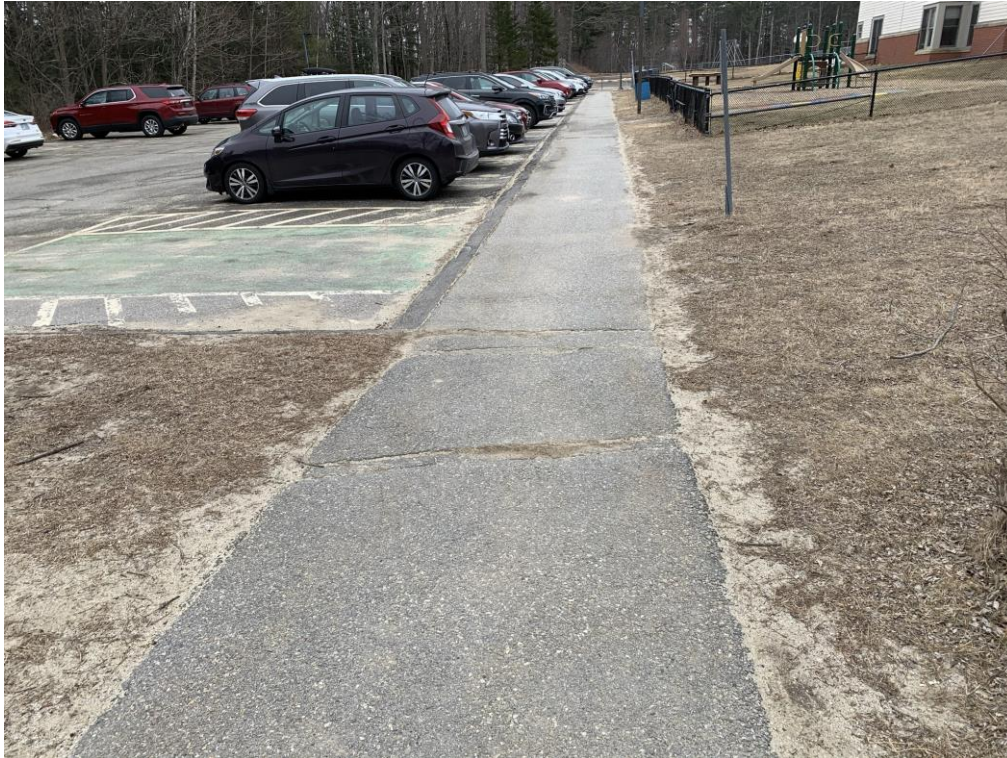
Sidewalk bordering the southern parking area

Priorities for Woodside Elementary School: The southern parking area is in fair to poor condition and in the greatest need of repair, and the sidewalks bordering it should be repaired at the same time. This includes the portion of the sidewalk along the exit road closest to the southern parking area (first 100± feet.) The loading area on the north side of the school off of the service road and the paved playground are in fair to poor condition. The remainder of the pavement on the campus is in fair to good condition.

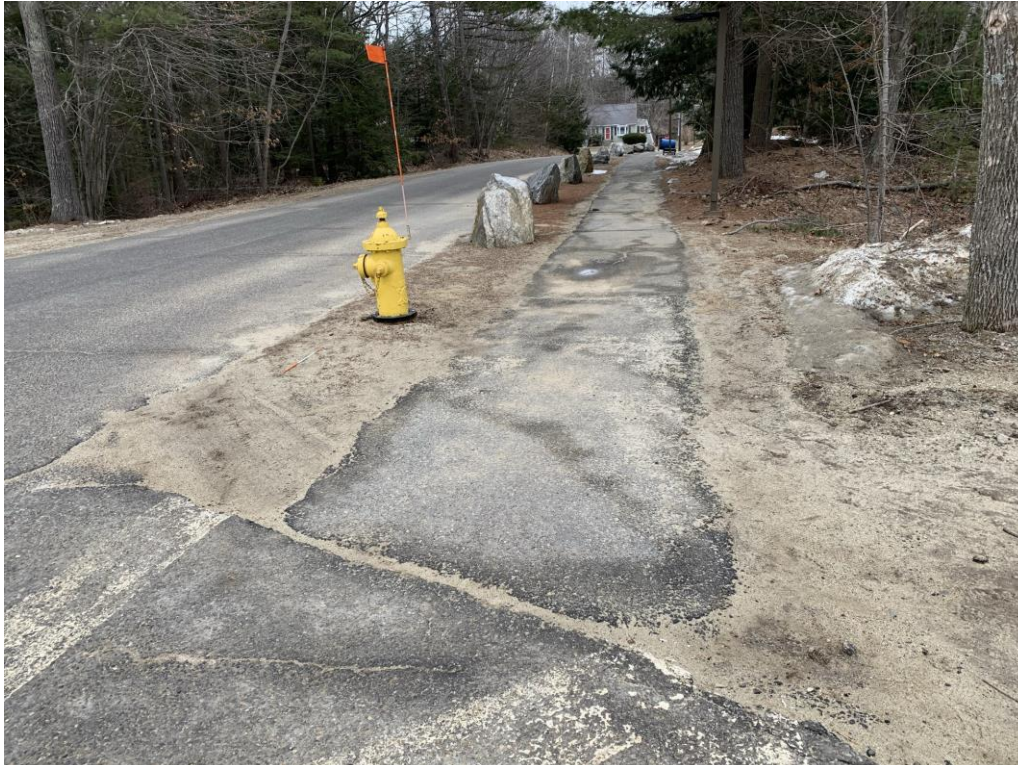
Sidewalk extending from the southern parking area along exit drive out to the Barrows Street

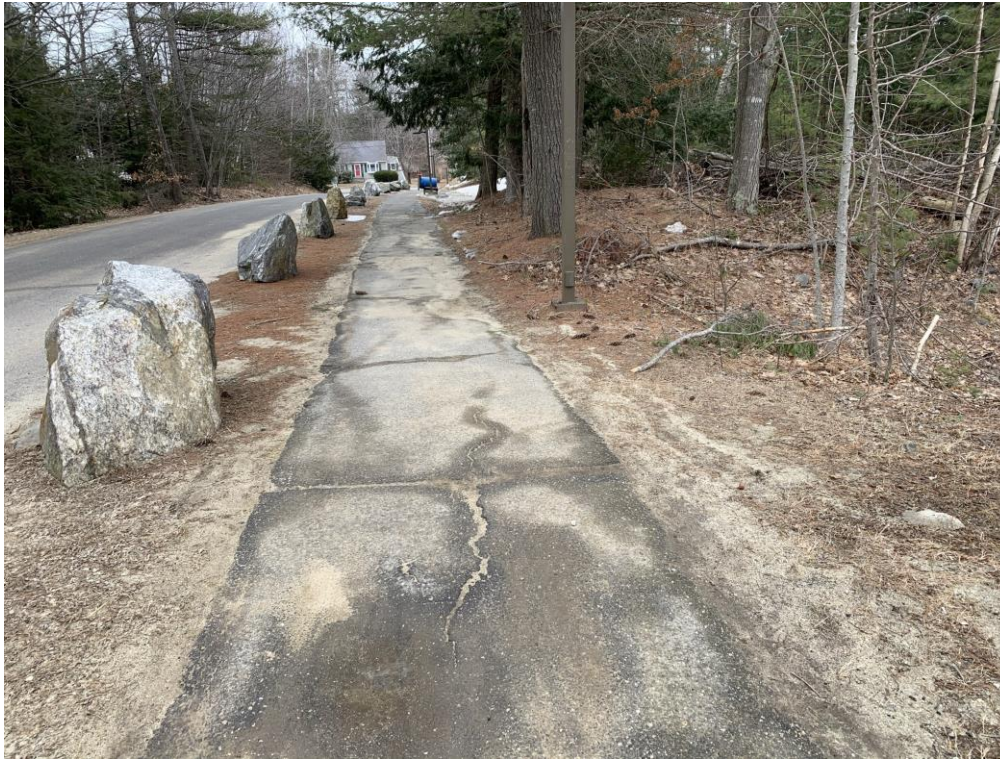
Woodside Elementary School walk from southern parking to Barrows Street along the exit drive

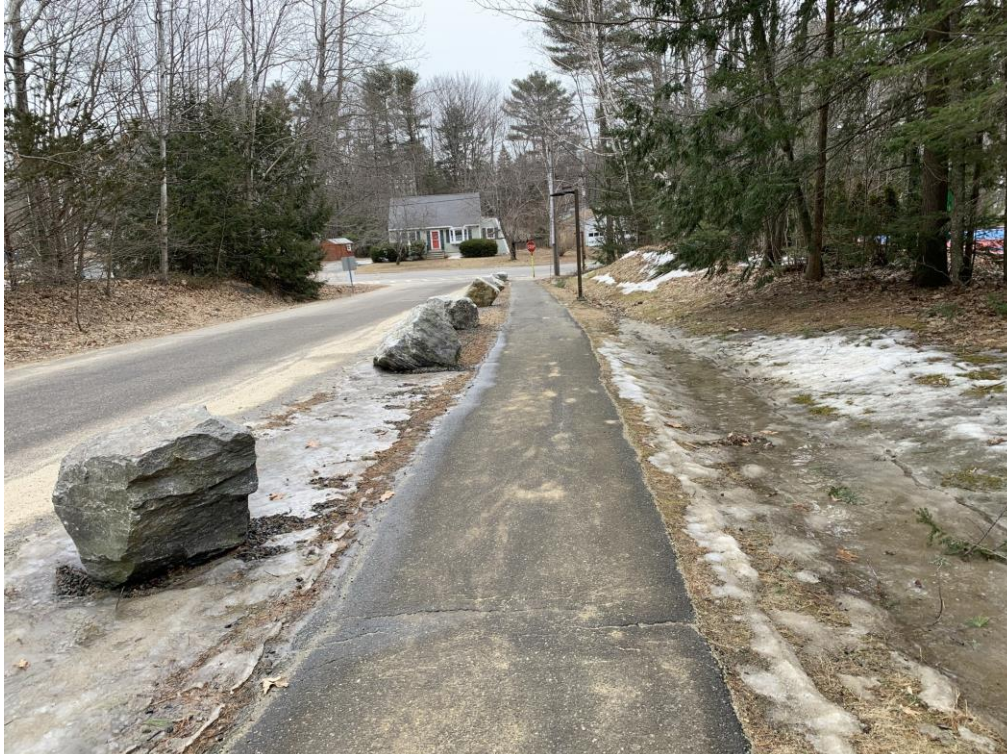
Sidewalk extending from the southeast parking area along exist drive out to the road
