Maine School Administrative District 75
Asphalt Assessment Study Report

Prepared for
Maine School Administrative District 75
50 Republic Avenue
Topsham, ME 04086

RFS 20-9466.001

June 09, 2021

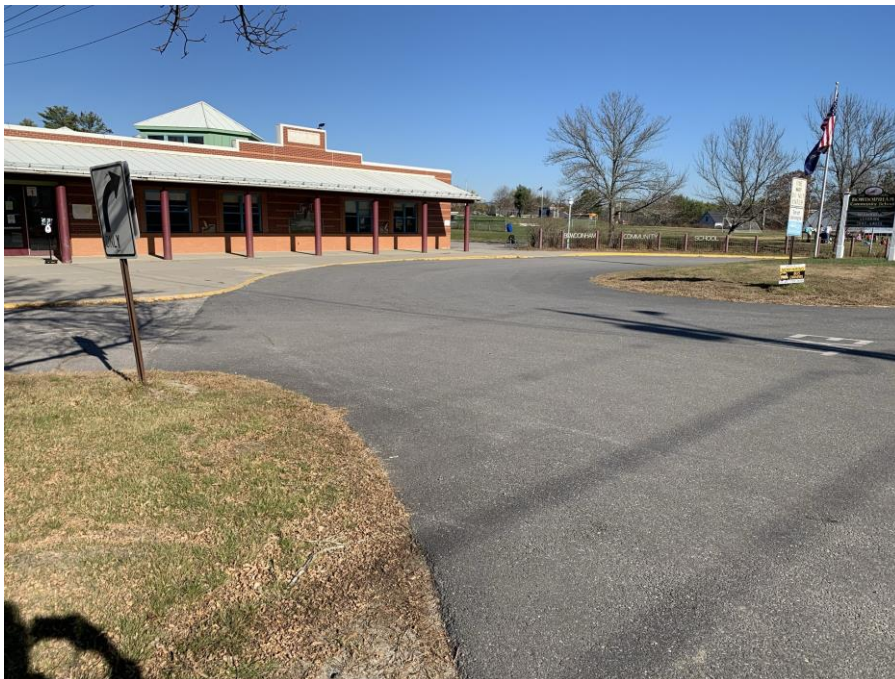
Access drive: The Bowdoinham Community School has a total of approximately 28,000 SF of asphalt surfaces, with access off of Cemetary Road. Two of these access points provide a U-shaped bus lane that loops in front of the school. This bus loop drive consists of newer pavement in good condition.

Bowdoinham Community School U-Shaped Bus loop

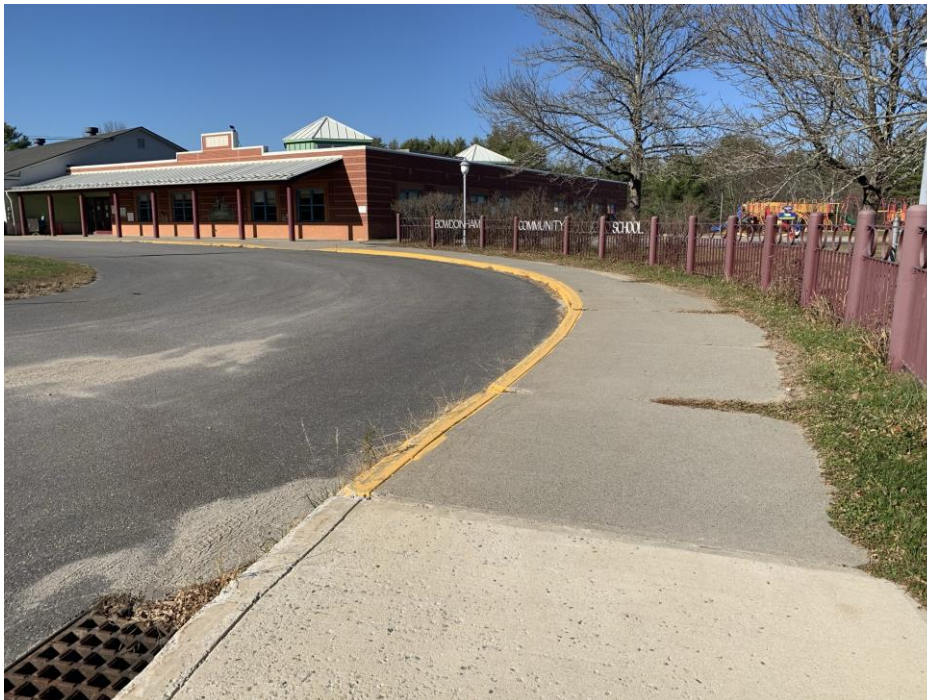
Front walk & entry plaza: Although not a part of this study, there is a 4000-SF concrete walkway at the front entrance to the school that extends the length of the front of the school, encompasses the main entrance plaza area, and extends out to and along Cemetery Road. The concrete is in fairly good condition.

Bowdoinham Community School Front walk

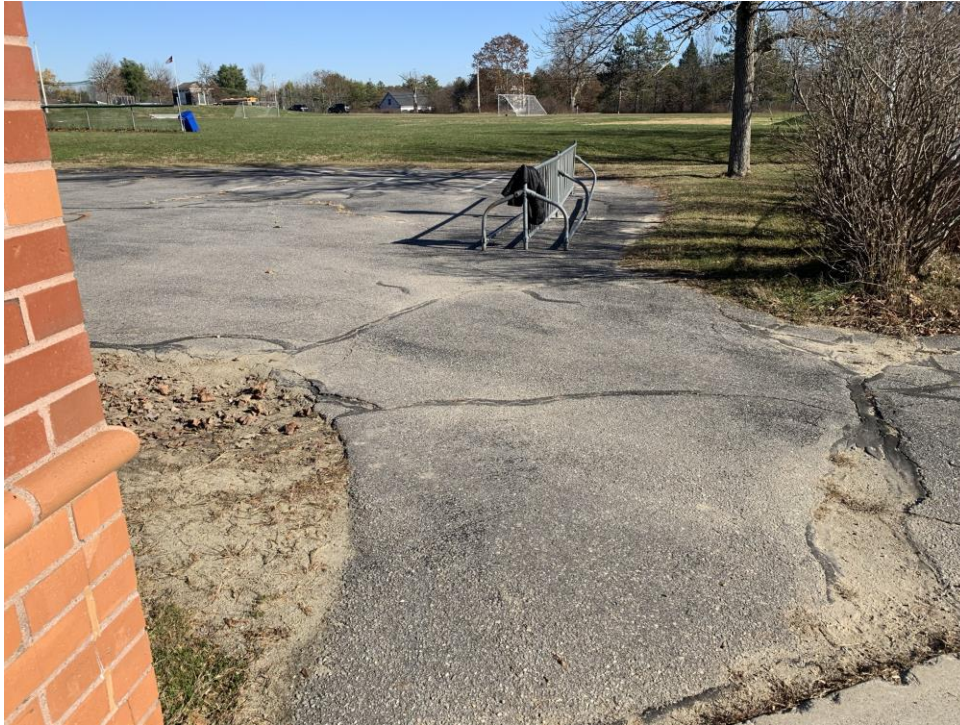
Paved playground: There is a 6000± SF paved playground area on the east side of the school that is used only as a play area. The pavement in this area is in poor condition, with cracks supporting grass growth, areas of differential settling, and deteriorated pavement observed.

Bowdoinham Community School entrance to playground from front of school

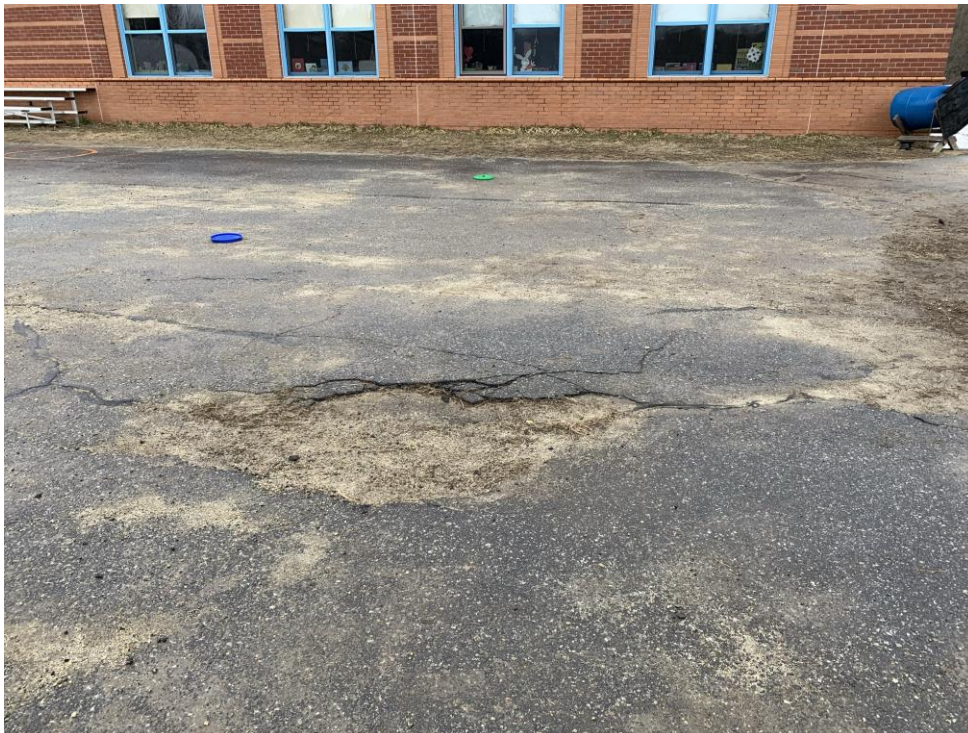
Bowdoinham Community School paved playground

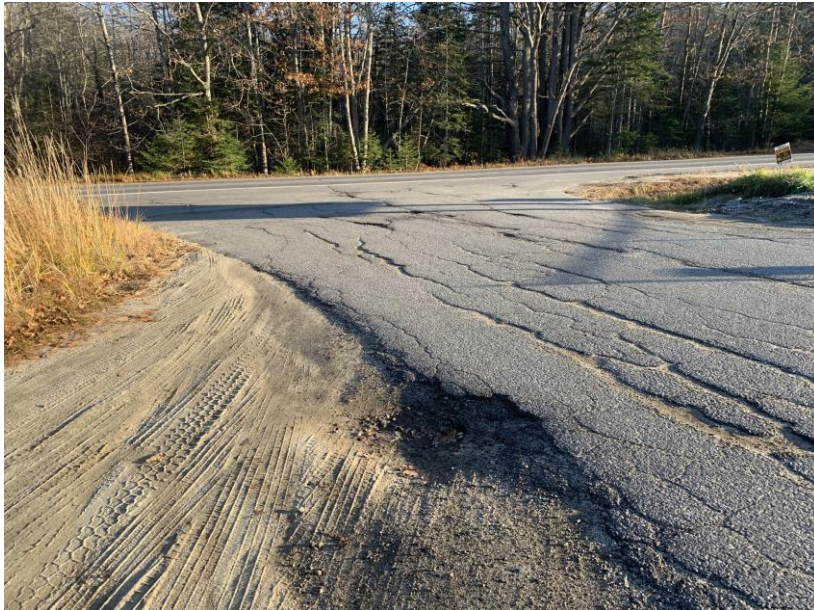
Access drive: The Harpswell Community School is set back on a hill about 500 feet from Harpswell Island Road, with one long access driveway. The site has a total of approximately 54,000 SF of asphalt surfaces. The 500+ foot access drive terminates in front of the school in a circular bus drop-off area. The lower, flatter part of the access drive (first 200± feet from Harpswell Island Road) is in poor condition with cracks, potholes, and broken edges observed. The upper, steeper section of the drive and the bus drop-off loop also has areas of cracking observed but is in somewhat better condition, although the entire drive and bus loop all appear to be of the same vintage. There is a drainage ditch along the access drive that is in need of maintenance.

Harpswell Community School lower access drive facing Harpswell Island Road

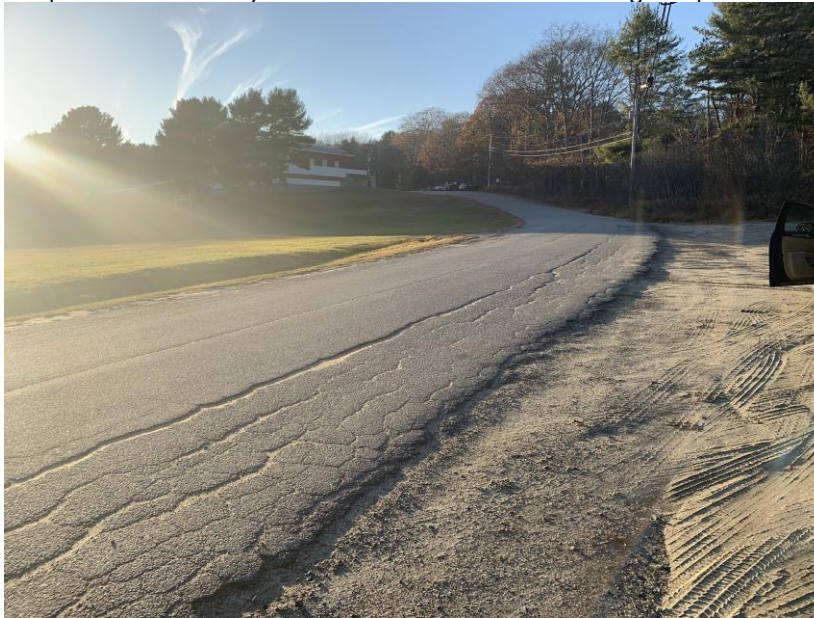
Lower access drive facing uphill

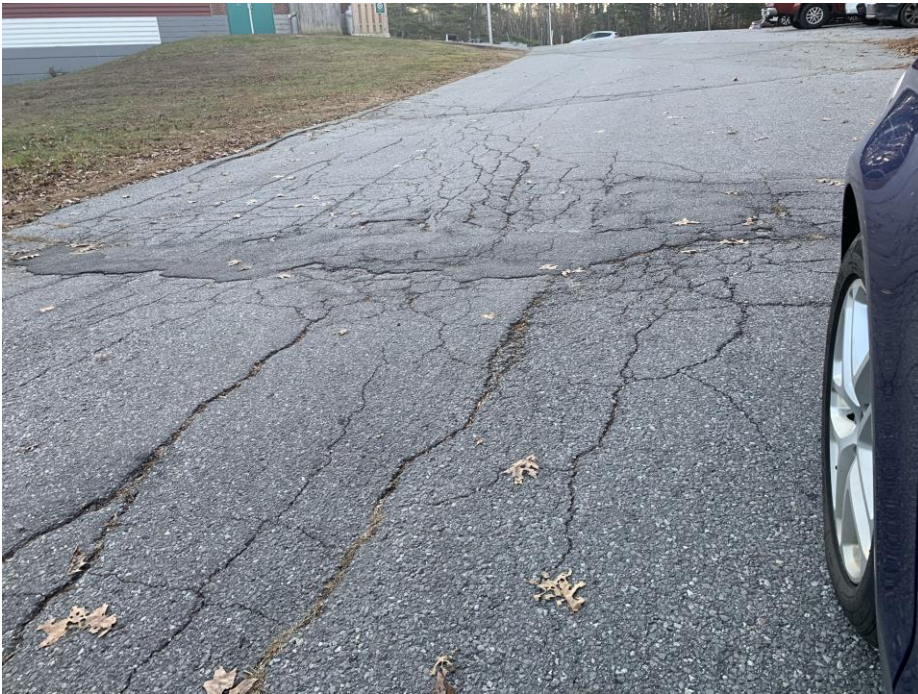
Harpwell Community School upper access drive facing uphill

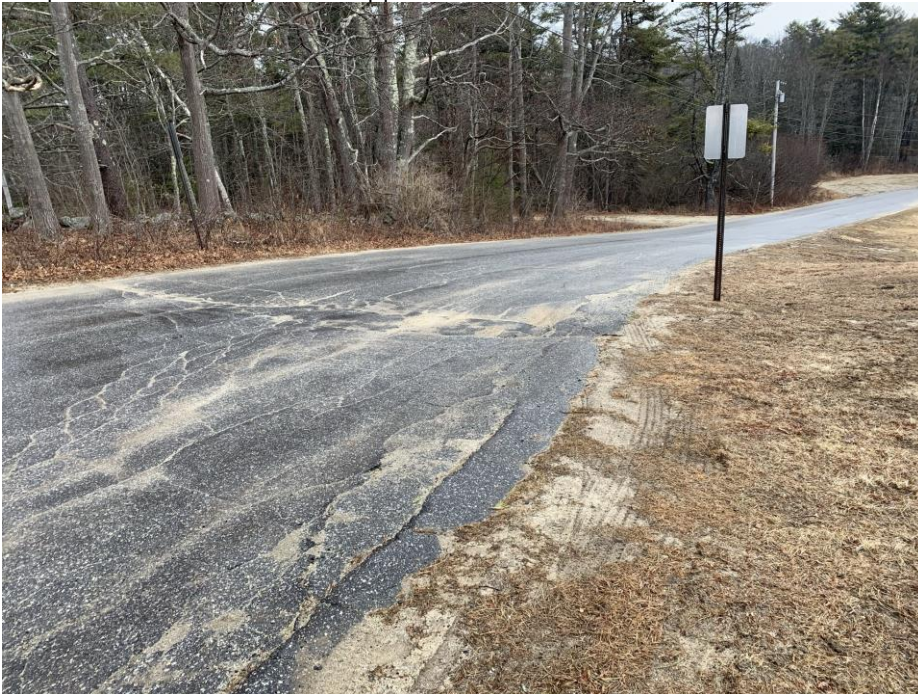
Harpwell Community School upper access drive facing downhill

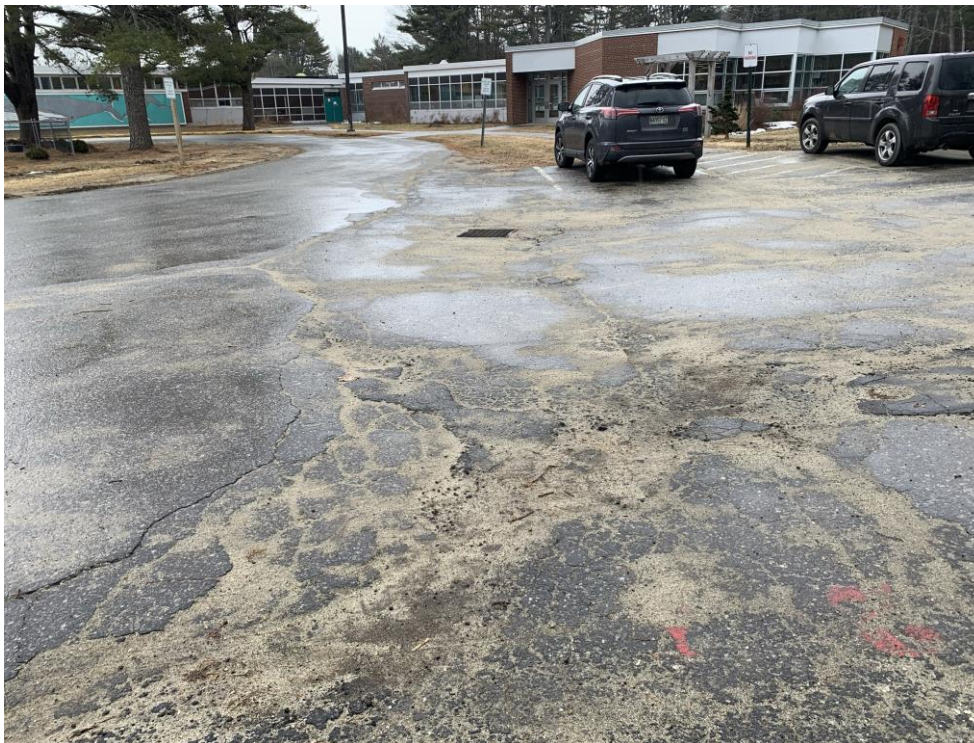
Parking area: There is a 21,000-SF parking area next to the bus drop-off loop at the top of the hill which has capacity for approximately 50 vehicles. The pavement in this parking area is in fair to poor condition with significant cracks and areas of differential settlement observed.

Harpswell Community School Parking area where it borders bus loop

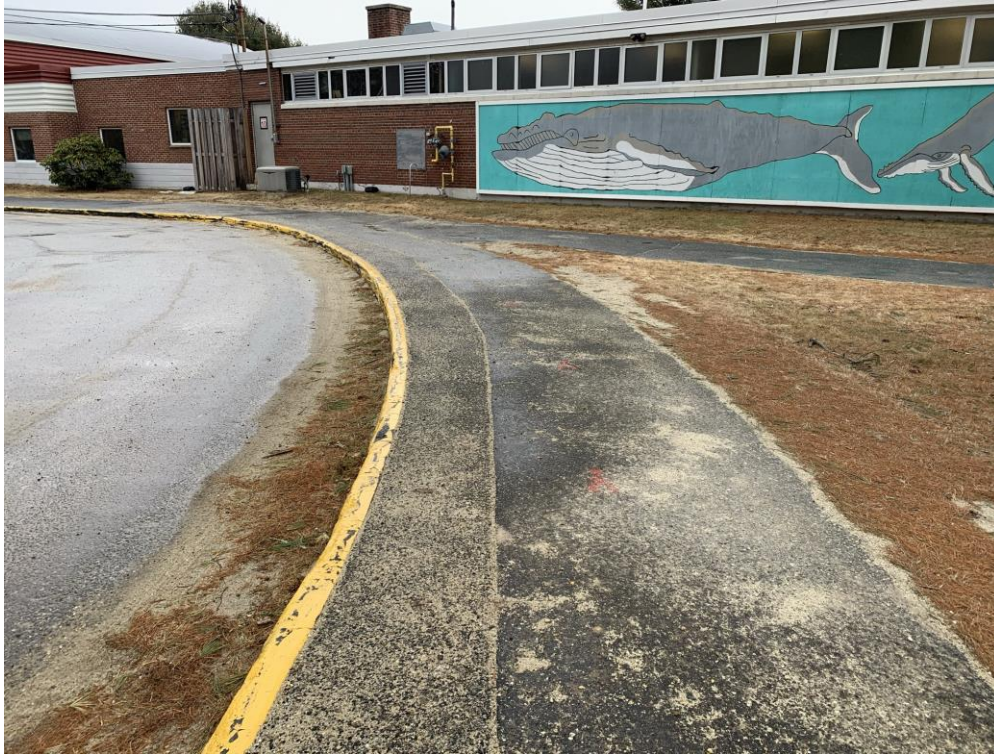
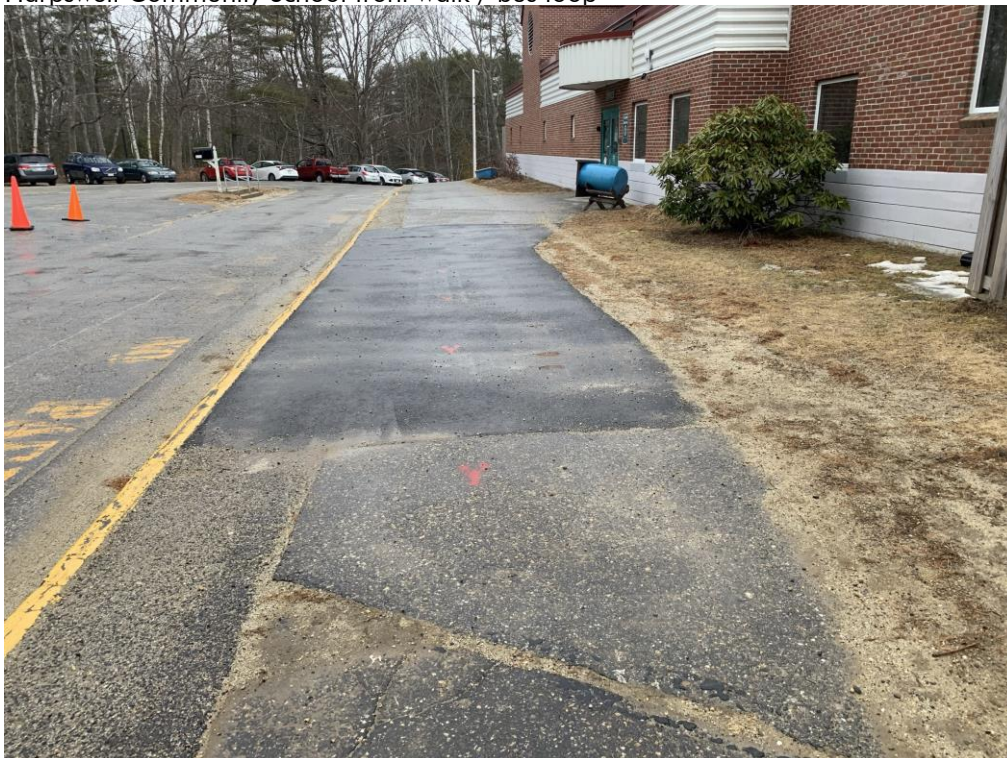
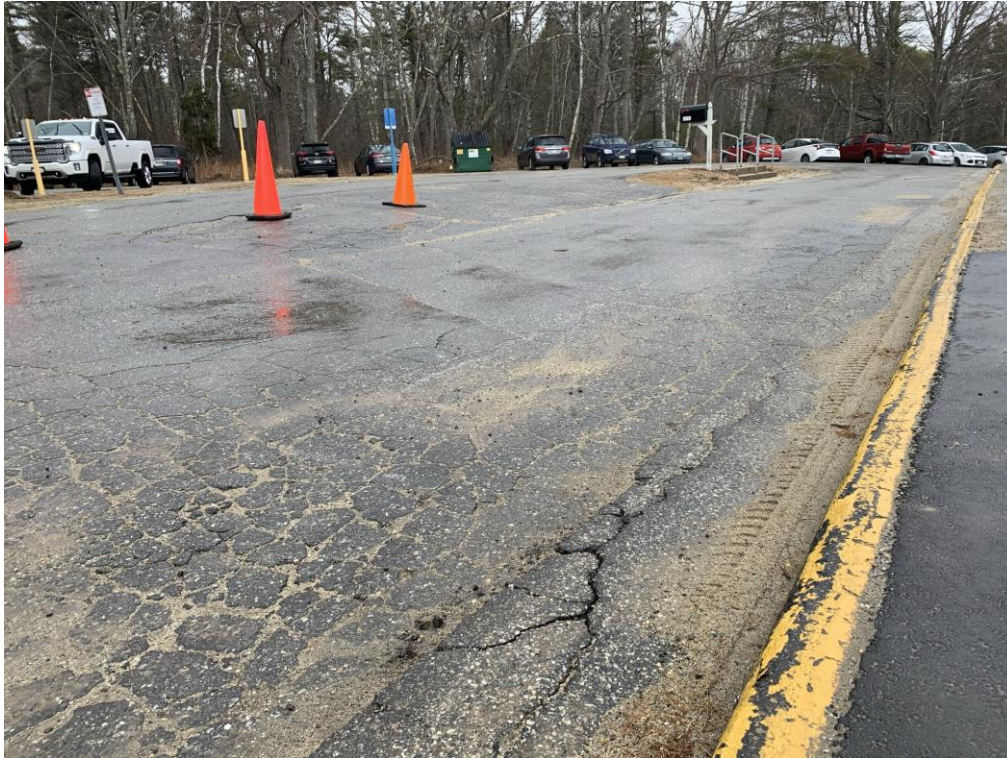
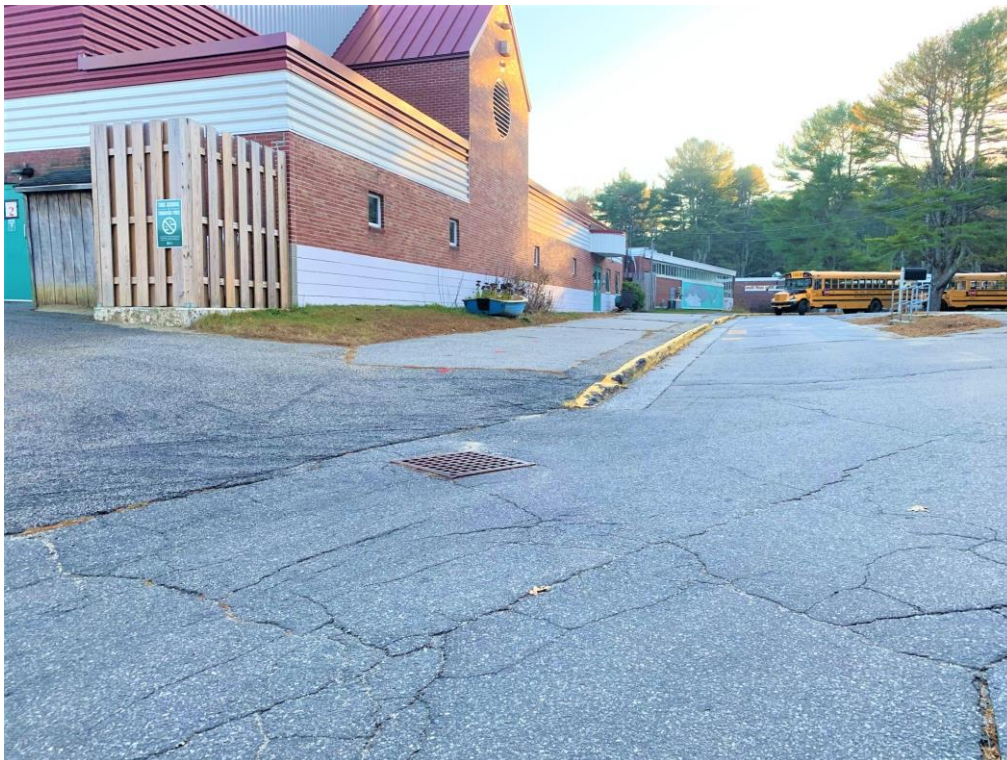
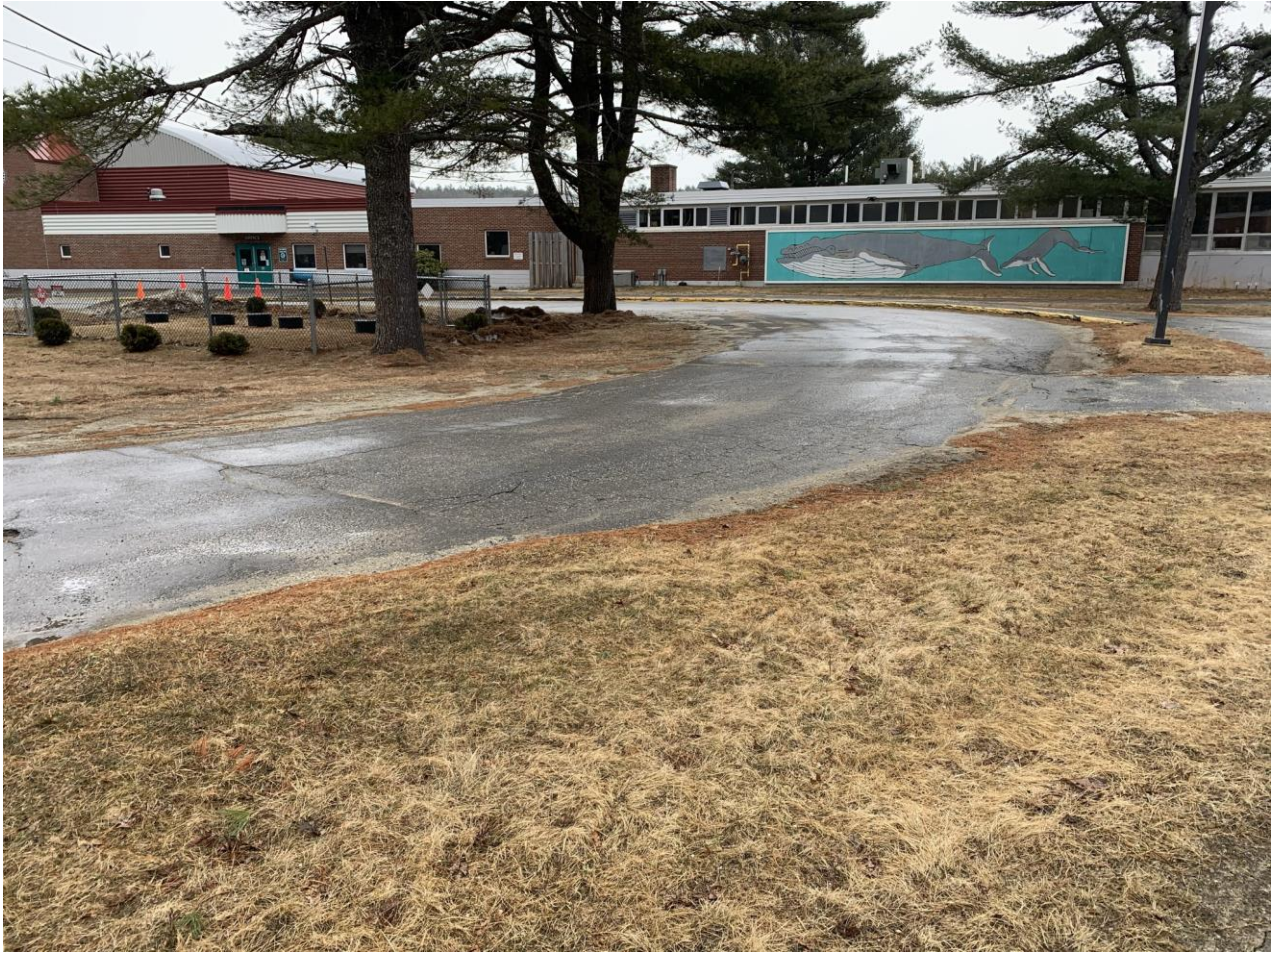
Front walk & entry plaza: There is an 8000-SF asphalt walkway at the front entrance to the school that extends the length of the front of the school, abuts the bus drop-off lane, encompasses the main entrance plaza area, and connects the parking area to the school. This pavement is in fair to poor condition.

Harpswell Community School front walk / bus loop

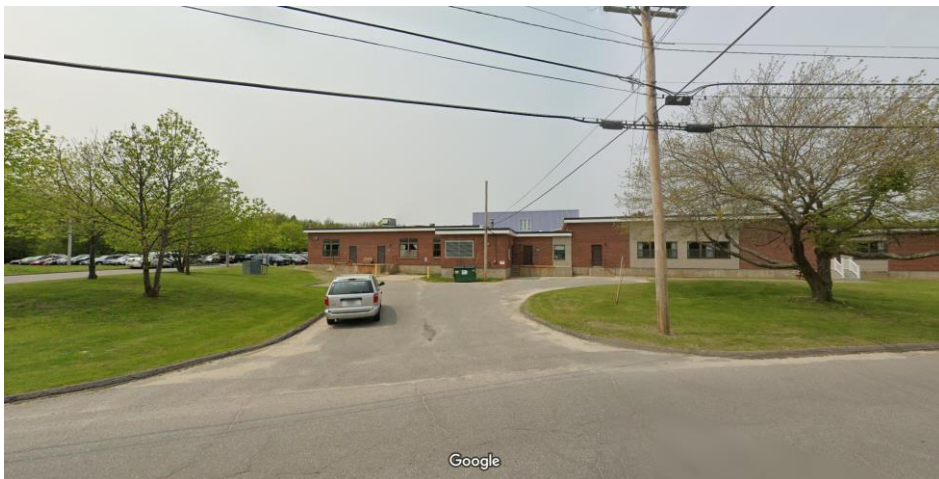
MSAD Office service driveway off Canam Drive (2019 photo)

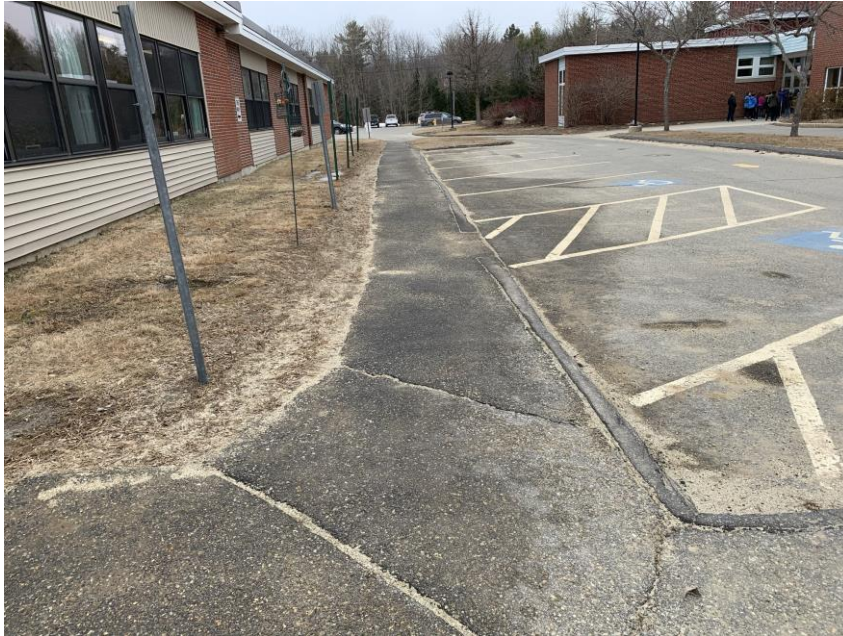
Sidewalk: The walkway connecting the two parking areas to the front of the school and Republic Ave is in fair condition, as shown below.

MSAD Office front walk and parking area #2

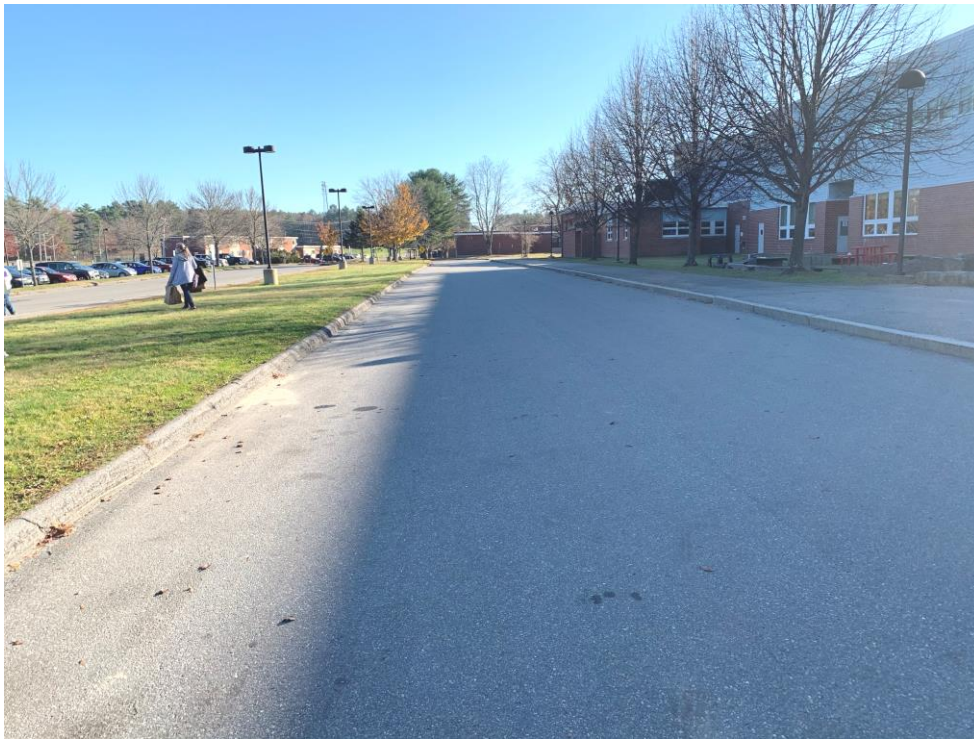
Mt. Ararat Middle School Republic Ave bus lane facing south

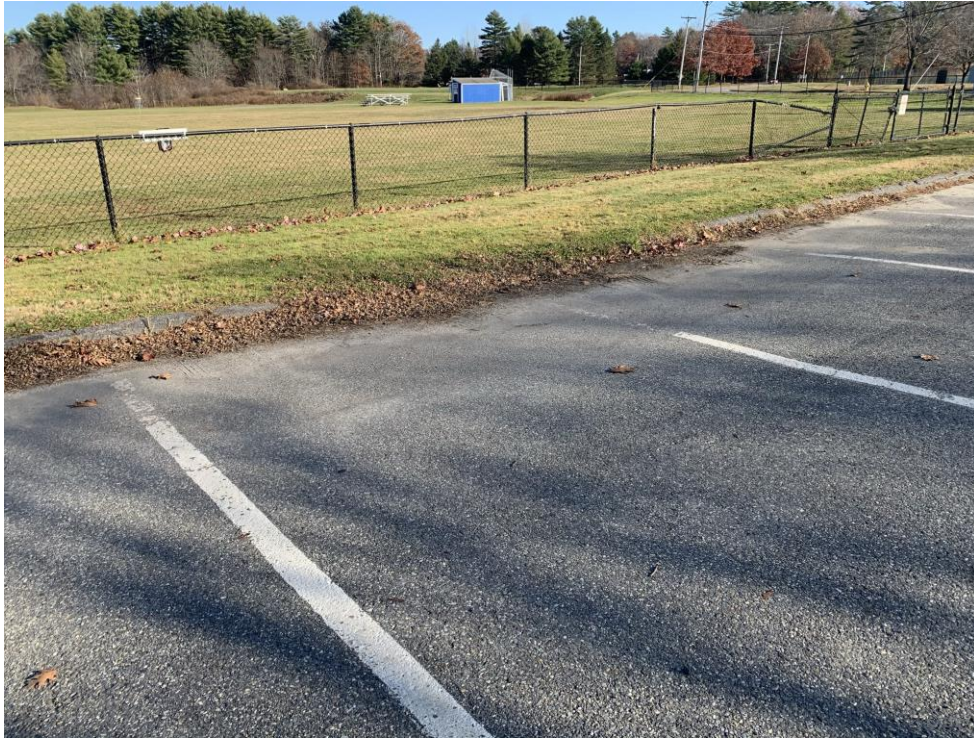
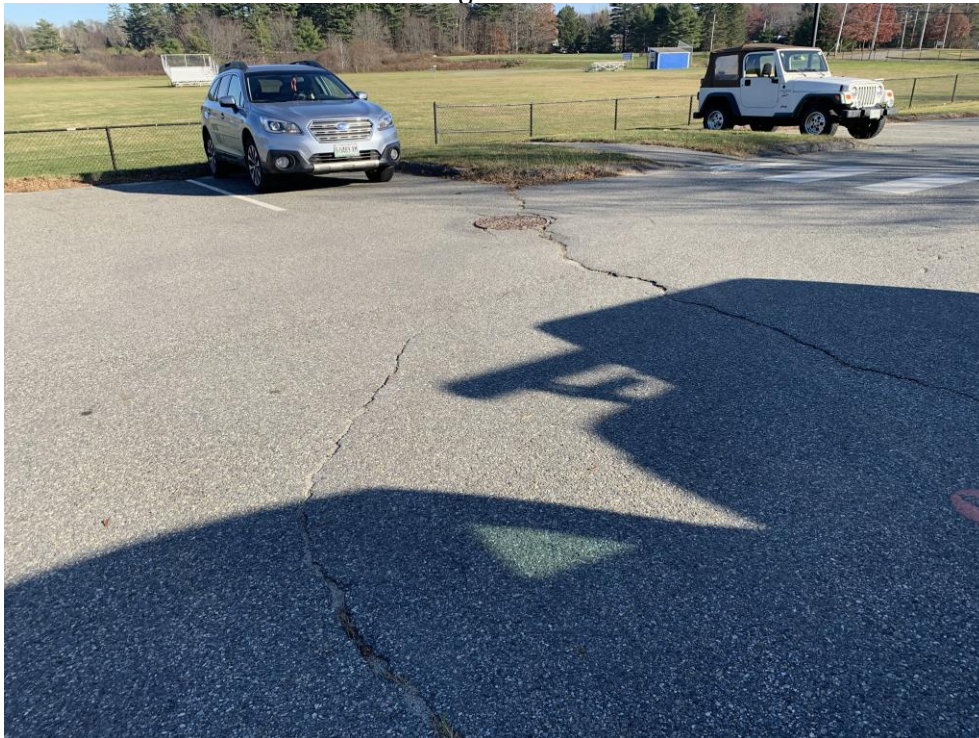
East Parking Area: The east parking area located parallel to Republic Ave is 26,000± SF, accommodates 75 vehicles, and is in fair condition.

Mt. Ararat Middle School East Parking Area

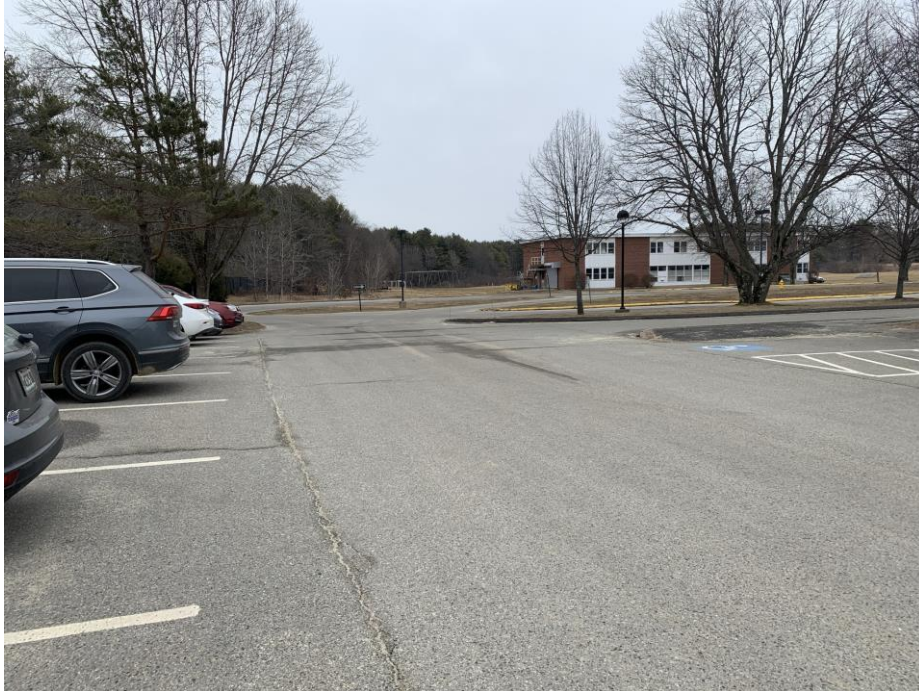
North Parking Area: The north parking area, located off the U-turn area of Republic Ave, is 23,000± SF and accommodates 62 vehicles.

Mt. Ararat Middle School North Parking Area

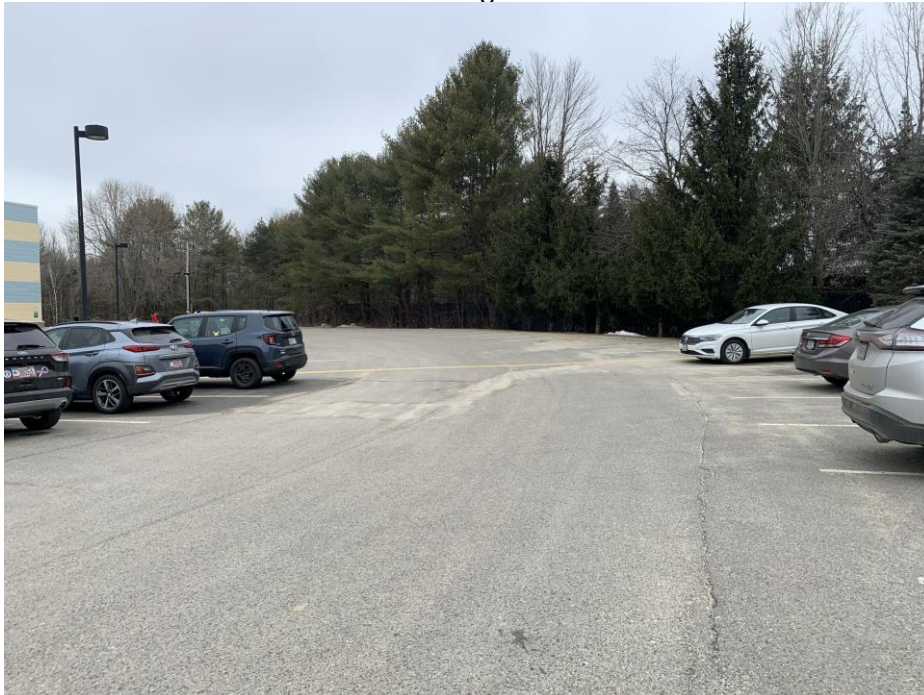
Mt. Ararat Middle School North Parking Area

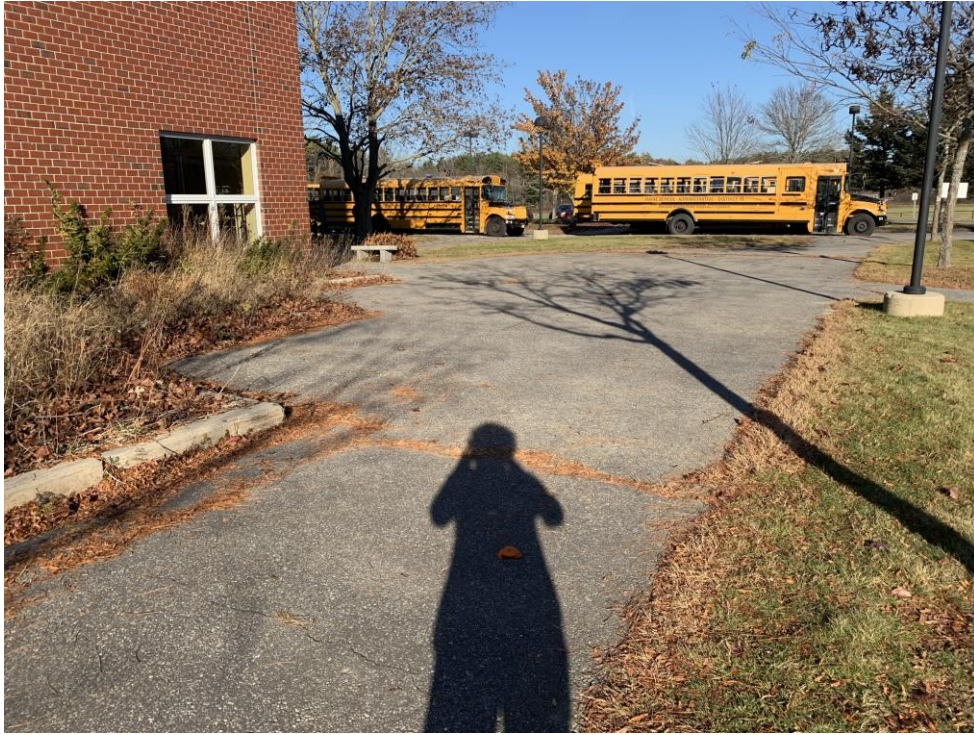
Orion Theater Walkways: The walks surrounding the Orion Theater are in fair condition, and appear to have been partially replaced over the years.

Orion Theater Walkway

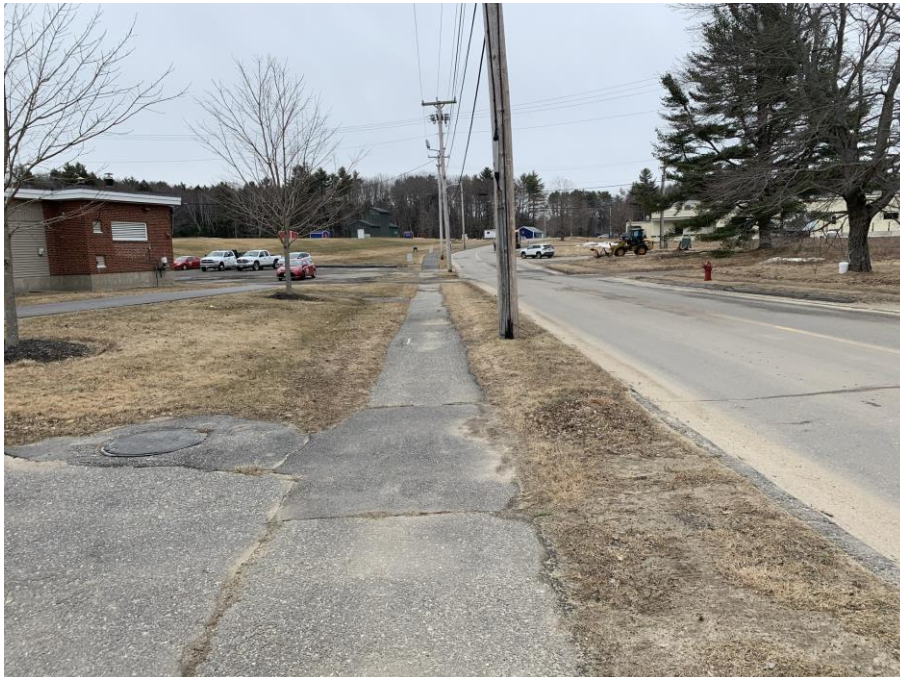
Republic Ave, facing south, showing sidewalk parallel to Merrymeeting building

Priorities for Republic Ave: The sidewalk from the end of the new sidewalk to Canam Drive should be a priority, as it is in poor condition, and this would complete the walk along this stretch of road. When the sidewalk is replaced, the connecting segment to the front of the Merrymeeting building should also be replaced. The road itself is in fair to good condition.

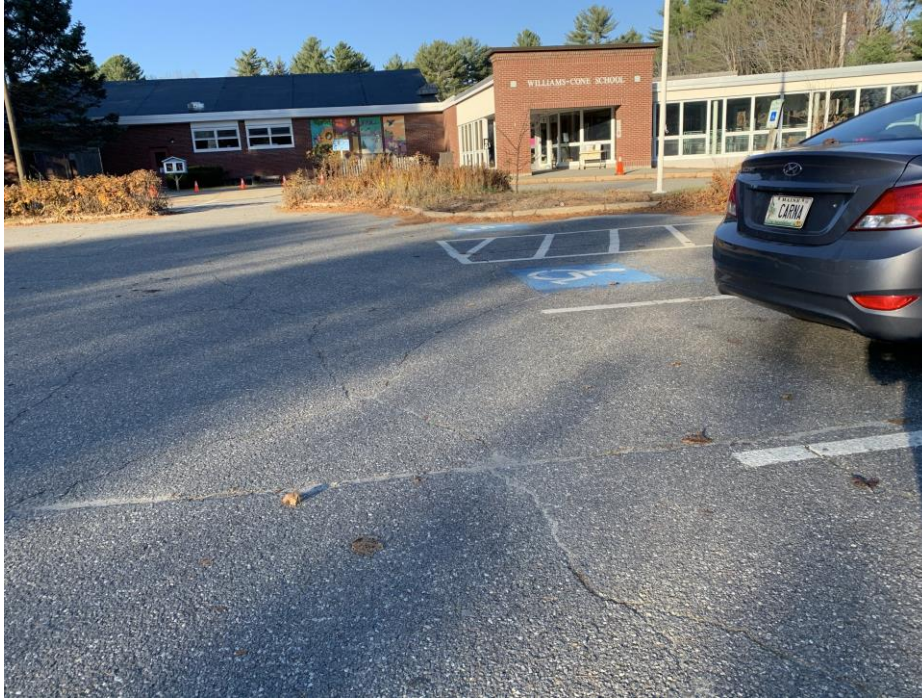
Williams-Cone School central parking area

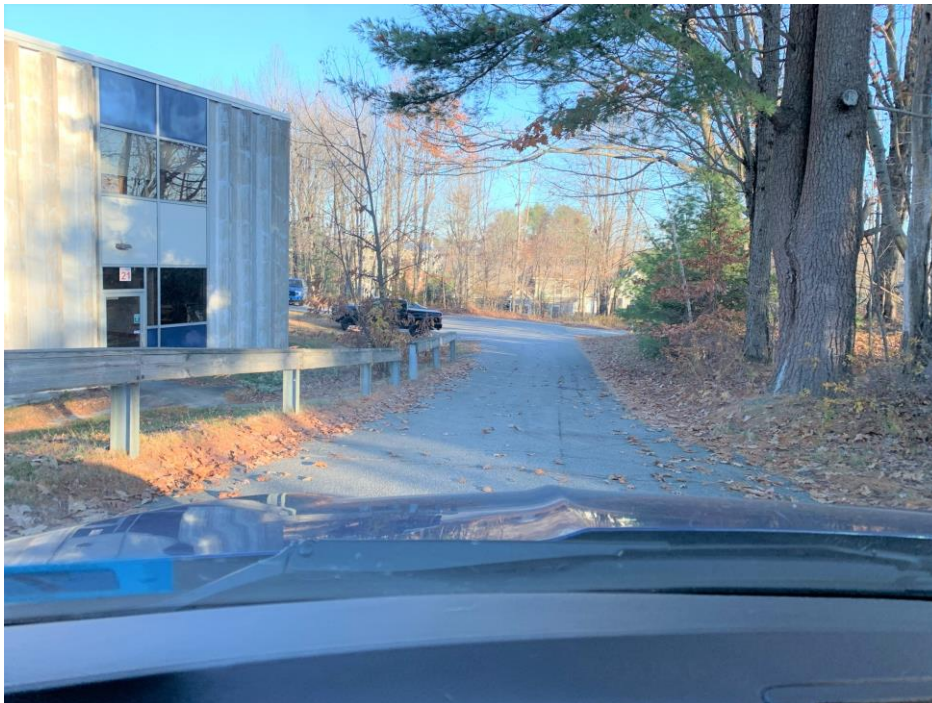
Lower Parking Area: There is a lower parking area on the east side of the school, accessed off a driveway that branches off the main access loop. The access drive has a fairly steep pitch down to the parking area. This parking area contains 10,000± SF of pavement, accommodates approximately 26 vehicles, and is in fair condition.

Williams-Cone School driveway to lower parking area

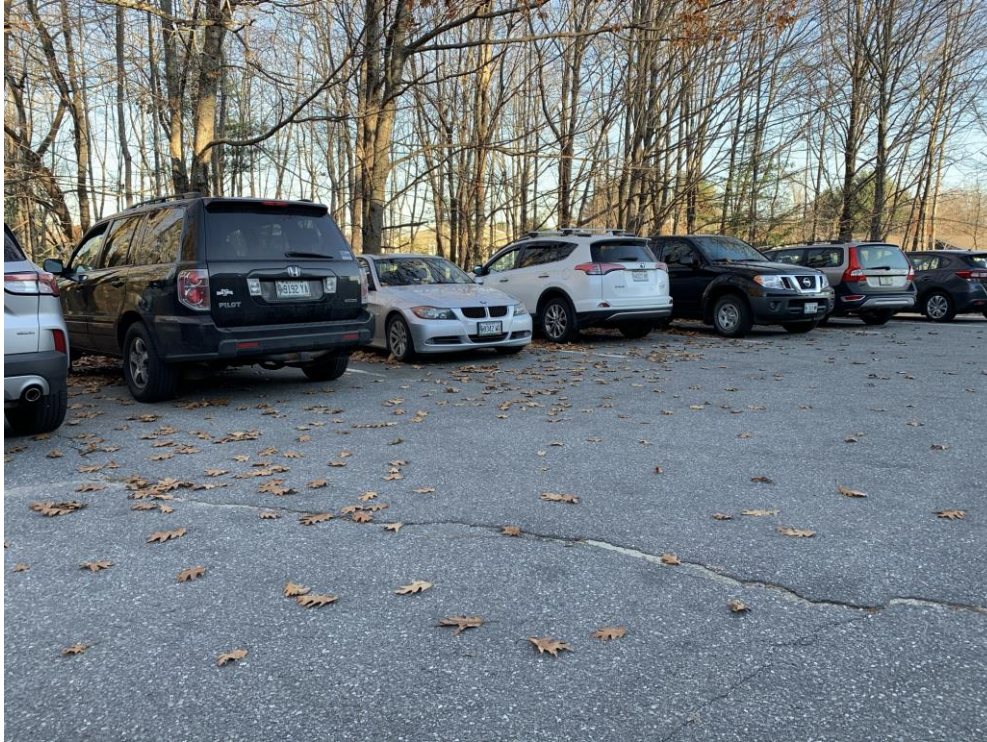
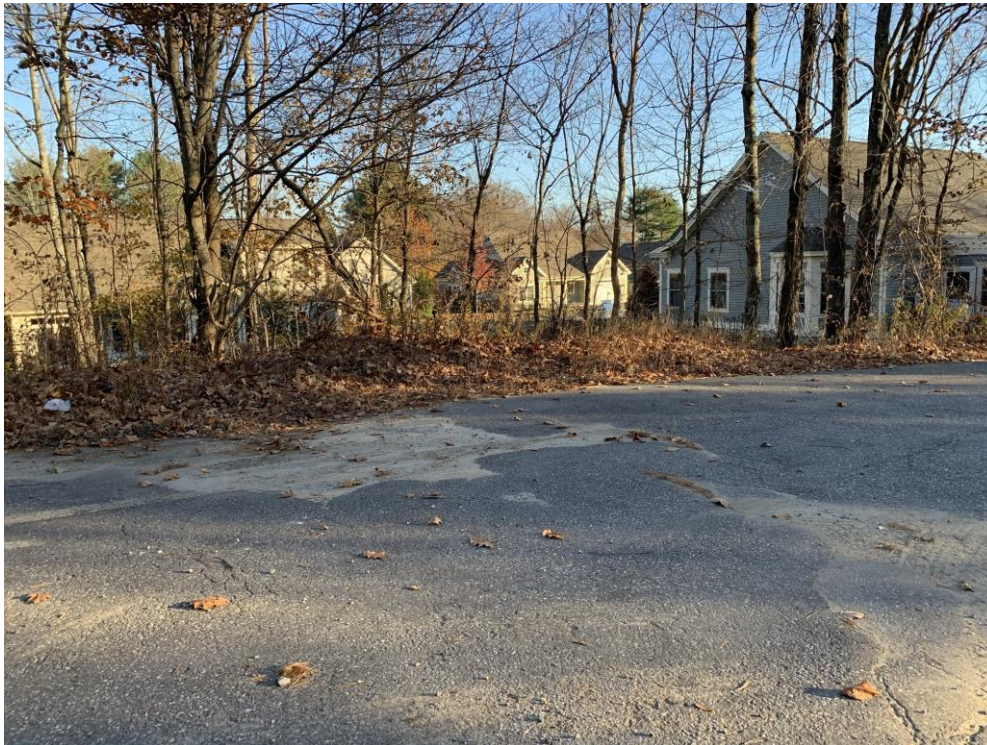
Williams-Cone School lower parking area

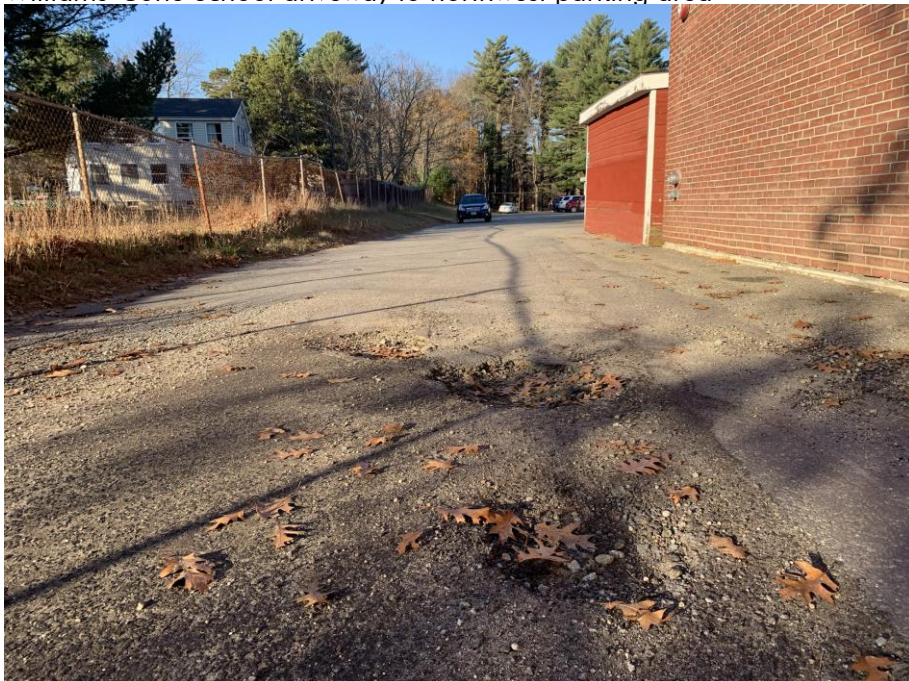
Northwest Parking Area: Another driveway branches off the main access drive that leads to the rear of the school (northwest side.) The drive and parking area are in very poor condition, with large potholes and significant amounts of spalling and cracked pavement observed. The parking area accommodates approximately 21 vehicles. The drive wraps around the north side of the school and connects to a large paved playground on the northeast side of the school.

Williams-Cone School driveway to northwest parking area

Priorities for Williams-Cone School: The northwest parking area, the drive to the northwest parking area, and the north/northeast playground are in very poor condition and warrant immediate attention. The remainder of the pavement on the campus is in fair condition.

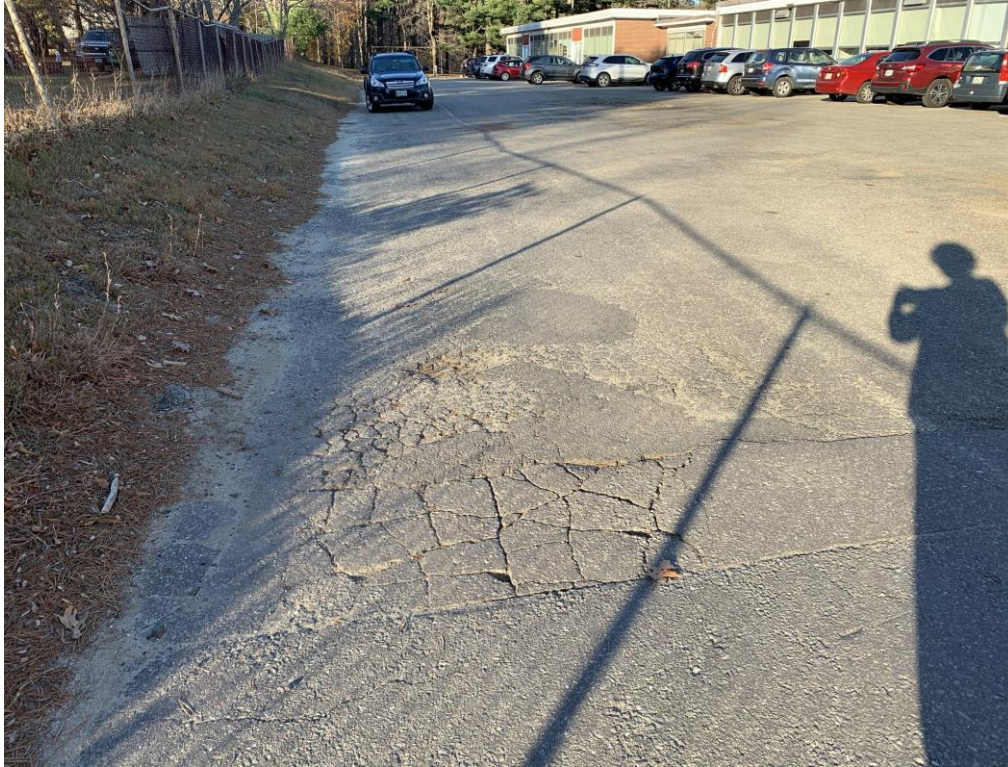
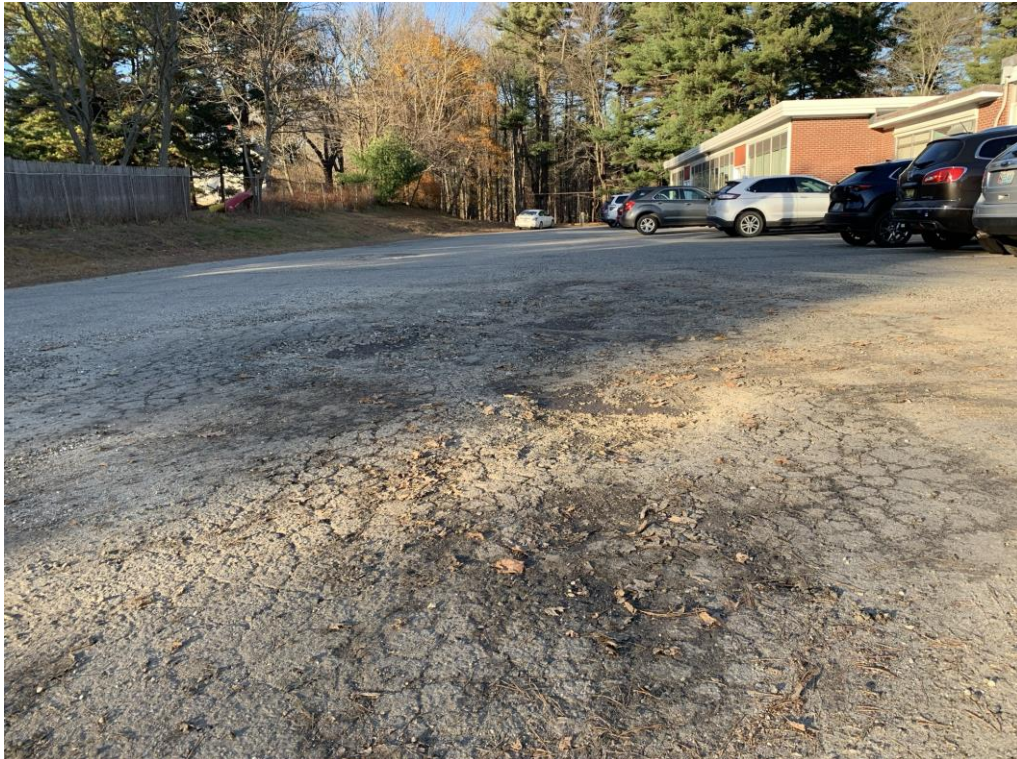
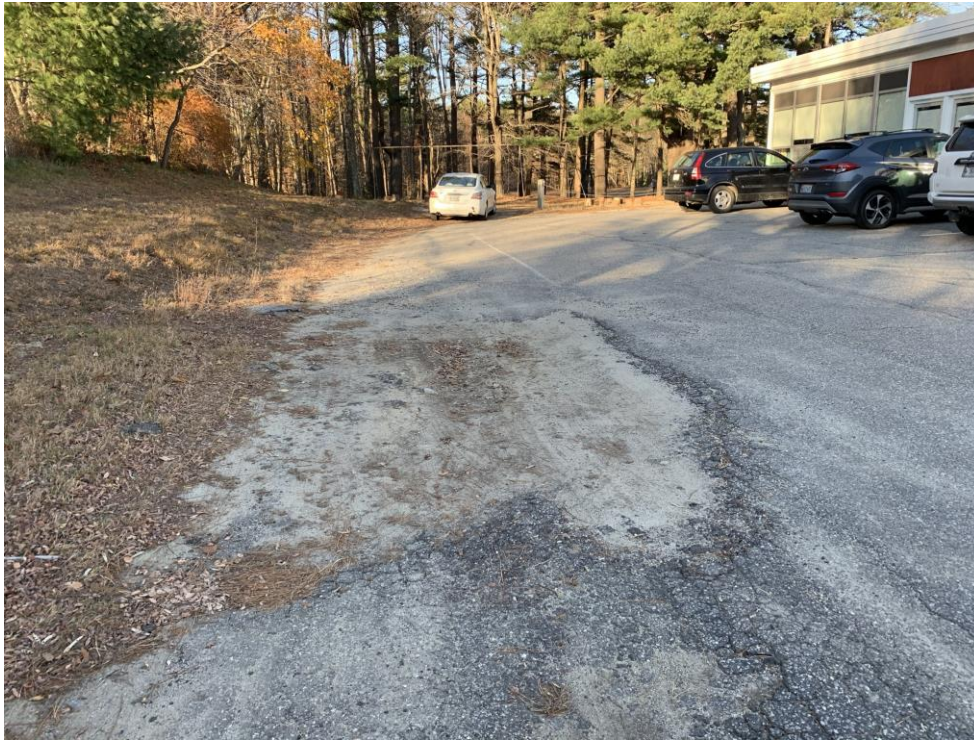
Williams-Cone School northwest parking area
