Maine School Administrative District 75
Asphalt Assessment Study Report

Prepared for
Maine School Administrative District 75
50 Republic Avenue
Topsham, ME 04086

RFS 20-9466.001

June 09, 2021

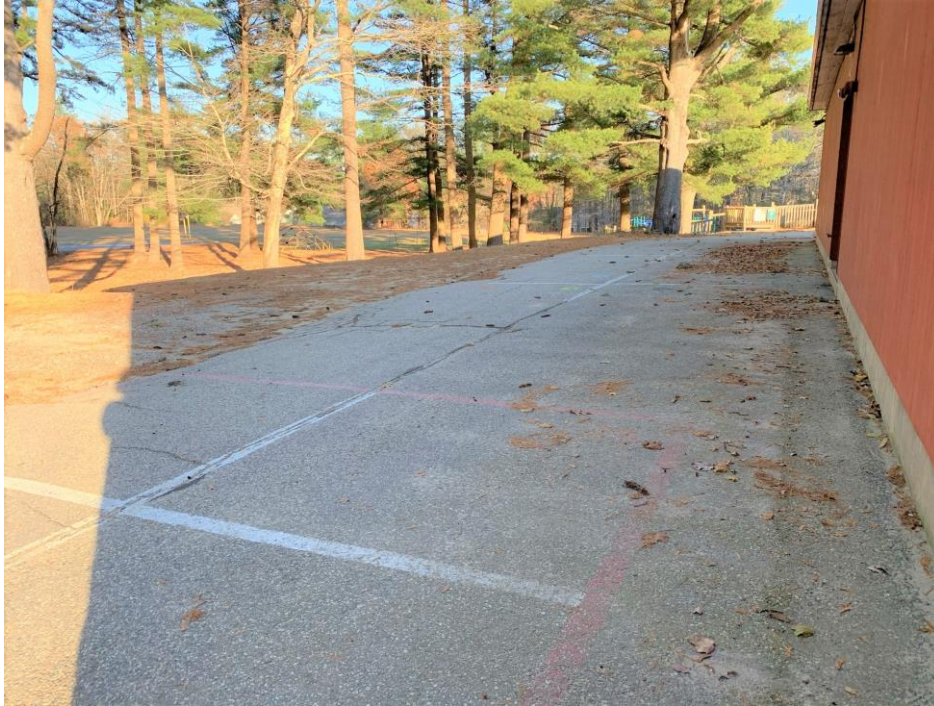
Williams-Cone School drive / playground area at north side of building

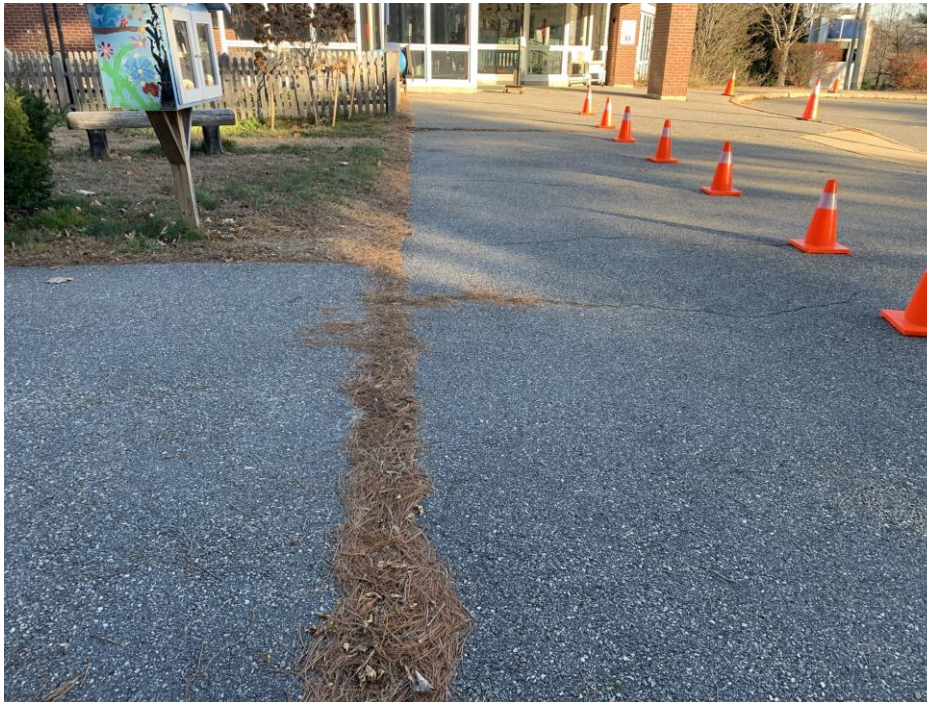
Williams-Cone School main entry plaza

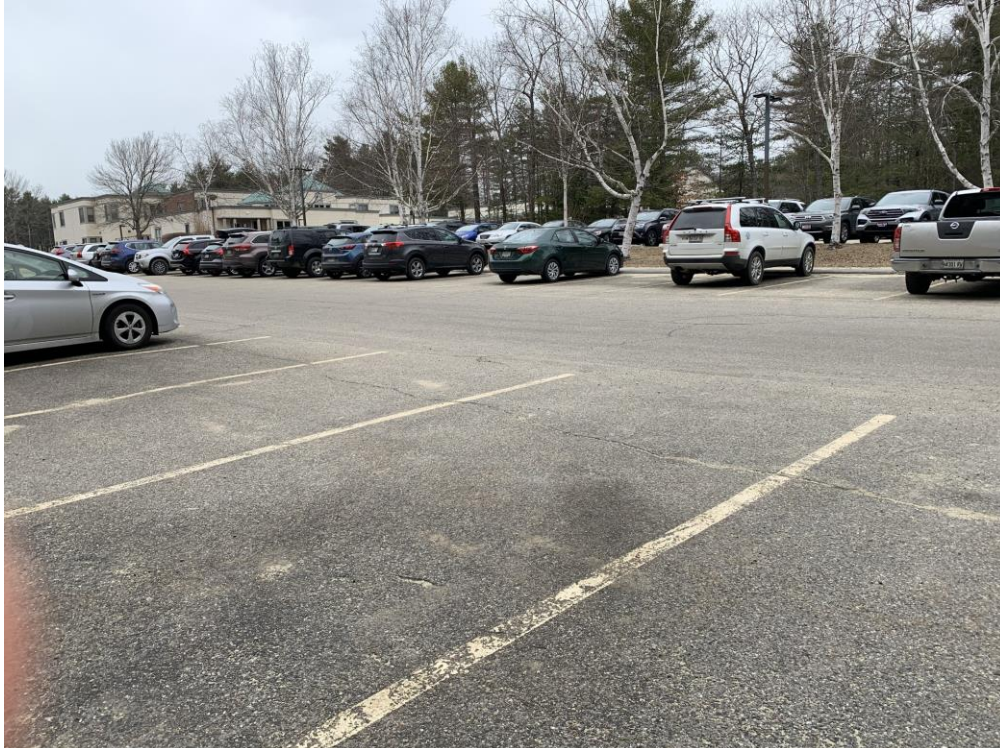
Woodside Elementary School northeast parking area

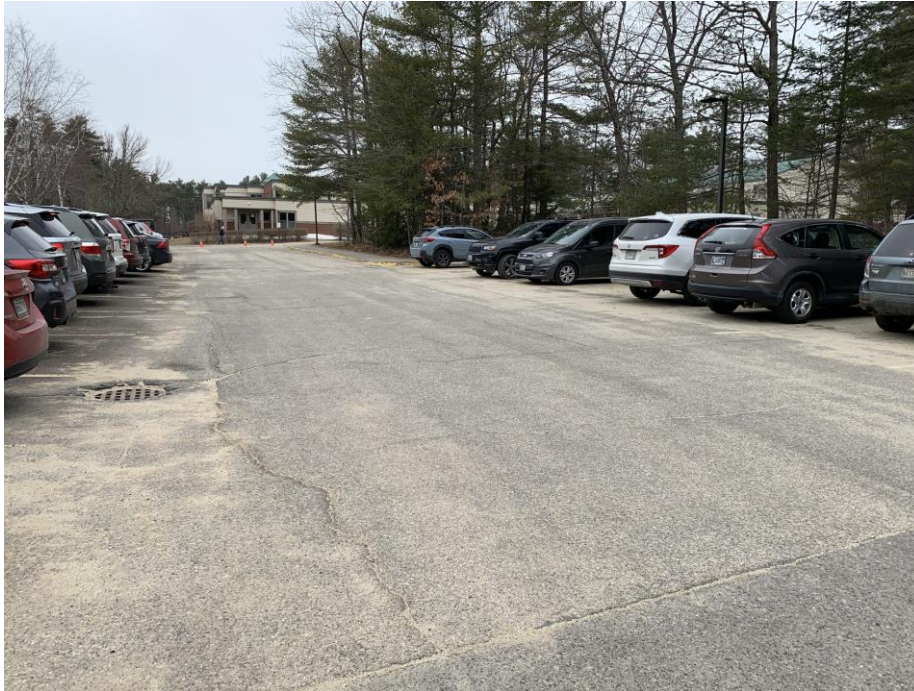
Woodside Elementary School northwest parking area
